St Andrews Harbour
North West Slipway

Feasibility Study into the
Reinstatement of the North
West Slipway & Harbour Wall

July 2024

CLIENT: St Andrews Harbour Trust
PROJECT TITLE: St Andrews Harbour North West Slipway
REPORT TITLE: Feasibility study into the Reinstatement of the North West
PROJECT REFERENCE: 159462
DOCUMENT NUMBER: 159462-DOC-01

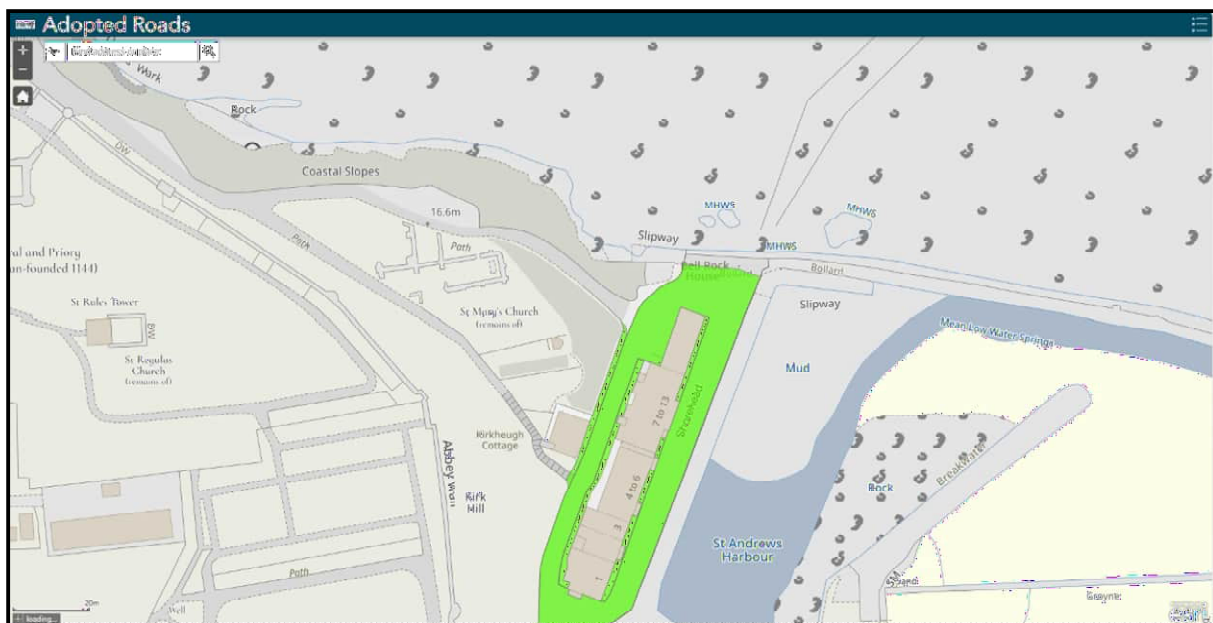
Figure 1: Fife Council Mapping Showing the Extent of Adopted Roads

Fife Council website provides mapping indicating the extent of adopted roads within the local authority area. This is presented in **Figure 1** below showing that the adopted road forms part of the eroded and damaged area and that the harbour wall and slipway appear to support the adopted road and therefore, Fife Council may have involvement and some form of responsibility for maintenance/repair.

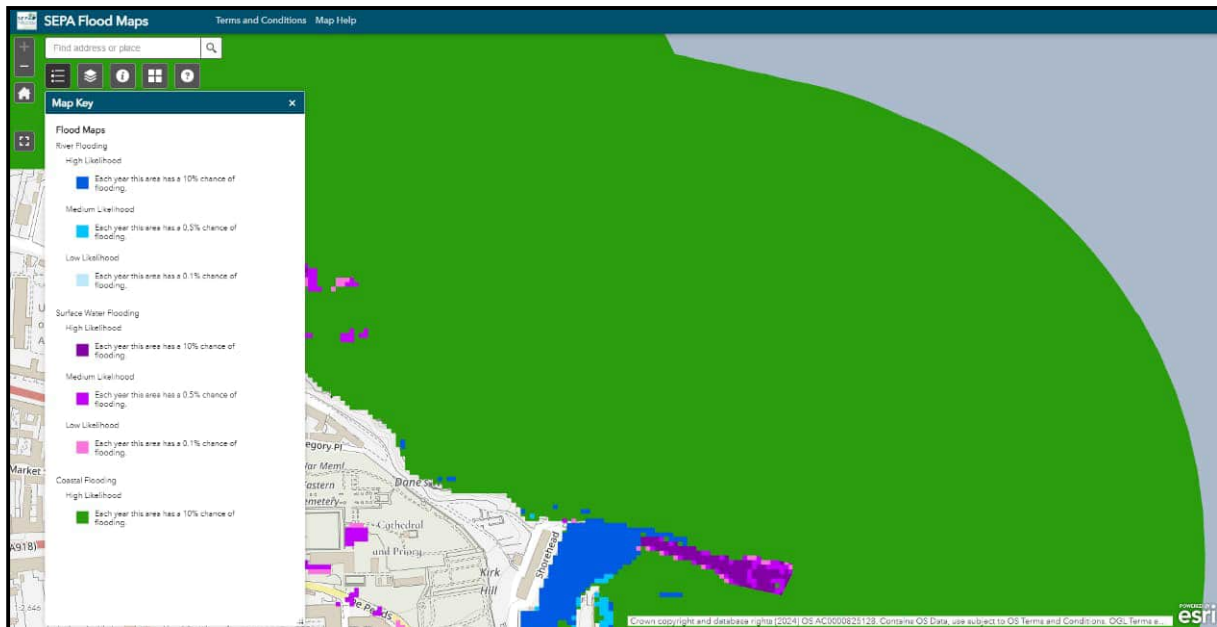
Figure 2: SEPA Flood Risk Mapping for the St Andrews Harbour Area (Courtesy of SEPA)

SEPA flood mapping was consulted for a preliminary assessment of Flood Risk at the site for both Surface Water, River and Coastal flooding. The results are shown below in **Figure 2**, where the site is at risk of all three types of flood risk.

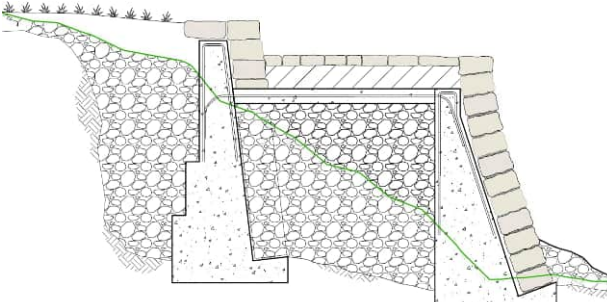
Option 1: In-situ Concrete Wall with Masonry Cladding- Rock Key Formed

Fife Council Comment- Fife council likely to be supportive but would need detail to ascertain how rock cladding would be fixed to the concrete. Fife council would need to see how any option ties in to existing wall and coastline.
---	--	---

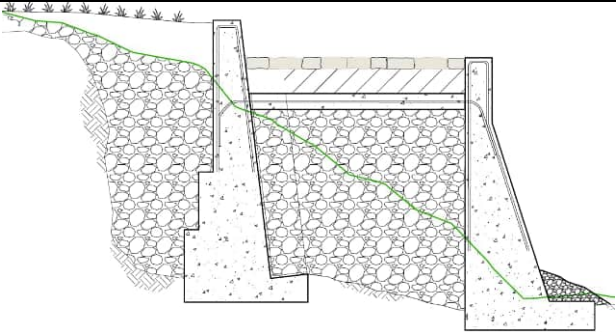
<p>Option 2: In-situ Concrete Wall with Patterned Concrete - Rock Key Formed</p>

<p>Fife Council Comment – Fife Council did not support the use of patterned concrete and would prefer plain faced concrete, and paraphrasing; don't disguise new for old, just be honest with the design. Fife council would need to see how any option ties in to existing wall and coastline.</p>
<p>Option 3: Gabion Basket Wall</p>

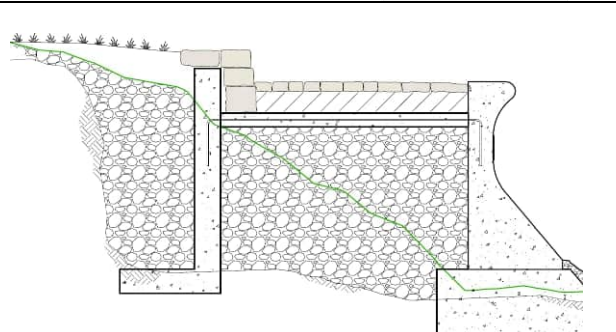
<p>Fife Council Comment- may be supported but would need to justify any erosional difference to coastline up and down stream. Fife council would need to see how any option ties in to existing wall and coastline.</p> <p>Fife Council Built Heritage - Limited in how supportable this would be from a heritage legislation/policy/guidance standpoint due to significant change in appearance of walling profile.</p>

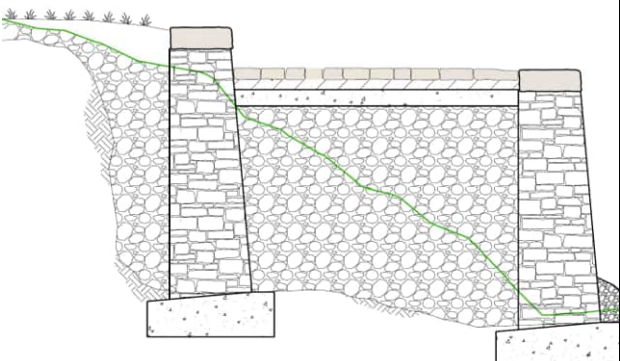
<p>Fife Council Comment- likely to be supportive but would need detail to ascertain how rock cladding would be fixed to the concrete. Fife council would need to see how any option ties into existing wall and coastline.</p> <p>Fife Council Built Heritage - Not clear on the Rock Key aspect of this and what this constitutes/ would look like. Concern also with viability long-term in differential construction methods where the masonry wall meets the concrete foundation. As such, is less supportable as an option.</p>
Option 7: Piled Wall (Sheet/Secant/Kingpost)
