# Bullhole Berthing Structure

## Construction Methodology

Project reference: HP2171065  
Project number: 60637648  
BUHO-ACM-XX-XX-RP-MT-000005

October 2022

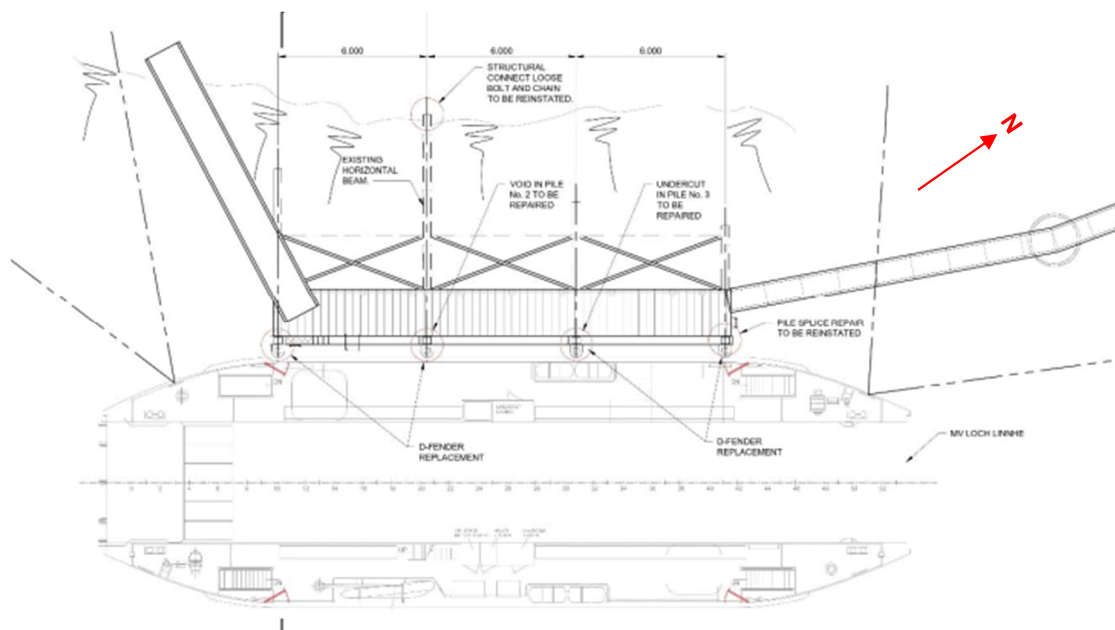
Figure 1-3: Structure on Plan

- 1.12 The primary berthing structure comprises four steel piles at 6m spacing. Each pile is cast into a base foundation comprising an in-situ concrete filled precast manhole. Lateral support at the head of each pile is provided by a raking strut which is anchored to the rock face.
- 1.13 A walkway is formed of a secondary steel structure supported off the pile head and stut and is accessed from bridging structures at either end. These structures do not contribute to the primary load path of the structure to resist vessel loads.
- 1.14 All pile foundations are located below LAT. The steel work fixed back to the rock face
