UB 132/017 Forth Viaduct

Form 001

Doc. No.: 2444-MHB-REP-005

NR/L2/CIV/003/F001: APPROVAL IN PRINCIPLE				
Document reference	2444-MHB-REP-005	Revision	A	Page 1 of 27
GRIP Stage	3	Date	28 May 2021

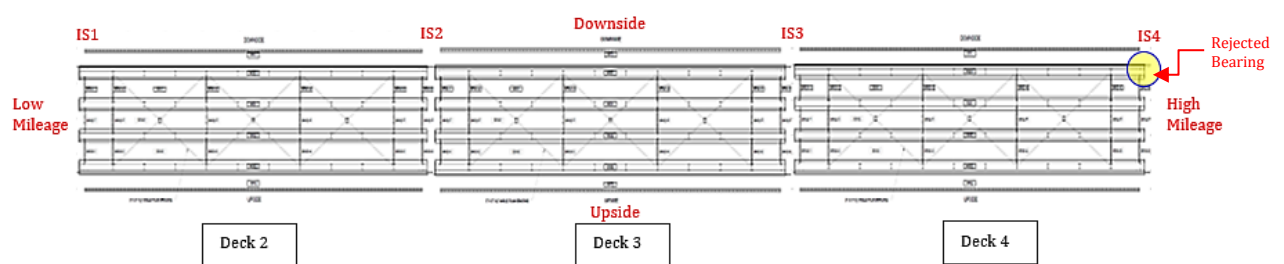
Figure 3-Bearings and Span Arrangements of UB 132/017

As part of the CRT for UB 132/017, Non-Destructive Testing (NDT) (reference LWC-Forth Viaduct 014) was undertaken during the initial site surveys to determine the condition of the bearings and whether any works would be required. The Magnetic Particle Inspection (MPI) testing was undertaken at all 24 bearings on 21 September 2020 by Gordon Wood Associates on behalf of Lanarkshire Welding Company (Reference: LWC-Forth Viaduct 014 to 017) with photos taken of all bearings inspected. Of the 24 bearings tested, 1 No. bearing was rejected, which was located at the High Mileage End of MGE1 on Deck 4 of the structure (see Figure 3 for location). The rejection of the bearing was due to a horizontal crack noted at the 'T' outstand at the end of the bearing as should in Figure 4.
