Site Hazard Log and Map

Workplace/Location/Access Ardoch Coach House Ardoch Cardross Dumbarton - W3W taskbar.fragment.skill -

Remit / Job Description 25/26 Repairs and Proactive works to scour and voiding - Replace damaged concrete toe to base of revetment at 18m 668-9yds, approx 2m length. (Opex Policy Target X)

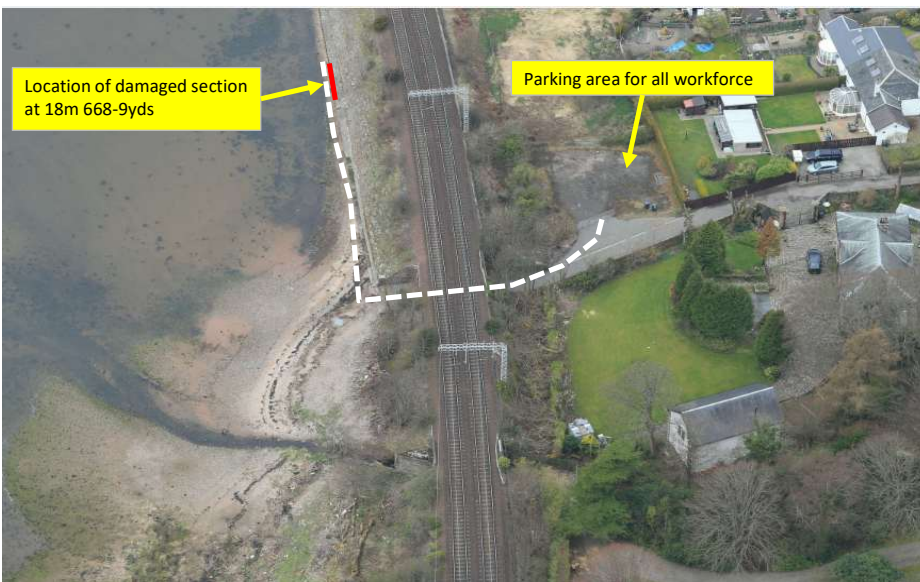
20 SKETCH OF WORKS

- 8 The supervisor will mark-up defective areas at 18m 668-9yds of the concrete base around the extremities of the exposed concrete. The workforce will then proceed to saw draft edges and breakout the defective concrete with the use of a Stihl Saw and hydraulic breakers. The workforce will then proceed to remove loose stones and dig in 600mm deep, 1.2m wide x 3m long toe for new concrete apron/toe to be poured.

- 13 Amco supervisor will check over the new concrete pour and if any areas need to be touched up amco operatives will carry out these works.
- 14 Loose and displaced stone work on slope at this location is to be removed and re-established on a bed of fresh mortar. Brickwork is to be used where re-claimed material is not available, to fill the void.
