# **MORAY EAST** OFFSHORE WINDFARM

# **Post Construction Benthic Monitoring Report**

November 2024

Produced by Fugro GB Limited on behalf of Moray Offshore Wind Farm (East) Limited		
Produced by Paul English		
Document Status	Final	
Version	1	
File Name         MWE-OW-OP-REP-0002		
Date     21 November 2024

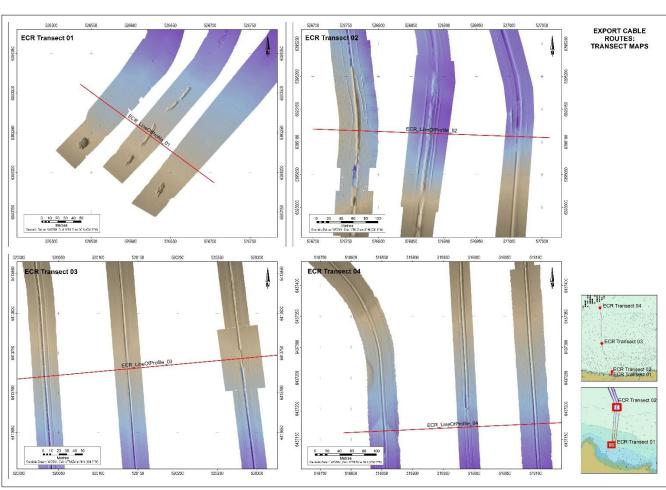
Figure 6. Selected locations along the OEC route reviewed for post-construction seabed effects

Placed cable protection material is evident along nearshore sections of the OEC routes. The absence of any linear scars or indentations at nearshore areas of the OEC corridor (Transect ECR 1 in Figure 6 and Table 10) suggests that they have been eroded since the 'as built' geophysical survey. In contrast, seabed impacts from cable installation along offshore and deeper water sections of the OEC routes remain visible within the geophysical datasets.

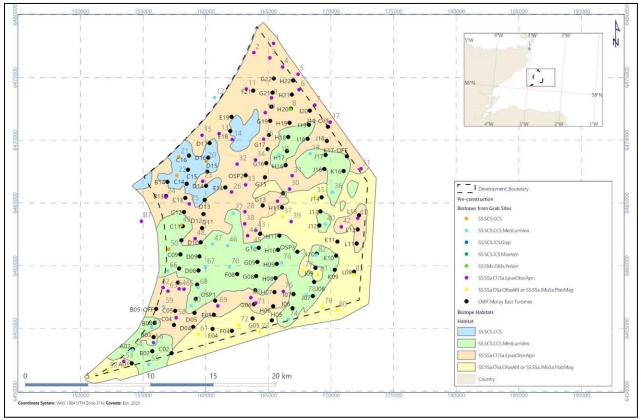
Figure 7. Moray East foundations overlaid onto the pre-application biotopes

Overlaying the locations of all of the Moray East foundations onto a map of the benthic biotopes (Figure 7), shows that up to 59 foundations have been installed in predominately sandy sediments (denoted by the SS.SSa.CFiSa.EpusOborApri, SS.SSa.OSa.OfusAfil or SS.SSa.IMuSa.FfabMag classifications). Assuming that all 59 foundations would be susceptible to seabed scour and effects and sediment alteration and that such effects are limited to predominately sandy sediments, then the total area of effect in this regard can be calculated as between 805.88 and 1,889.65 m<sup>2</sup> based on the widths of the pits and shell accumulations varying between 1 and 2 m around each of the three foundations piles at each turbine and OSP. This equates to between 0.0027 and 0.0064 % of the area of Moray East that is potentially susceptible, and may be experiencing, post-construction seabed scour effects and local sediment alteration.
