# Loch Carnan Jetty Refurbishment South Uist, Outer Hebrides Method Statement

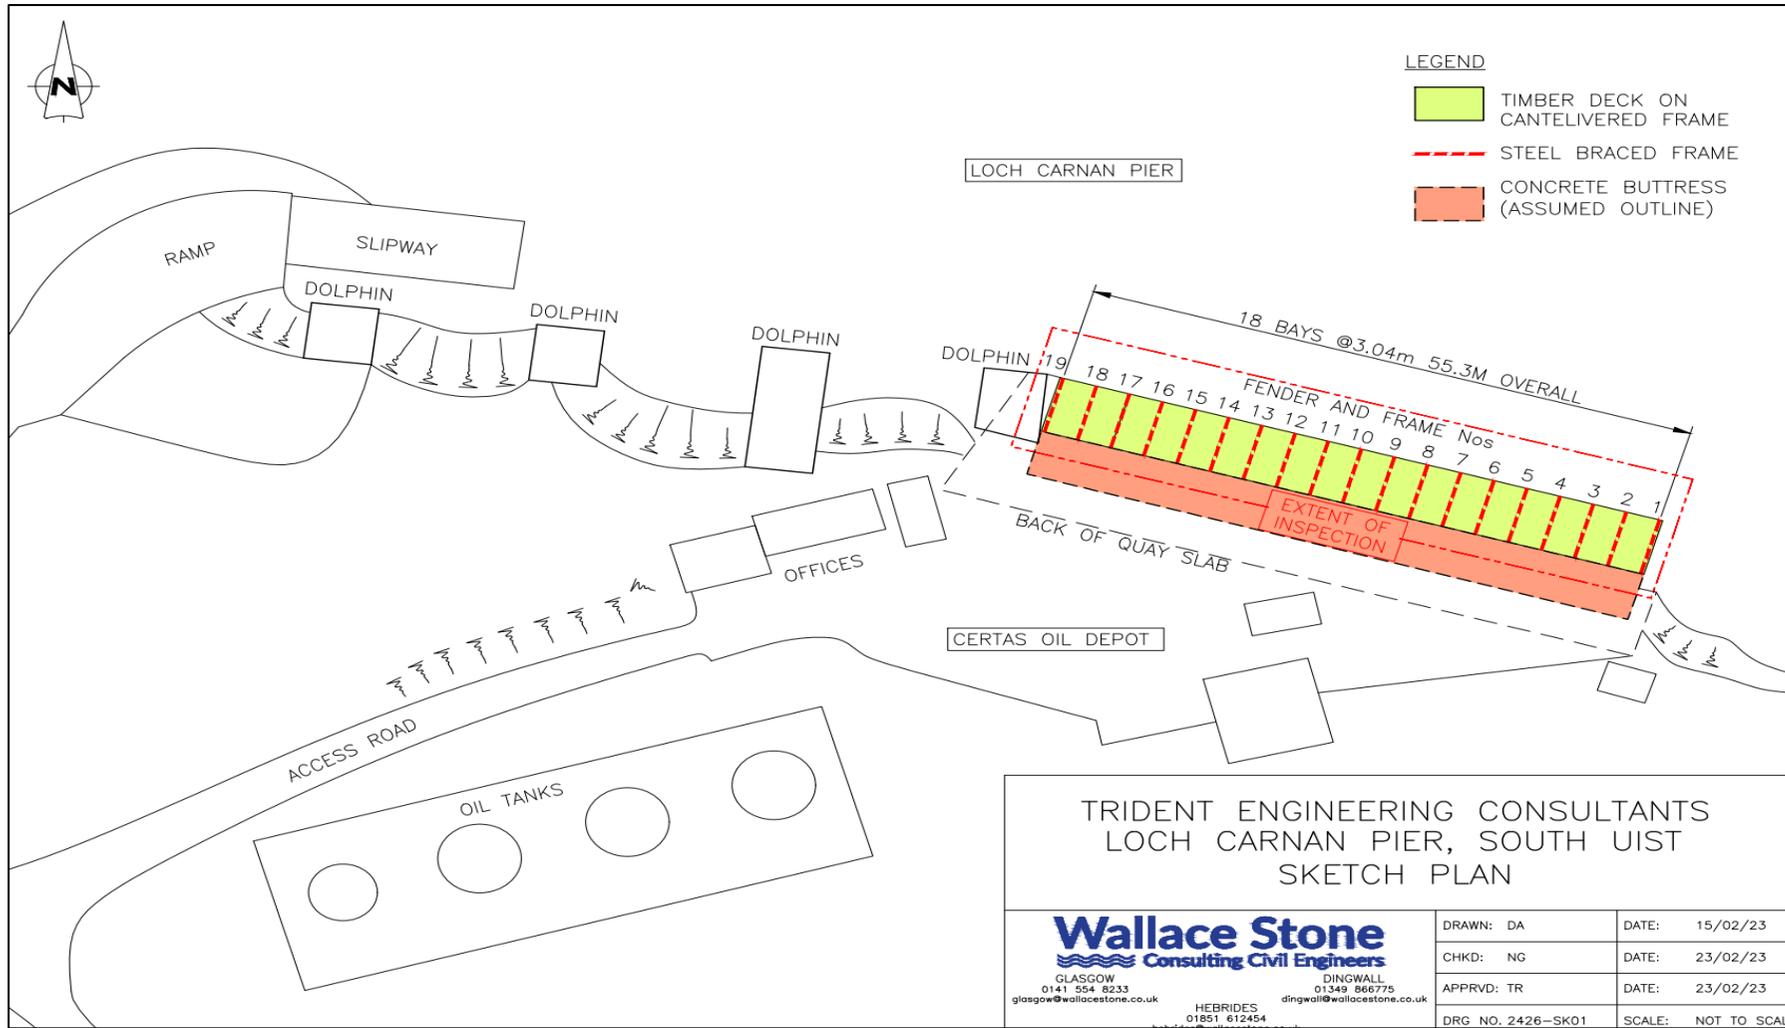
Figure 2 - Loch Carnan jetty location design

The jetty comprises 19 near-identical main frames supporting the structure, summarised as follows and shown on Figure 2 and Figure 3:

A detailed jetty inspection will be carried out prior to works commencing, building on the existing survey work, to ascertain the exact repair requirements. It is not expected that

substantial repairs will be needed to the steel structure. Works will concentrate on the most corroded areas and will include:

- Replacement of existing bracing beams
- Over-plating of steel members
- Replacement of steel attachments for fenders and shear fenders
- Replacement of nuts, bolts and other fixings.
