Underwater Examination
ELR: GSW
Contract Mileage: 106 m 1481 yds 67.32 ch
Struc. Ref
161/343

| Structure Name: ANNAN VIADUCT | Type: BV | Exam ID: 3090230 |
| Route: Gretna - Glasgow Central (via Kilmarnock) | | Complete Exam: No |

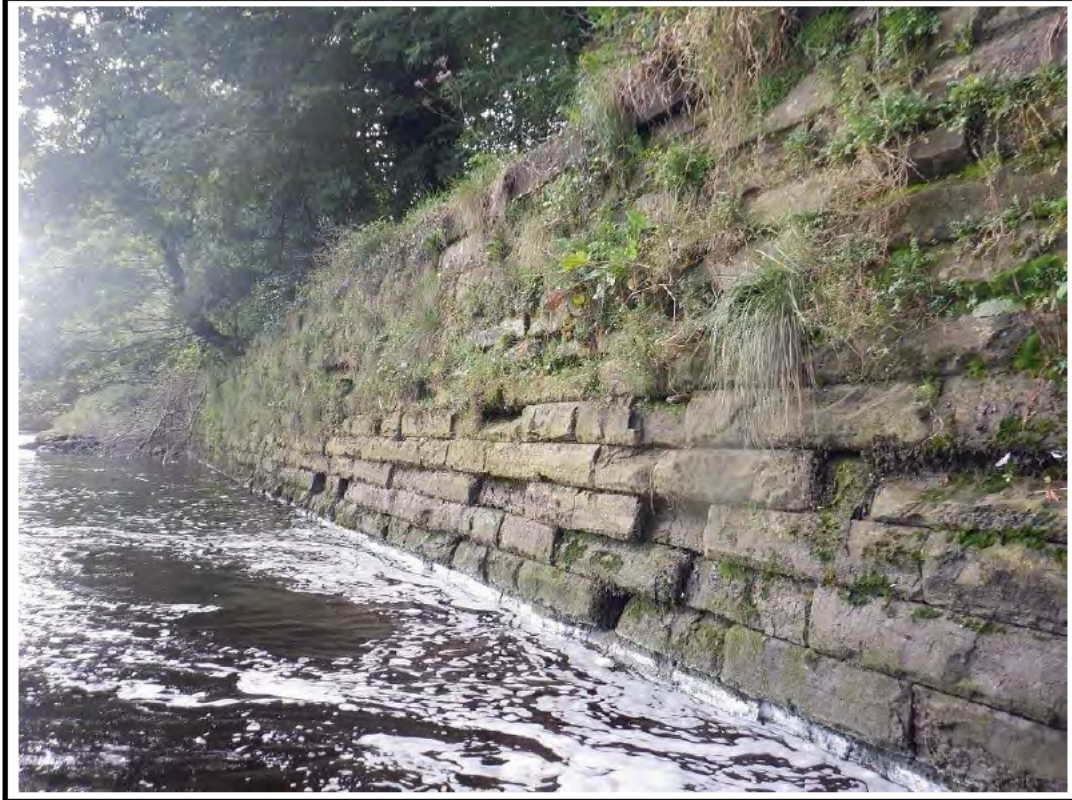
PHOTO 13: P13 - DOWNSTREAM LM RETAINING WALL 14/09/20

Downside (Downstream) (Photo 13)

Masonry Construction.
Poor condition

- O/S Numerous areas of voiding and spalling located throughout the wall 10m² x 400mm typical depth NFD (Photo 13)
- O/S Joint loss located throughout the lower 3 courses measuring 30 linear metres x 100mm max depth. NFD
- O/S 1no void 1.3m L x 500mm H x 700mm D located 8m from the abutment at 2m above bed level with associated displacement +20mm NFD (Photo 14)
- O/S Sapling and moss growth located sporadically throughout the wall. NFD
- O/S Intermittent areas of bulging and slumping throughout the lower three courses of the retaining wall. NFD

| HIDDEN PARTS NOT EXAMINED (EXCLUDING FOUNDATIONS) | | Part | | | Reason | | | | | Works Category |
|--|---|--|---|---|---|---|---|---|---|---|
| 5 | Carry out repairs to areas of spalling and voiding | LM up and downstream retaining walls | | | | 2 | 5 | E10 | Brickwork/Stone Repairs | |

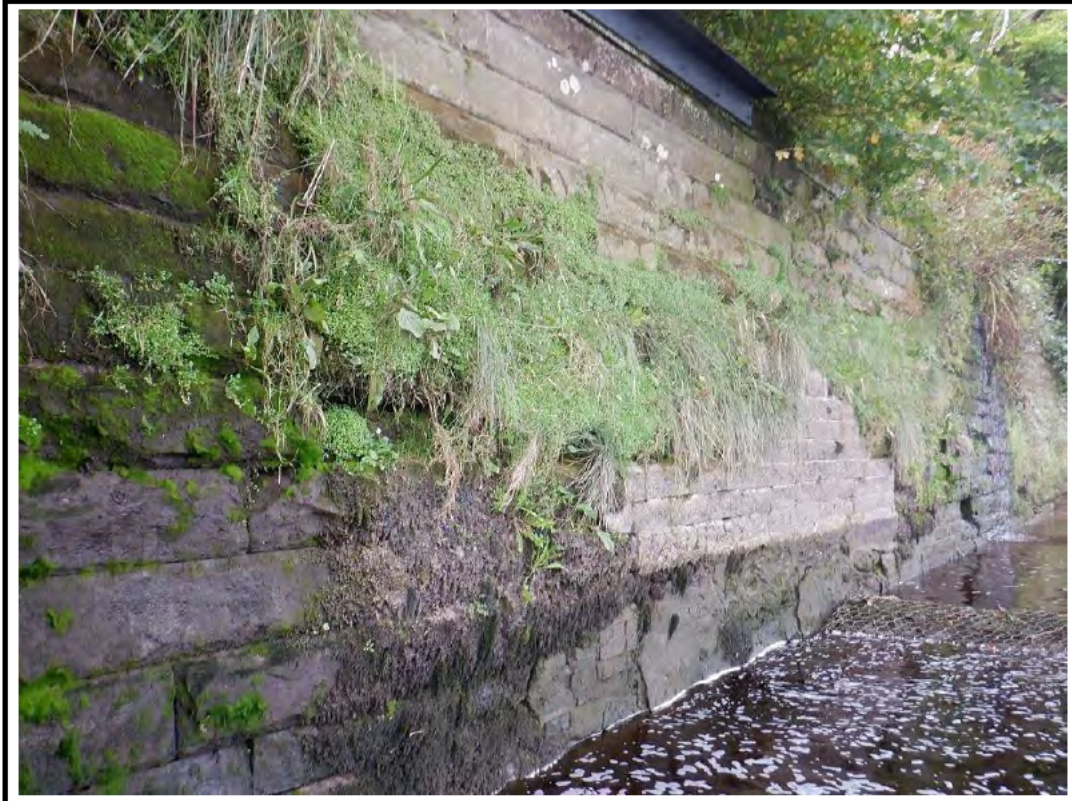
PHOTO 15: P15 - UPSTREAM LM RETAINING WALL 14/09/20

Upside (Upstream) (Photo 15)

Masonry construction.
Poor condition.

- O/S 4m² area of re-casing located 2.5m – 10m from the abutment, spalling to the base 2m² x 40mm depth. NFD
- O/S 2no spalled stones each 700mm L x 300mm H x 350mm D located 1.2m from the abutment at 1.7m above water level. NFD

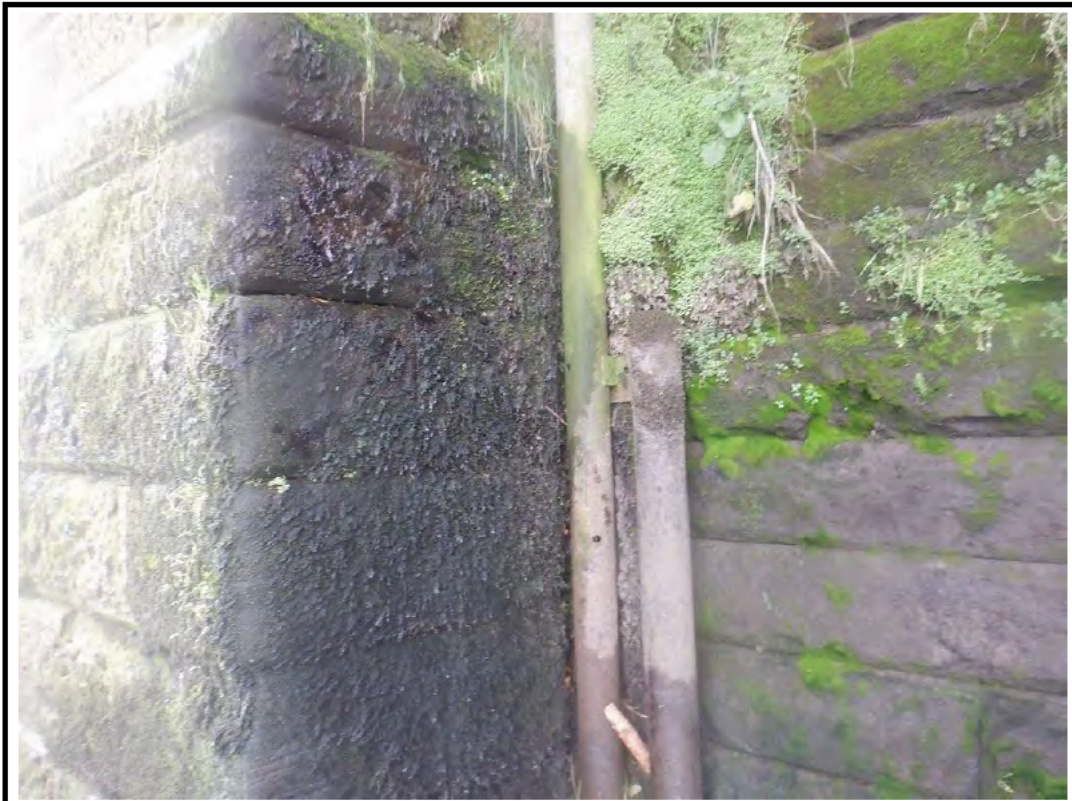
PHOTO 16: P16 - DOWN PIPES LOCATED ADJACENT TO THE ABUTMENT 14/09/20

- O/S 2no down pipes located adjacent to the abutment with one broken at mid height, associated wetness to the surrounding area now repaired intact. (Photo 16)

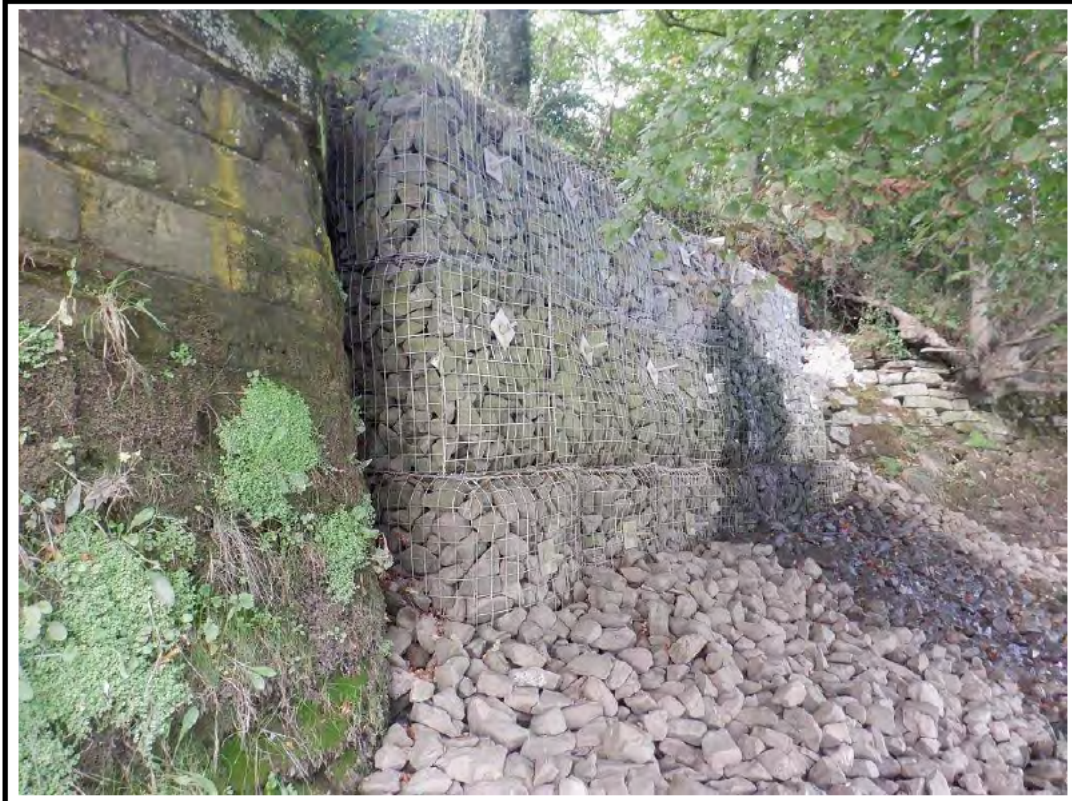
PHOTO 19: P19 - UPSTREAM GABION BASKETS PROTECTED BY PITCHING STONE 14/09/20

- O/S At 18m from the abutment isolated spalling 600mm L x 400mm H x 150mm D located 750mm above water level. NFD
- INS band added top coping 5m long
- Upstream gabion baskets 7m long added protected by pitching stone (Photo 19)

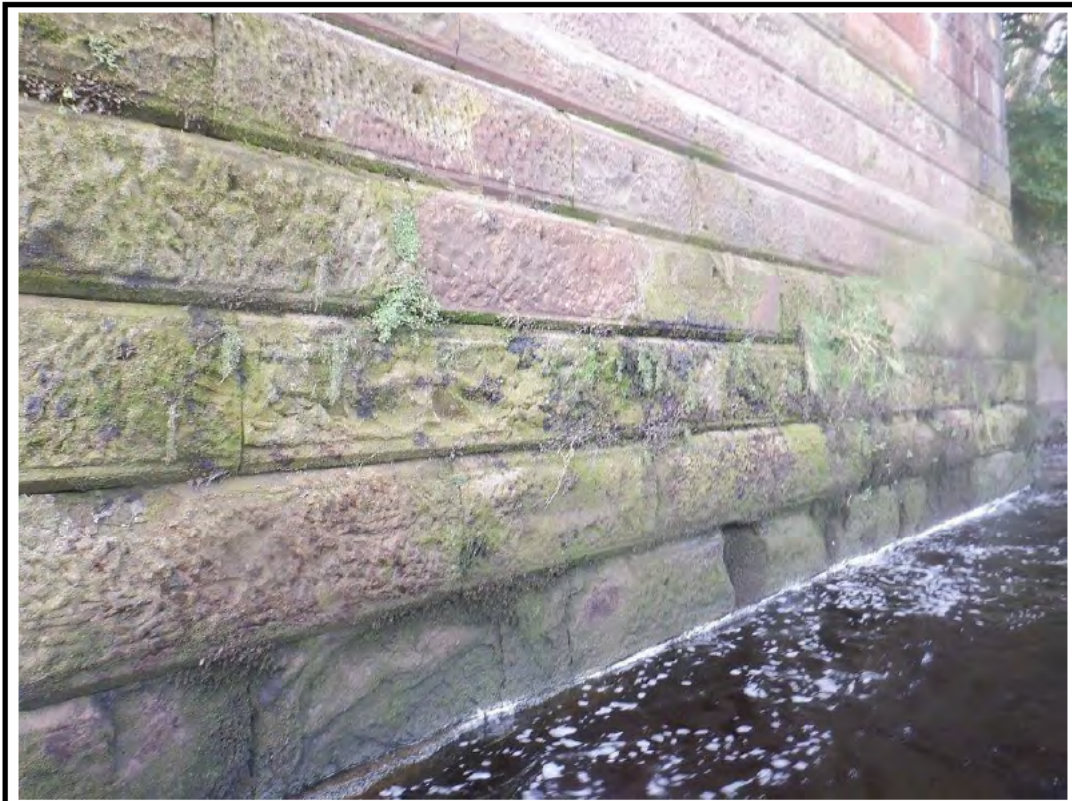
PHOTO 20: P20 - PIER 1 ANNAN STATION (HIGH MILEAGE) FACE 14/09/20

Annan Station (high mileage) Face (Photo 20)

Masonry construction.
Fair condition.

- O/S 1m² spalling x 200mm typical depth located sporadically throughout the lower 1m of the pier face. NFD
- O/S 2m² joint loss x 30mm max depth located sporadically throughout the pier face. NFD
- O/S 1no vertical fracture 1m L x 2-3mm W with associated spalling to 40mm depth located to the DS return. NFD (Photo 21)

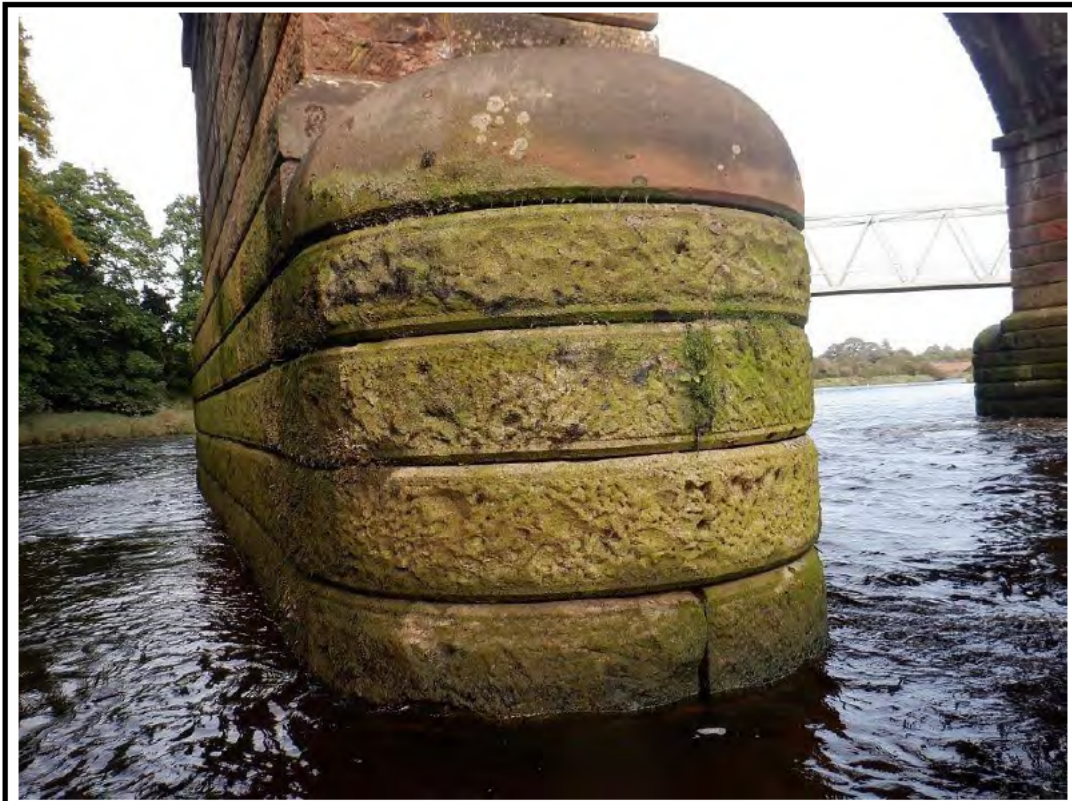
PHOTO 22: P22 - PIER 2 DOWNSTREAM NOSE 14/09/20

Downside (Downstream) Nose (Photo 22)

- O/S 1no Y shaped fracture 900mm long x HL-2mm W located to the HM side at water level. NFD
- O/S 1.5m² joint loss x 200mm depth located throughout the nose. NFD
- O/S Spalling 200mm H x 200mm W x40mm D located at water level. NFD
- O/S Undercutting / joint loss to 80mm depth between the pier and corbel course. NFD

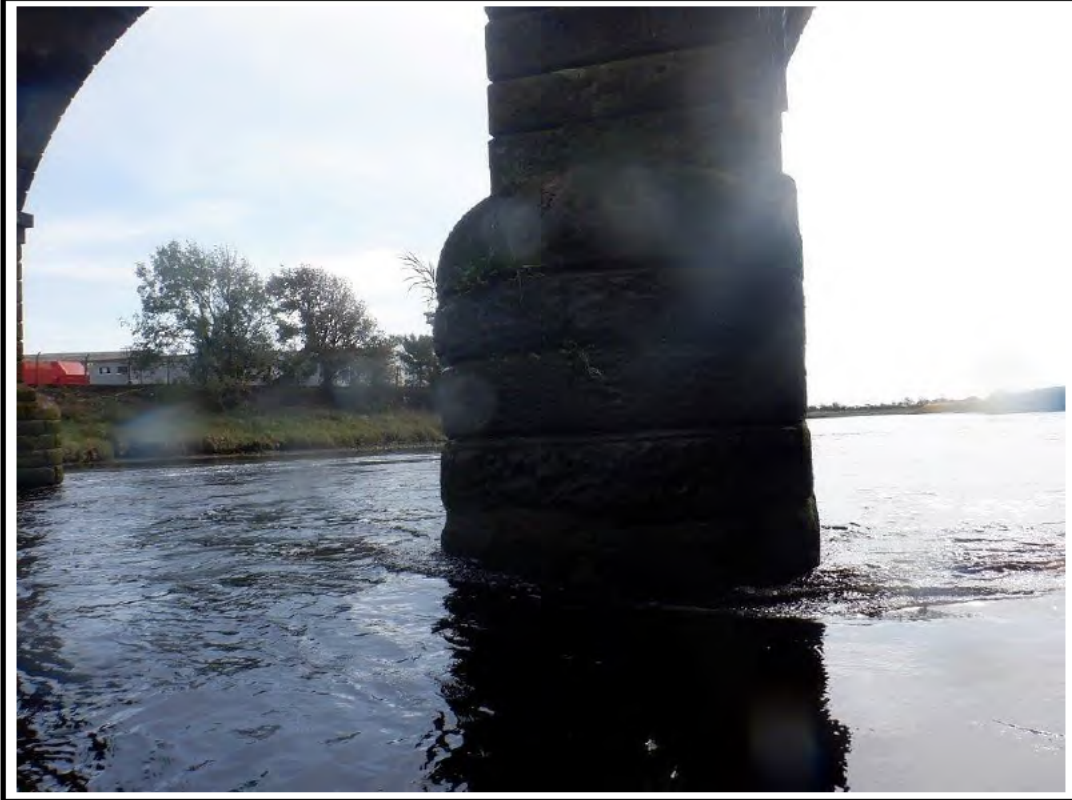
PHOTO 23: P23 - PIER 2 UPSTREAM NOSE 14/09/20

Upside (Upstream) Nose (Photo 23)

- O/S Spalling 700mm L x 150mm H x 200mm D located 500mm above water level to the HM side. NFD
- O/S 1.5m² joint loss x 200mm depth located throughout the nose. NFD
- O/S Undercutting / joint loss to 150mm depth between the pier and corbel course, the corbel course is displaced and fractured to 5mm. NFD

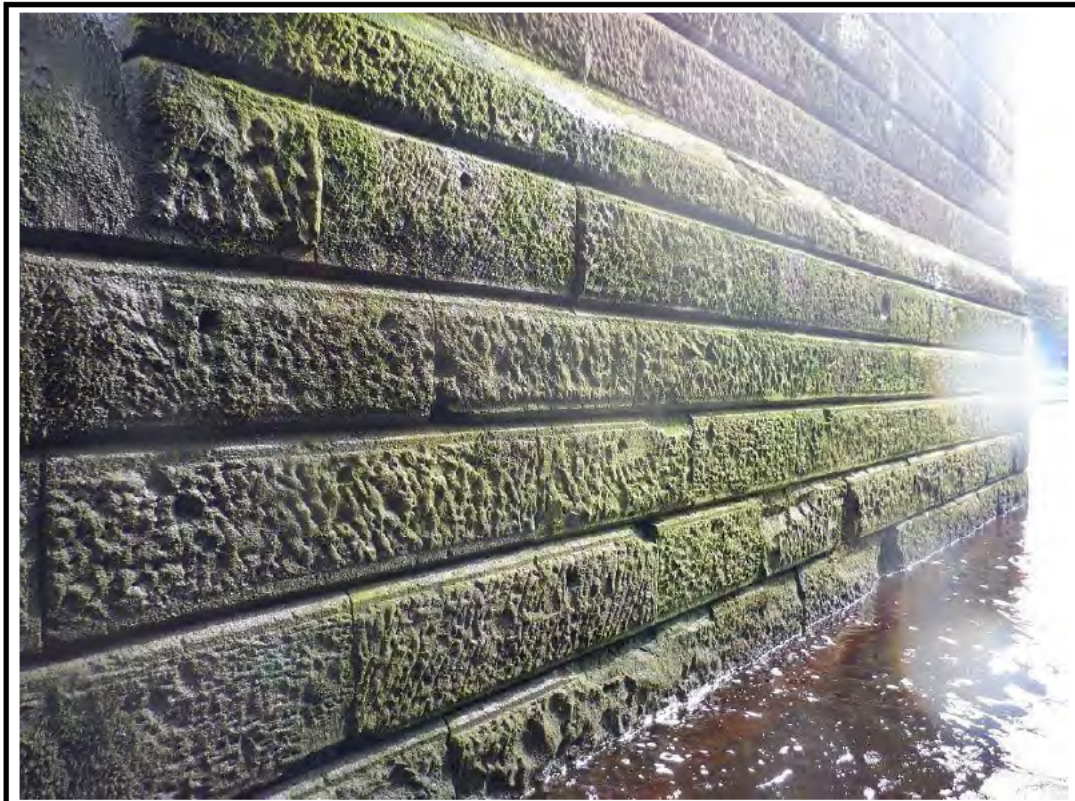
PHOTO 24: P24 - PIER 2 LM FACE 14/09/20

Dumfries Station (low mileage) Face (Photo 24)

- O/S 2.5m² joint loss x 60mm depth located throughout the face. NFD
- O/S 1m² spalling x 50mm depth located throughout the upstream half at and below water level. NFD
- O/S Isolated spalling to 1no stone x 60mm D at the centreline. NFD

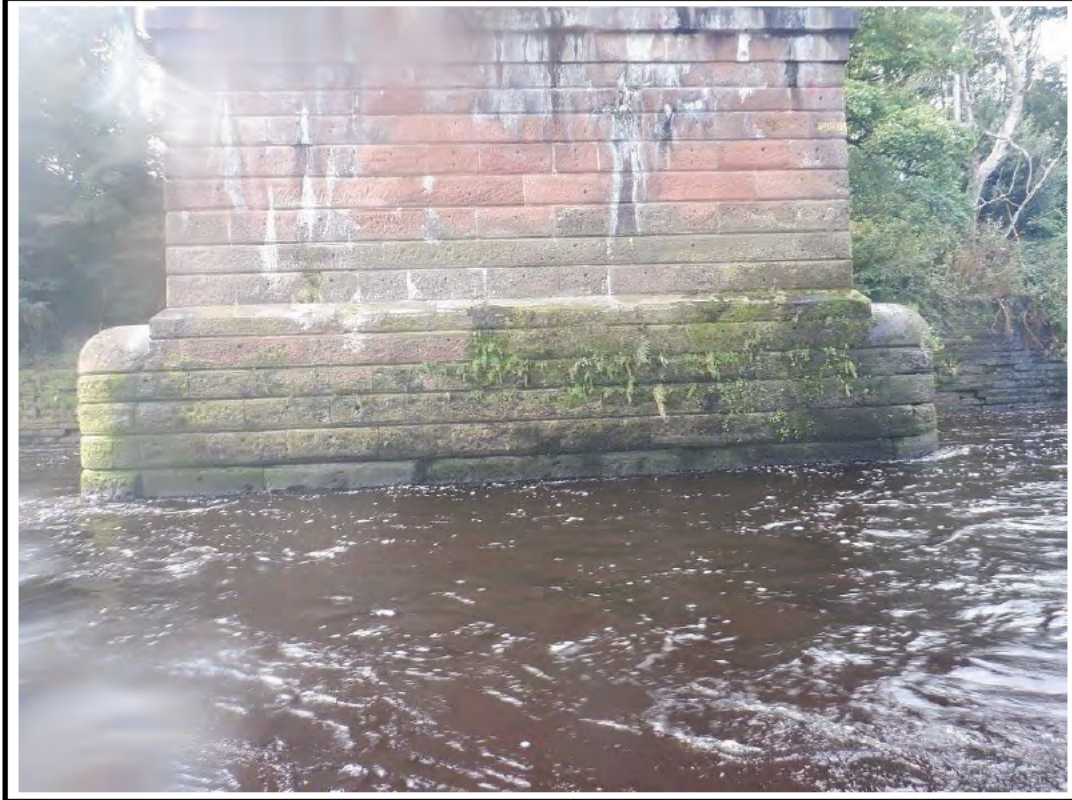
PHOTO 25: P25 - PIER 2 HM FACE 14/09/20

Annan Station (high mileage) Face (Photo 25)

- O/S 2.5m² joint loss x 60mm depth located throughout the face. NFD
- O/S 0.5m² spalling x 50mm depth located throughout the face below water level. NFD

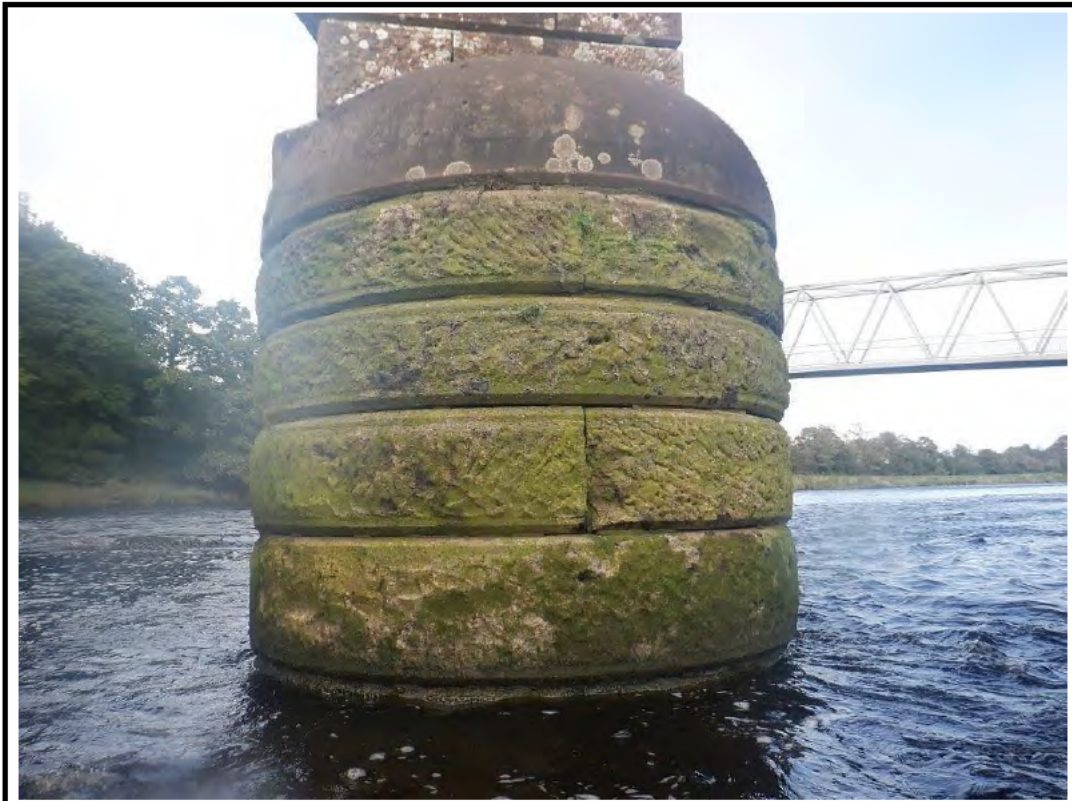
PHOTO 26: P26 - PIER 3 DOWNSTREAM NOSE 14/09/20

Defect Location: Pier 3 – Downside, HM and LM face

Defect Description: Fractures to bullnose.

Downside (Downstream) Nose (Photo 26)

| HIDDEN PARTS NOT EXAMINED (EXCLUDING FOUNDATIONS) | | Part | | | Reason | | | | | Works Category |
|--|---|--|---|---|---|---|---|---|---|---|
| 4 | Carry out hand pointing and date tabbing repairs to fractures | Pier 3 - Downside, HM and LM face | | | | 2 | 4 | S8 | Hand Pointing | |

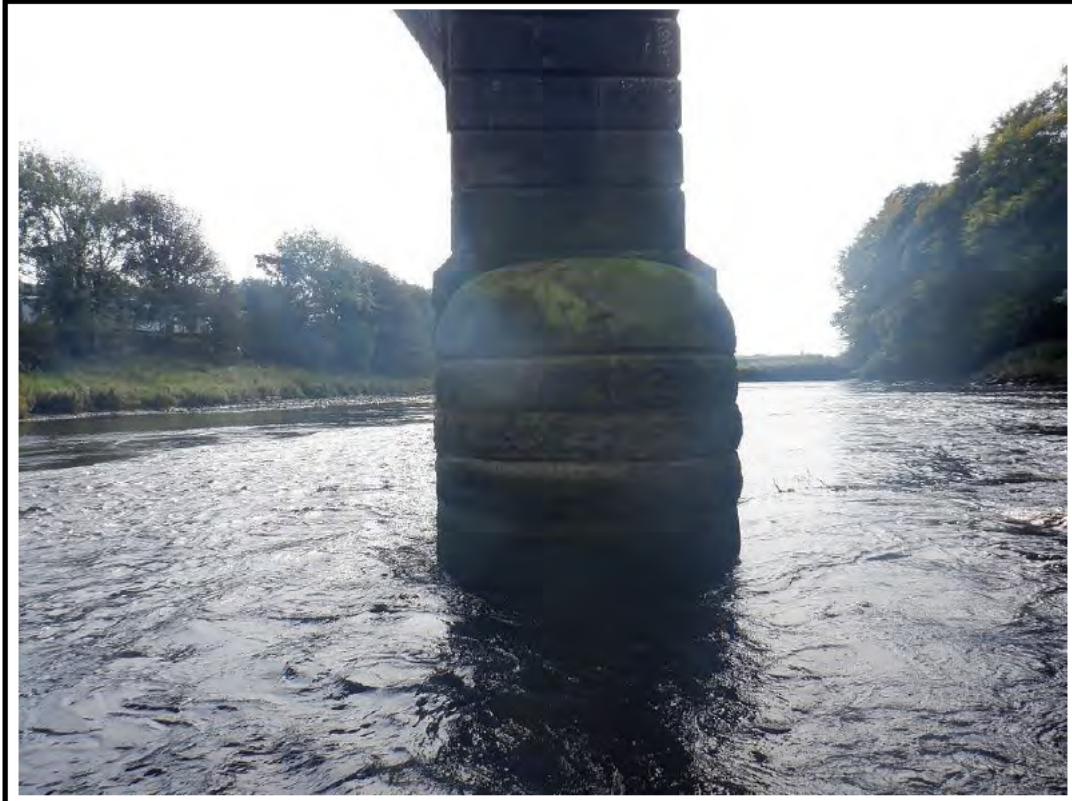
PHOTO 27: P27 - PIER 3 UPSTREAM NOSE 14/09/20

Upside (Upstream) Nose (Photo 27)

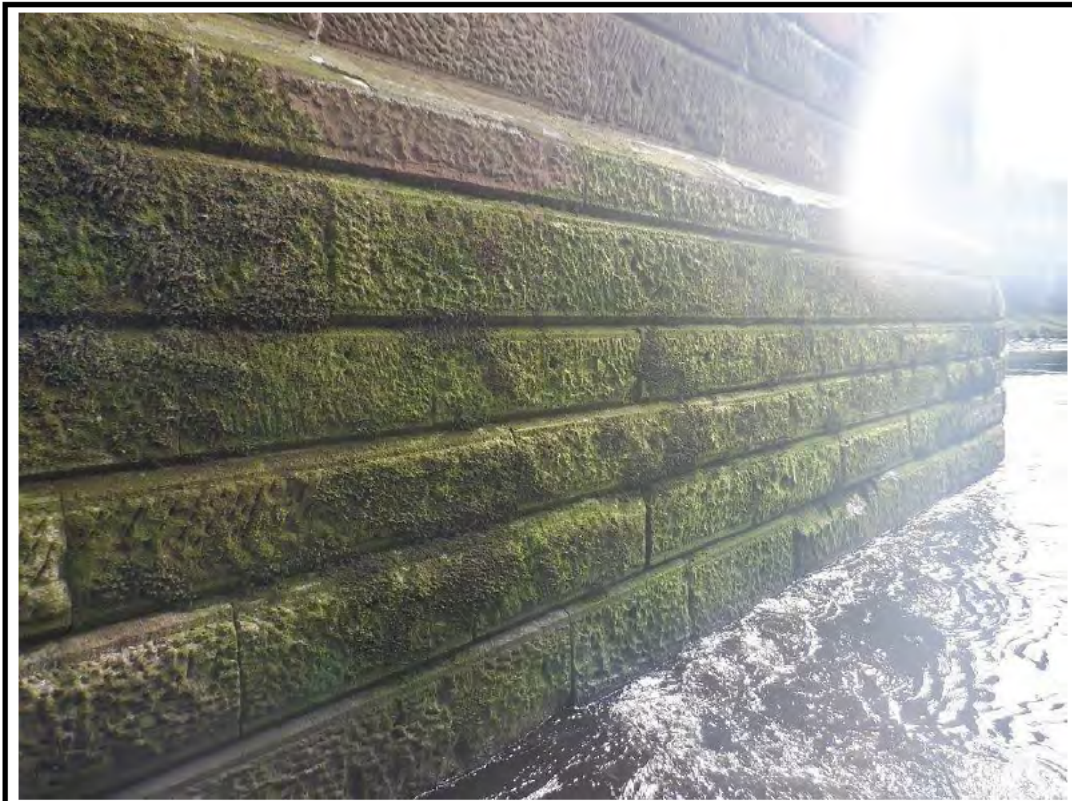
PHOTO 28: P28 - PIER 3 LM FACE 14/09/20

Dumfries Station (low mileage) Face (Photo 28)

- O/S 2no vertical fractures totalling 4.5m L x 2-10mm W located to the downstream end of the face NFD (Photo 29)
- O/S 1no vertical fracture 300mm L x 2mm W located 1.5m from the downstream nose, below water level at the time of the examination. NFD
- O/S 2no through block fractures each 800mm L x 2-10mm W located 2.2-2.5m from the downstream nose, below water level at the time of examination. NFD
- O/S 1no through block fracture 400mm L x 3-5mm W to the centre of the pier face, below water level at the time of the examination. NFD
- O/S 4m² joint loss x 200mm D located throughout the pier face NFD.
- O/S 1.5m² spalling x 60mm typical D located throughout the pier face, typically worse at and below water level to the upstream half NFD.

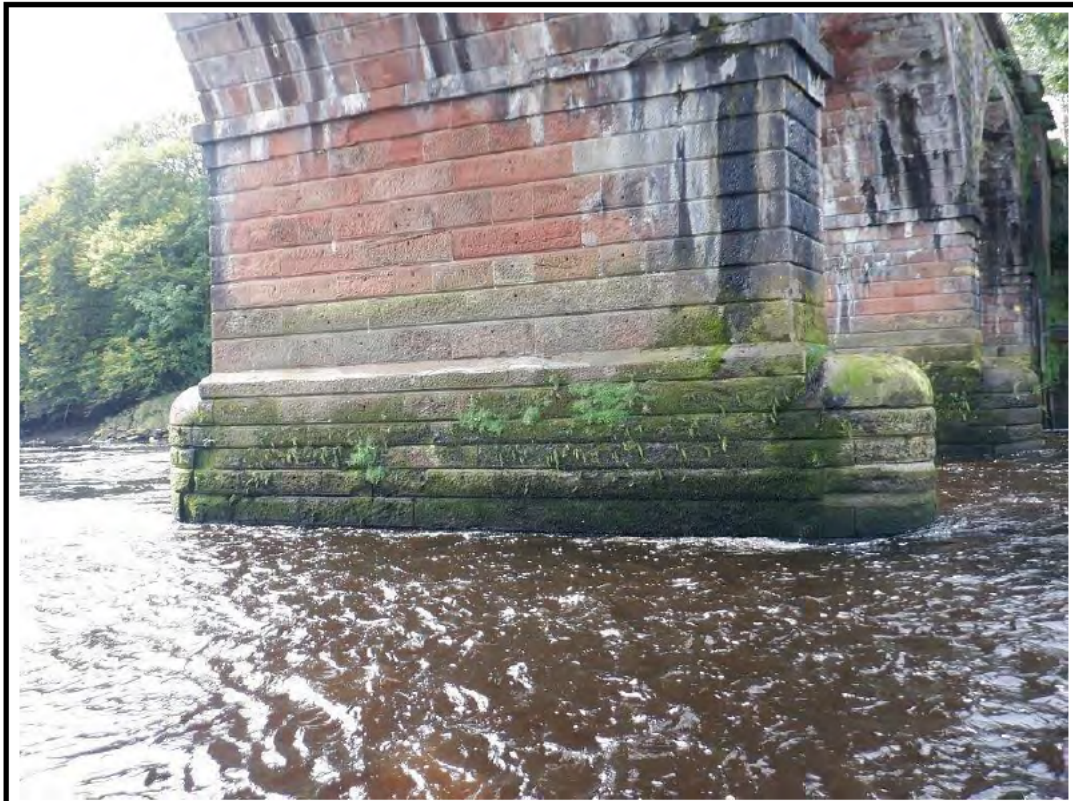
PHOTO 30: P30 - PIER 3 HM FACE 14/09/20

Annan Station (high mileage) Face (Photo 30)

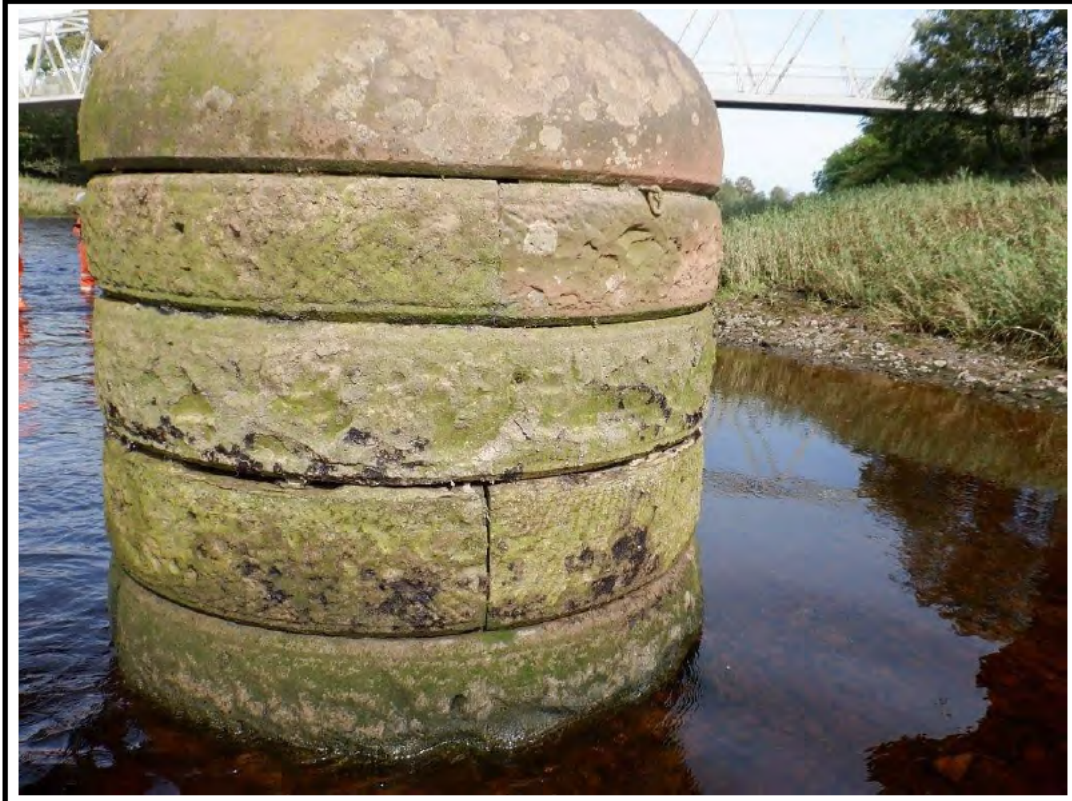
PHOTO 31: P31 - PIER 4 DOWNSTREAM NOSE 14/09/20

Downside (Downstream) Nose (Photo 31)

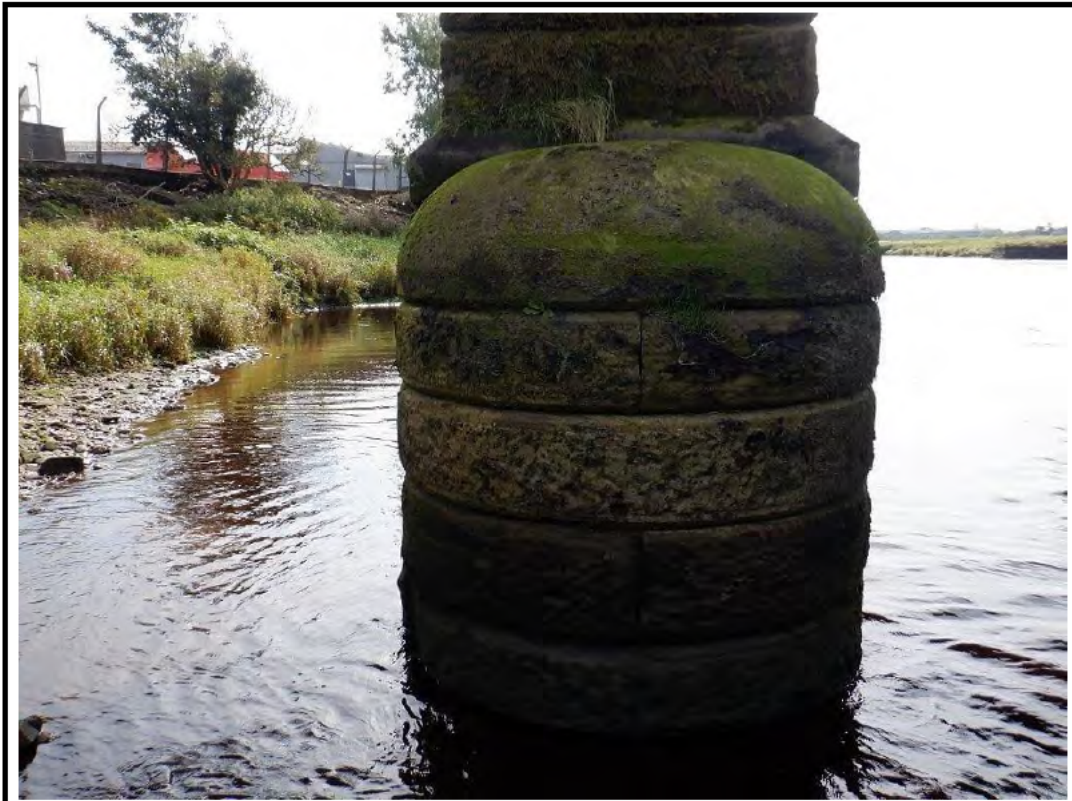
PHOTO 32: P32 - PIER 4 UPSTREAM NOSE 14/09/20

Upside (Upstream) Nose (Photo 32)

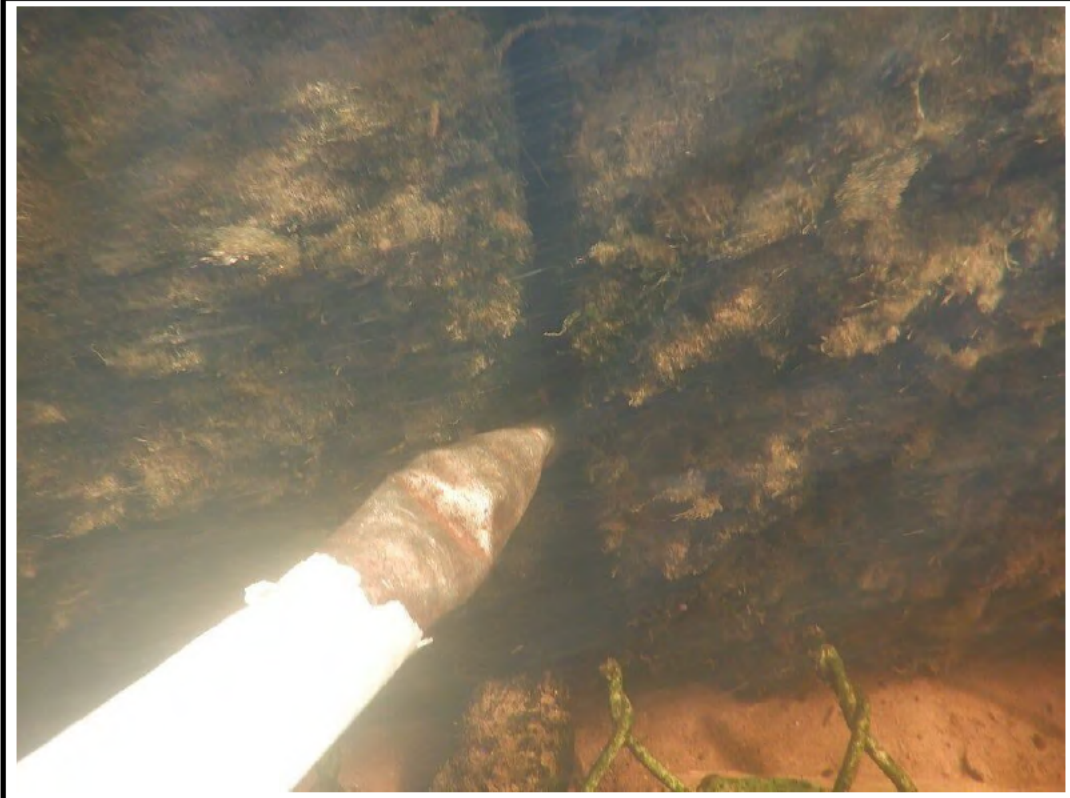
PHOTO 33: P33 - PIER 4 LM FACE 14/09/20

Dumfries Station (low mileage) Face (Photo 33)

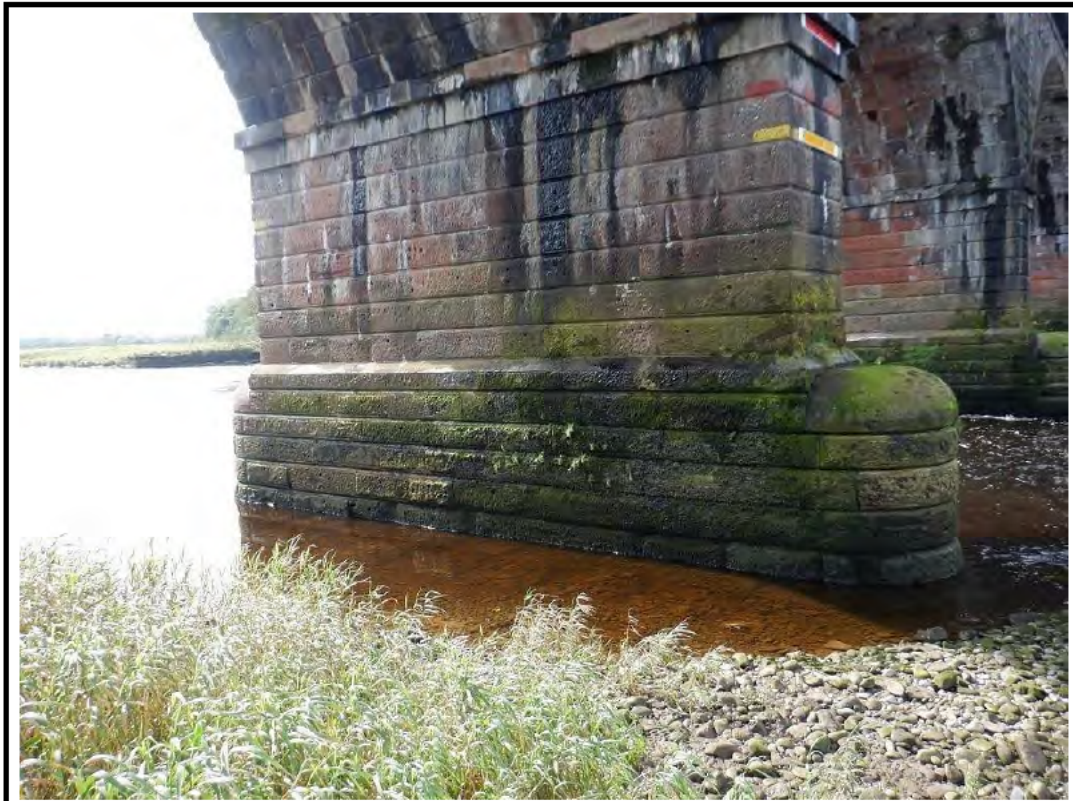
PHOTO 34: P34 - PIER 4 HM FACE 14/09/20

Annan Station (high mileage) Face (Photo 34)

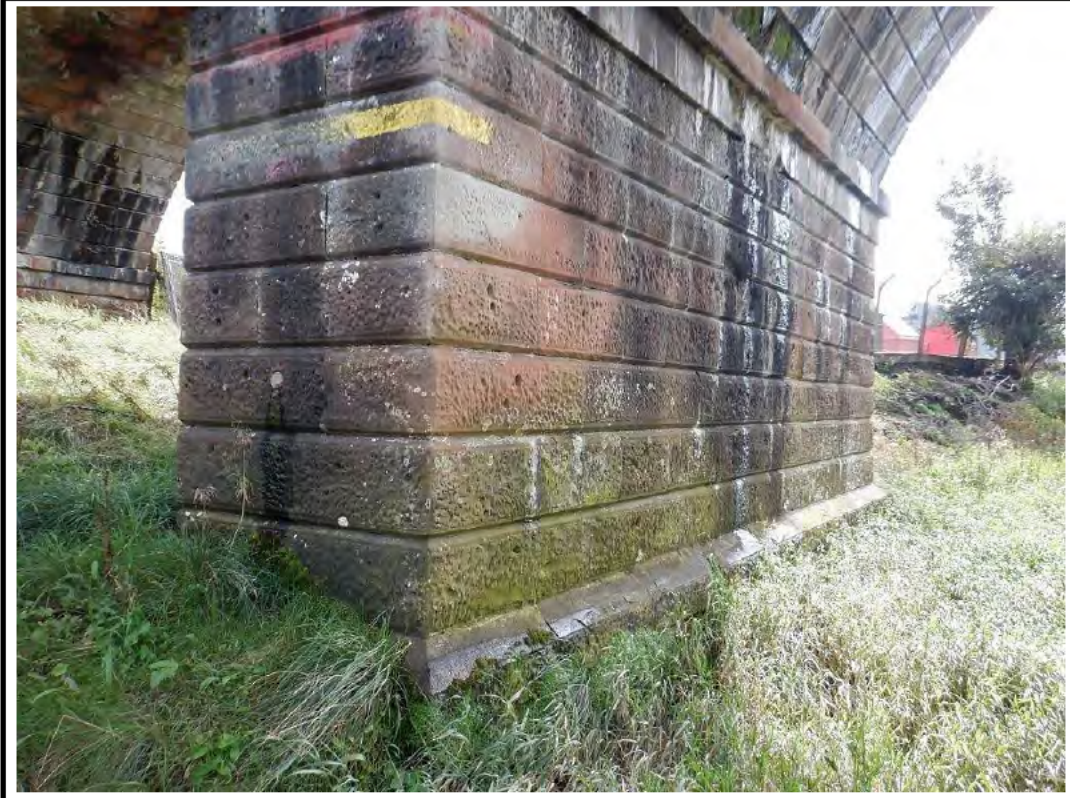
PHOTO 35: P35 - PIER 514/09/20

Pier 5 (Photo 35)
