1.0 INTRODUCTION:

Tongland Bridge, a distinguished 'Category A' listed structure, stands as a testament to engineering brilliance with its 34m span circular segmented arch and three 2.7m gothic arch approach spans on either end. Crafted from the enduring rough-faced grey sandstone of Arran, this architectural marvel was conceptualized by the renowned Thomas Telford and brought to life between 1805 and 1808.

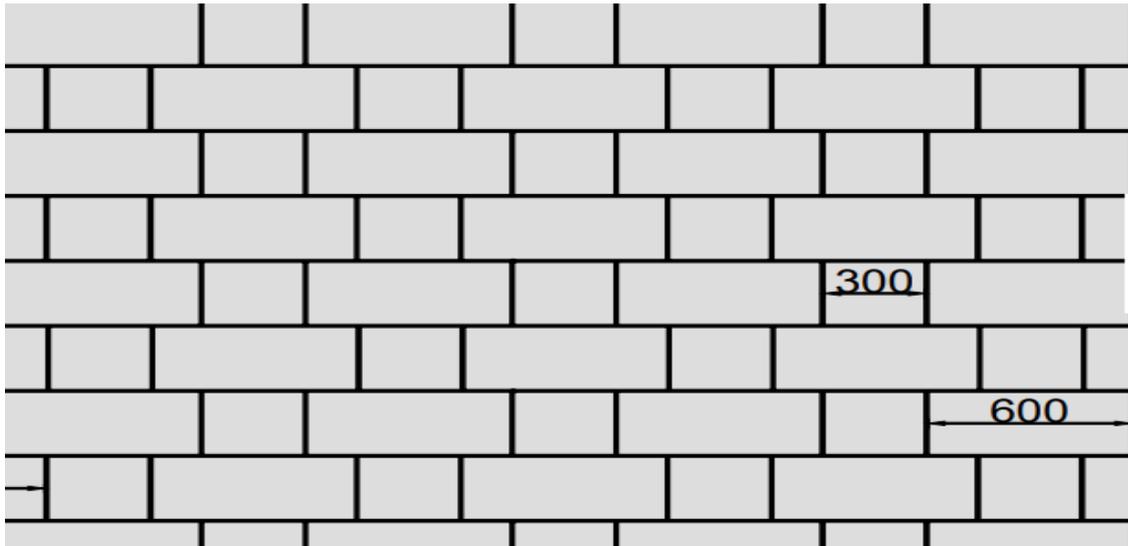
Figure 12: Sketch showing 'Flemish bond' pattern along longer surface of new Pier Jacketing Wall

Given the varying nature of the coursework, our proposal suggests employing a coursework pattern resembling 'Flemish bond' showcased in 'Figure 12' along the longer surface of the 'Pier Jacketing wall' for South and North Intermediate Piers.

The proposed typical facework along the longer direction of the new 'Pier Jacketing' wall features an alternating arrangement of 600mm and 300mm length stonework as can be seen in 'Figure 12'.

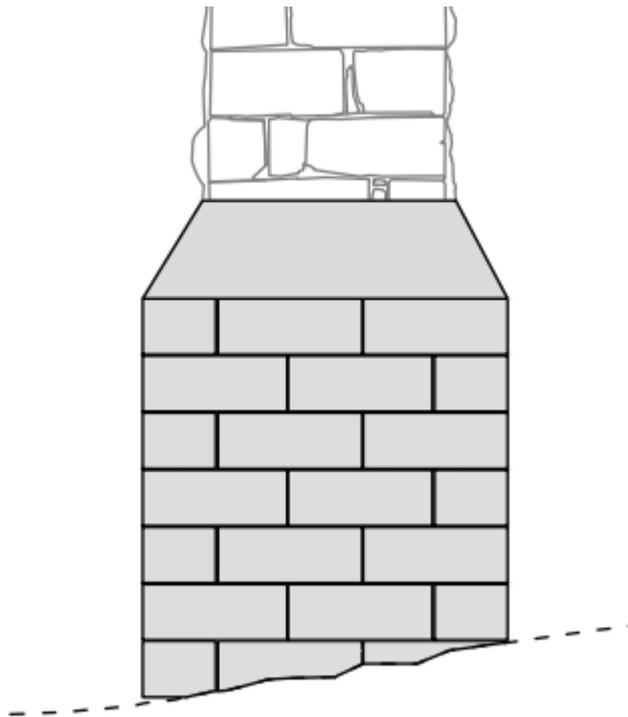
Figure 14: Elevation showing 'Running bond' pattern proposed for 'Pier Jacketing wall' at shorter face

Conversely, in shorter direction of existing Pier has different arrangement of 'Stone pattern'. See Figure 13 for reference. This pattern is closer to 'Running bond' pattern and similar arrangement is proposed for the new 'Pier Jacketing wall' Refer to 'Figure 14' for the detail .

It has come to our attention that in certain areas, the length of the current ashlar stone masonry units surpasses 1.4 meters. Additionally, these existing stone masonry units can range from 100kg to 400kg in weight. However, to restrict the weight of individual stone units to approximately 100kg, the length of new masonry units is generally capped at 600mm (maximum), except in a few isolated locations.
