# Kyleakin Feed Mill Pier

Navigational risk assessment

Marine Harvest (Scotland) Ltd

November 2016

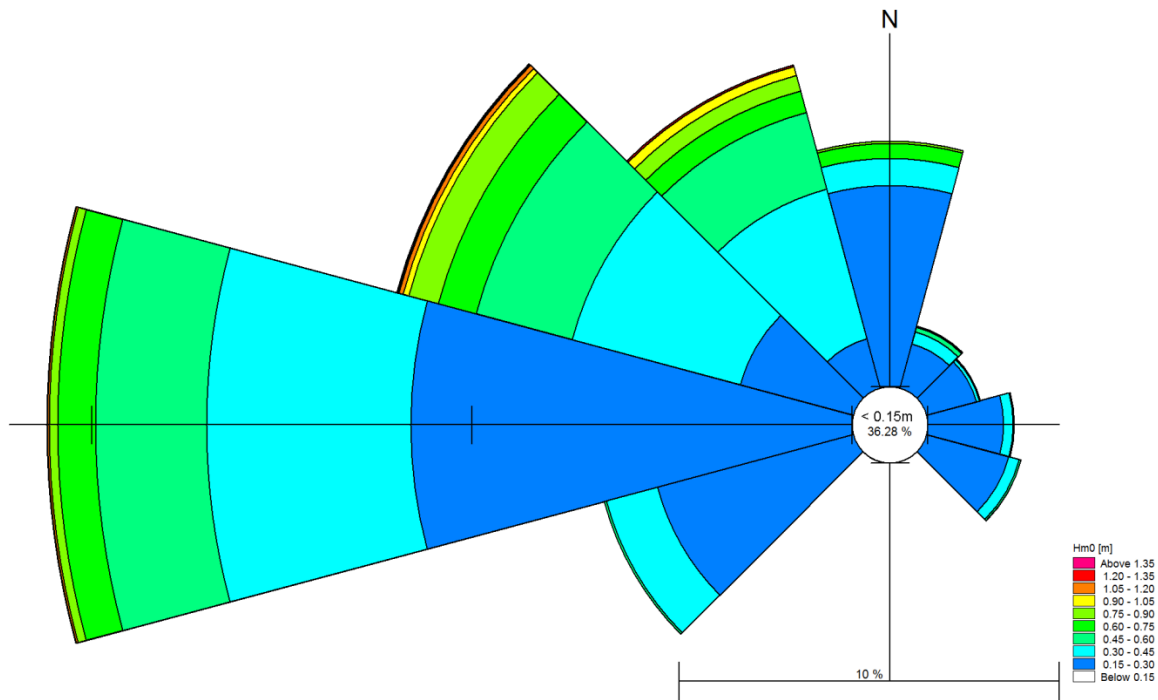
Image 1. Rose plot of wave height against direction

Image 1 shows that the largest percentage of waves comes from a westerly direction and are less than 0.9 m in height. The greatest proportion of waves larger than 0.9 m are from the north-west, this is likely due to the larger fetch in this direction.

Kyleakin is well sheltered by the surrounding land although there is the potential for larger waves to affect the area from a northerly direction due to the large fetch from this direction. Image 1 shows a wave rose for the marine works site derived from data gathered from an inshore located in close proximity to the pier development site.

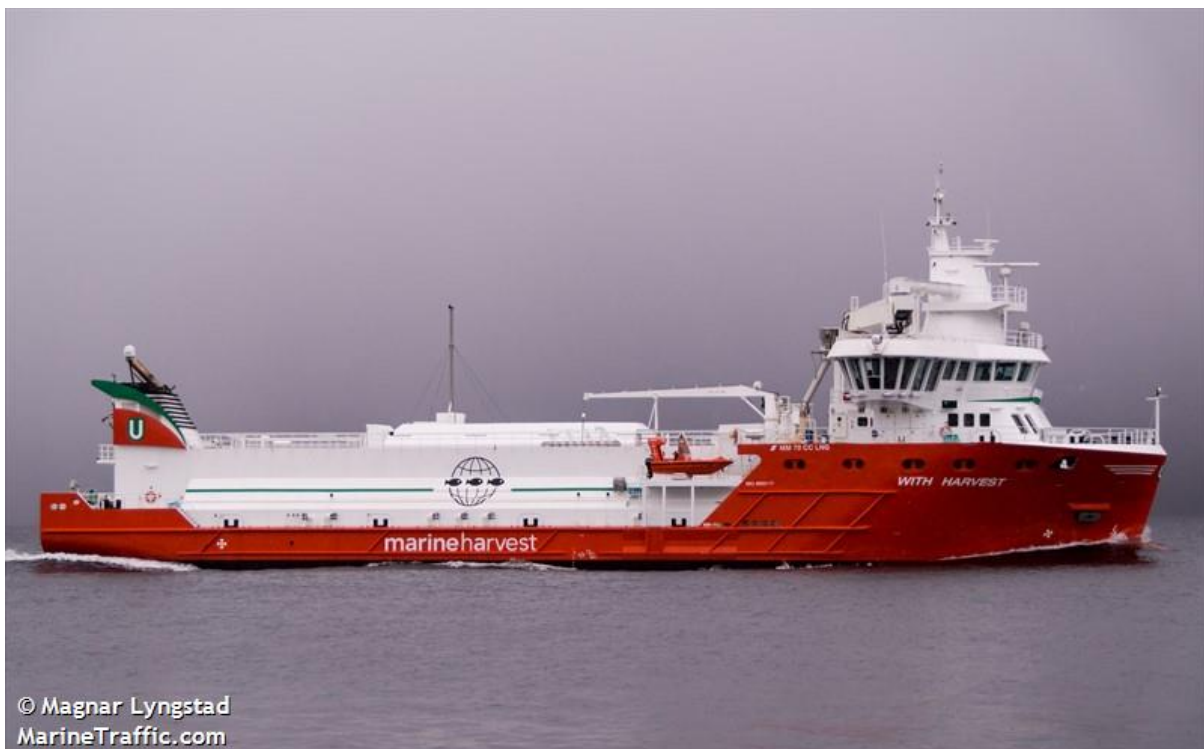
Auxiliary Engines: Design: Scania, Engine Builder: Scania Cv Ab  
2 x DI16M, Mcr: 570 kW

Thrusters: 1 Tunnel thruster (f) 800kW (1,088 bhp), 1 Tunnel thruster (a) 800kW(1,088 bhp)

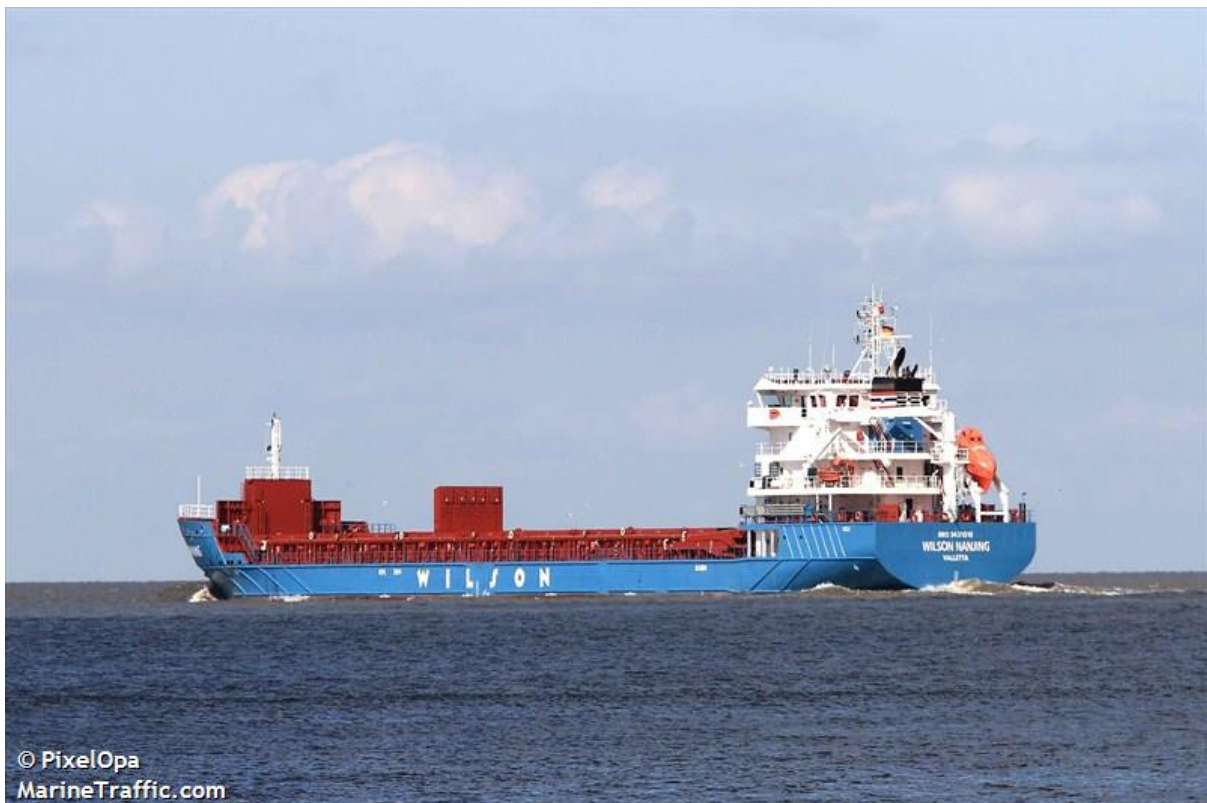
Name of Ship: Wilson Nanjing  
MMSI: 215061000  
Ship Type: Cargo  
Deadweight: 8357 t  
Length: 123.1 m  
Beam: 16.5 m  
Draught: 7.4 m  
TEU: 60

Auxiliary Engines: Design: Man, Engine Builder: Man  
2 x D2840LE, 4 Stroke 10 Cy.  
128 x 142, Mcr: 770 kW

Thrusters: 1 Tunnel thruster (f) 450 kW (612 bhp)

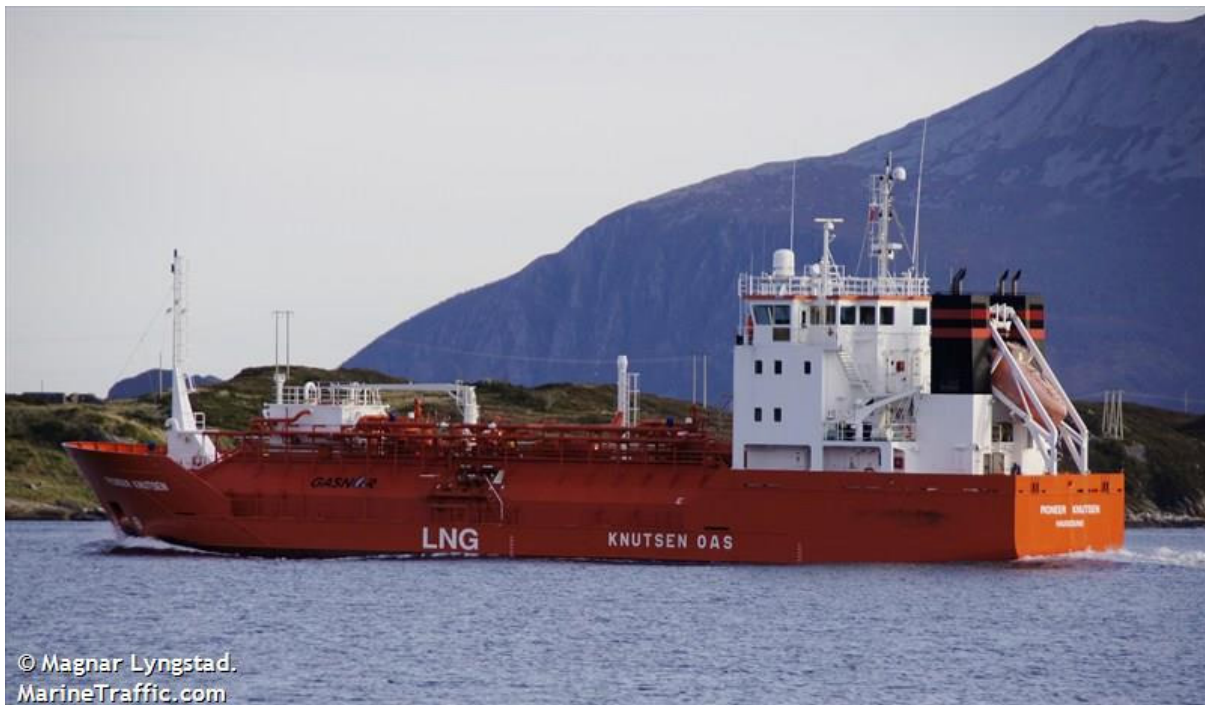
Name of Ship: Pioneer Knutsen  
MMSI: 259393000  
Ship Type: LNG tanker  
Deadweight: 817 t  
Length: 69 m  
Beam: 11.8 m  
Draught: 3.5 m

Auxiliary Engines: N/A

Thrusters: 1 Tunnel thruster (f) 200 kW (272 bhp)
