Aberdeen Harbour Expansion Project

Construction Environmental Management Document

AHEP-DRA-APP-0001 Rev 5 23 October 2019

16 Nigg Bay Site of Special Scientific Interest Management Plan

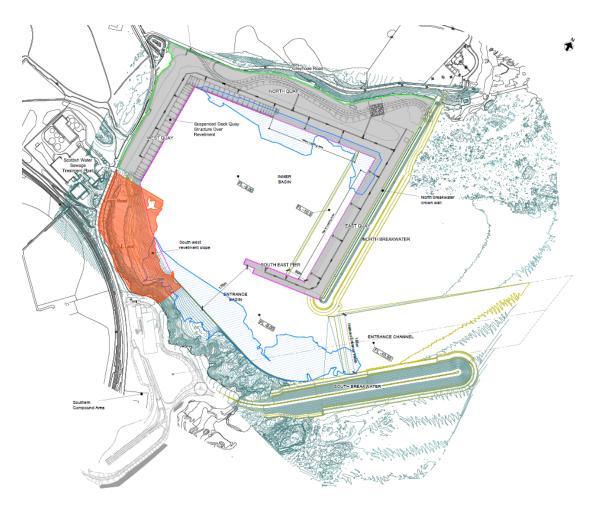
Figure 16.1: SSSI boundary in relation to AHEP

The location of the SSSI can be seen in Figure 16.1

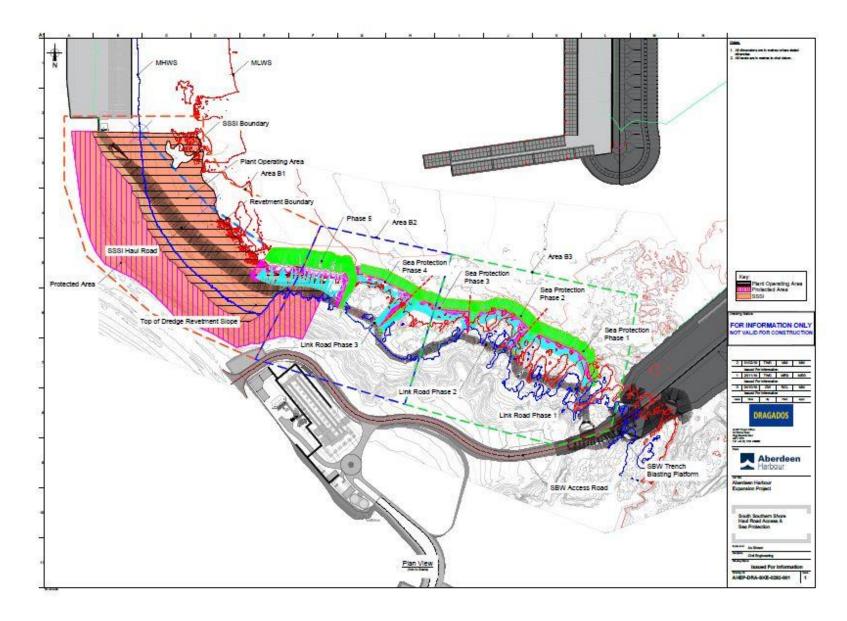
Figure 16.2: Temporary Southern Haul Road (indicative route)

The proposed route runs from north west to south east through the SSSI area as pictured in Figure 16.2.

Reference should be made to Figure 16.2 which shows the route of the haul road in relation to the SSSI boundary.

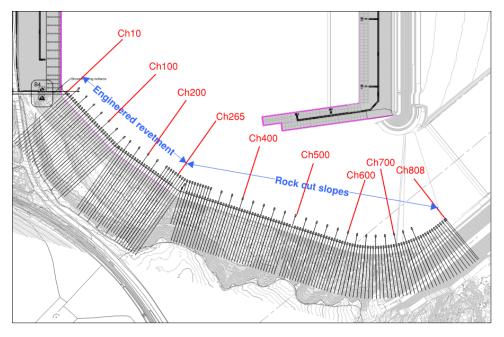
Figure 16.4: Extent of southern revetment area (Extract from NBY-ARP-Z1-XX-DR-CM-0000)

Figure 16.4 details the areas requiring works to be carried out in the Southern Shore area.

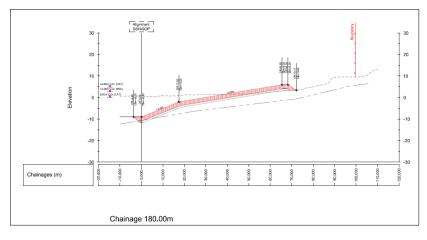
The revetment slope will comprise of a primary rock armour overlaying a rock fill core material. Figure 16.5 provides an example of the rock fill revetment.

Figure 16.5: Rock fill revetment design

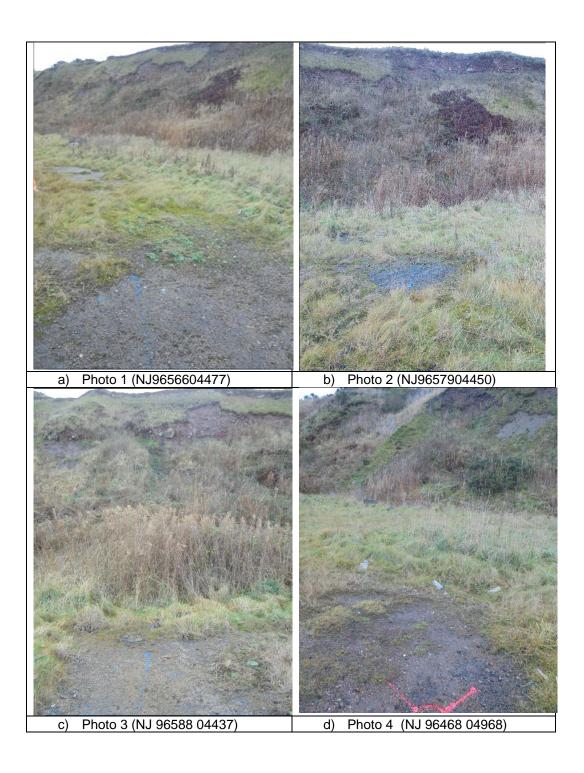
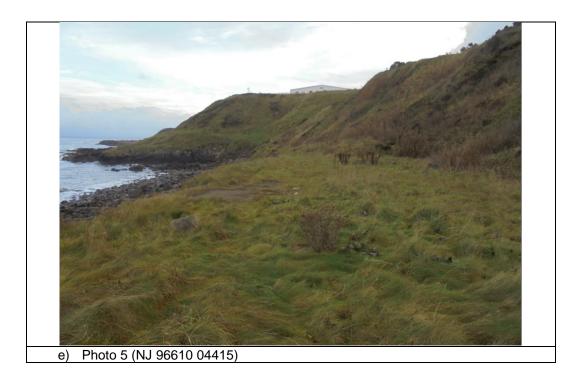
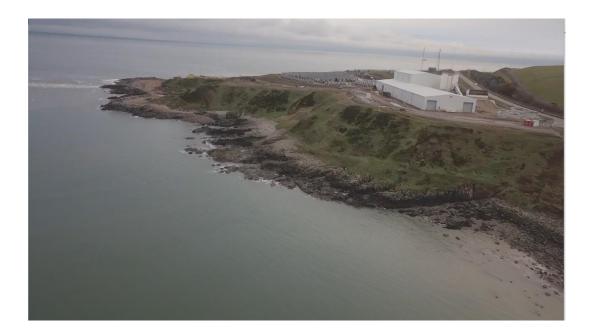
Figure 7: Pictures of slope from marked points (as at 18 December 2018) to be the focus of routine photographic comparison.

Since September 2017, the ECOW has carried out weekly observation of the cliffs and has taken photographs of the cliff face from the vantage points on the preexisting platform. Markers painted on the pre-existing platform define the places and directions from photos are taken for comparison of the slope and identification of changes. Sample photos from these positions are shown in Figure 7. If there is any change in the profile of the soil edges shown in photos taken from these locations during construction, the works will be paused pending notification of SNH and discussion of the causes of the change and possible mitigation.

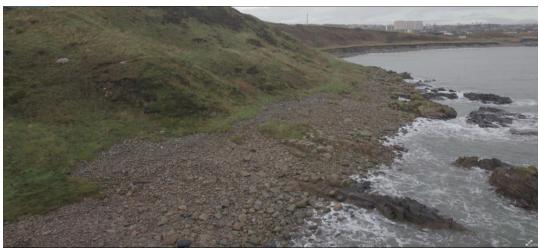
Figure 8: Photographs of East Slope in SSSI taken from drone in December 2018

The east-facing cliff of the SSSI below the Concrete Batching Plant has been viewed from the air in December 2018 (see Figure 8).

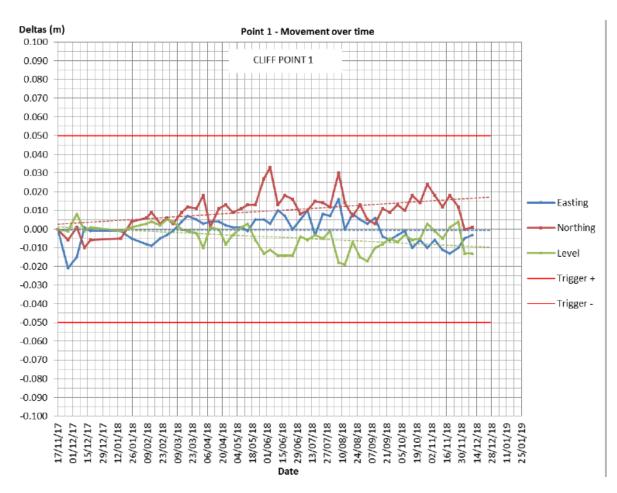
Figure 9: Example of routine survey point monitoring

Since November 2017 DUK has monitored four cliff top points (Cliff Point 1-4) in the SSSI for survey purposes, with weekly measurements of lateral displacement and level to within 1 cm and warnings set at ± 5 cm (that have not yet been triggered). These are defined in Table 2 in Section 4.3.2 below.

DUK routinely monitors the movement of these points (see Figure 9). When weather prevents weekly measurement, the measurement may be fortnightly. DUK will take a level change of 3 cm during construction as indicative of potential slumping on the cliff face and will pause works to notify SNH and will not resume the works until a response has been agreed with SNH as described in Section 4.4.

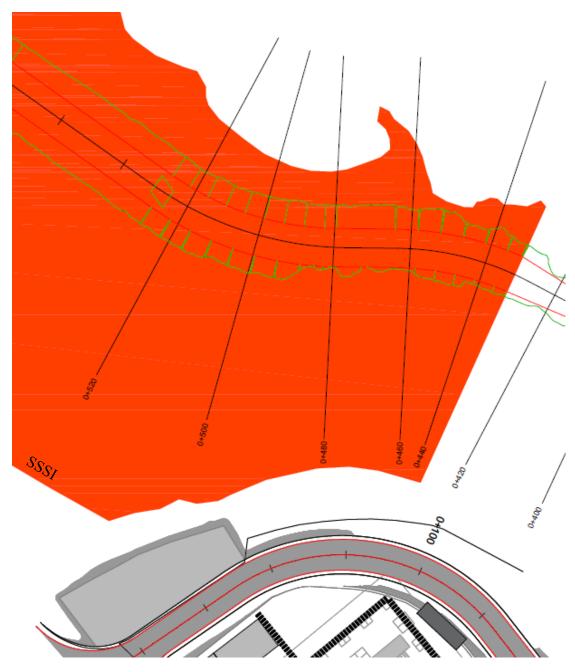
Figure 11: Sections through Slope at East End of the SSSI

Figure 11 locates the chainages for which sections through the SSSI slope have been prepared. Examples of the sections presented in Figure 12 for chainage 460m and 500m, show how the road embankment or natural features can arrest the movement of debris.

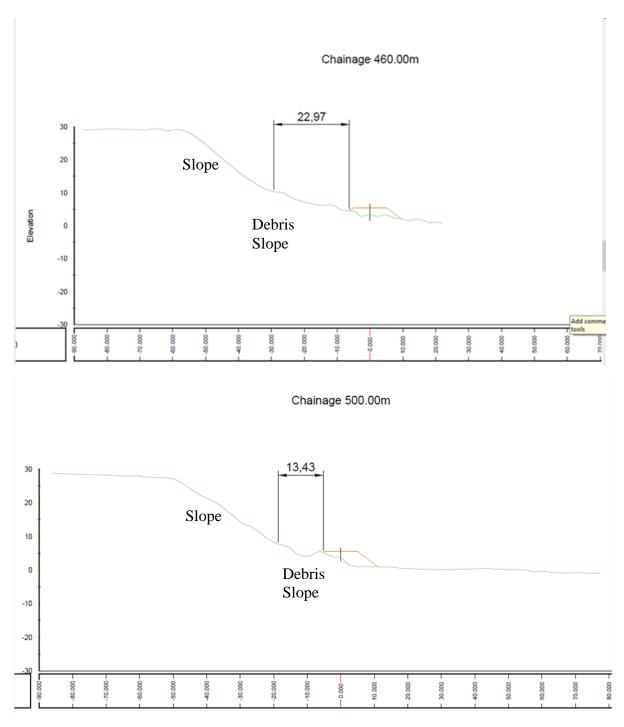
Figure 12: Sections through SSSI slope at chainage 460m and 500m.

Given the gradients involved at the foot of the east slope of the SSSI between chainage 440 and 520, DUK considers that the haul road can be constructed safely, but that regular observation of the condition of the slope should be carried out.

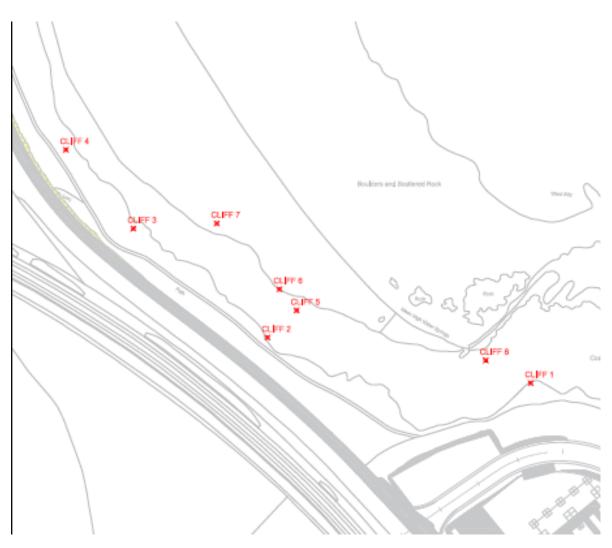
Figure 13: Survey points in the SSSI (excerpt from Appendix E).

Photograph points				
Photo 1	Blue arrow towards slope		NJ 96566 04477	
Photo 2	Blue arrow towards slope		NJ 96579 04450	
Photo 3	Blue arrow towards slope		NJ 96588 04437	
Photo 4	From red point towards blue markers		NJ 96468 04968	
Photo 5	From vibration monitor towards car park		NJ 96610 04415

If the recorded level of these points shows uplift outside the normal range of variation for the Cliff Points (\pm 3cm), it will be taken as a sign of incipient slumping. Works in the SSSI will be paused, SNH notified and the condition of the cliff face will be reviewed.

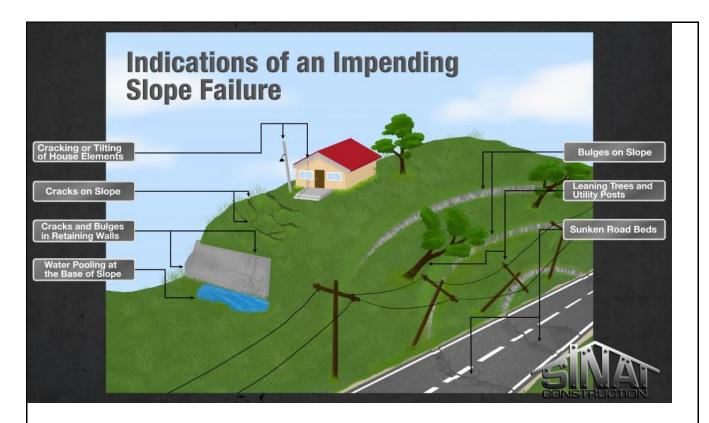
-	that the alignment of marker flags set in t	
changed from	n previous days, it may mean the slope is s	starting to slip.
If you notice any of	f these signs, point them out to your super-	visor or to the ECOW.

Figure: examples of signs of slippage.
