# **Tarbert (Loch Fyne) Harbour Authority**

Access Slipway and Car Park: Intertidal Survey  
Report

**Document reference:** 107065-24-A

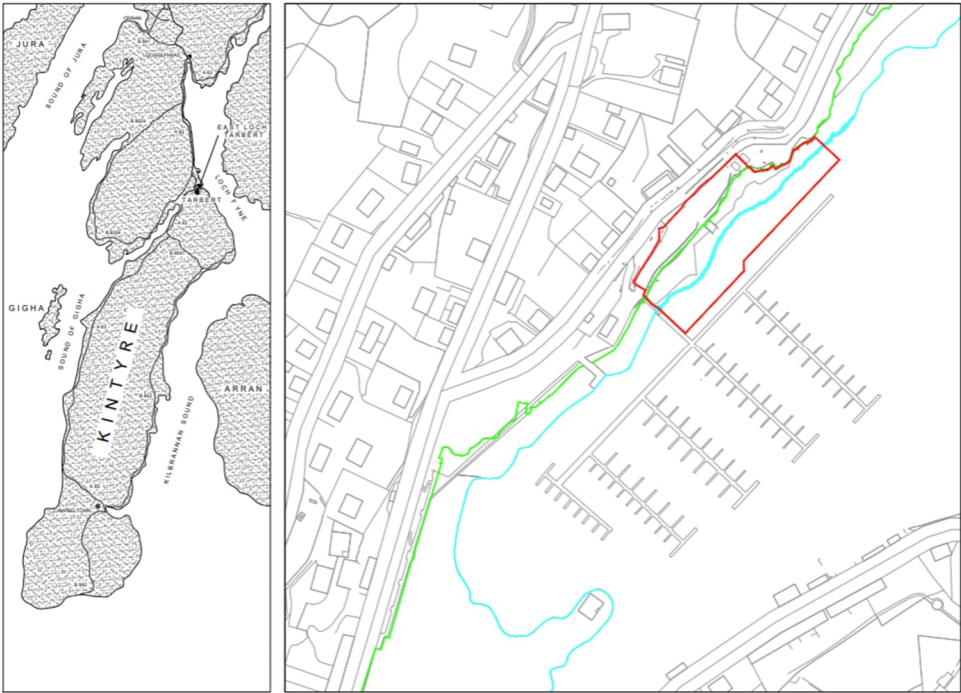
Figure 1.2: Site location plan

The focus area for the survey, herein referred to as the 'site', is highlighted in red on Figure 1.2 which encompasses the foreshore intertidal area in the immediate area of the proposed development.

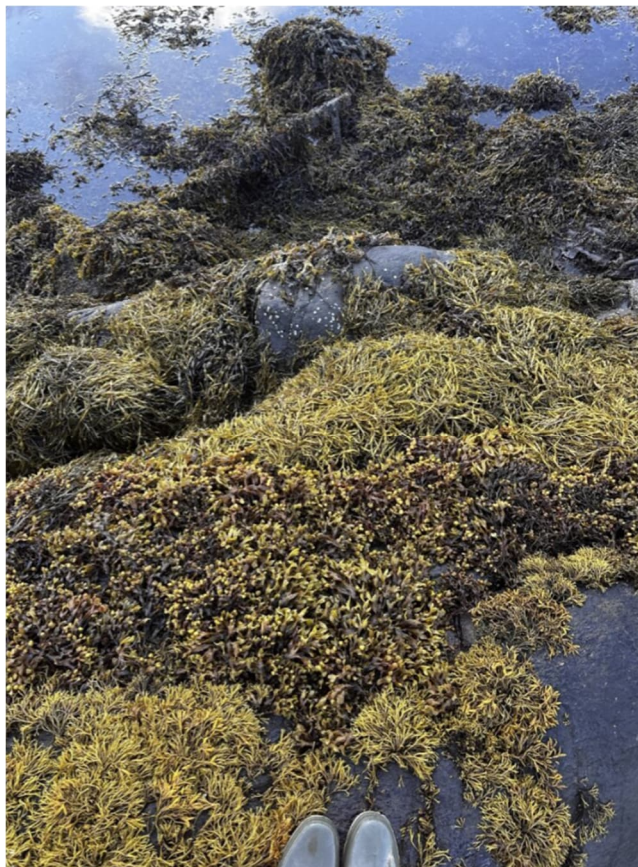
Figure 3.1: Rocky shore habitat in northern end

The upper littoral zone in the north end of the site featured rocky shore, with the splash zone characterised by white, orange (*Caloplaca* spp) and green lichens. Below this, the upper littoral was dominated by bands of channel wrack (*Pelvetia canaliculata*) and spiralled wrack (*Fucus spiralis*), forming the biotope ***Pelvetia canaliculata* on sheltered littoral fringe rock LR.LLR.F.Pel** (Figure 3.1). The mid littoral comprised bladder wrack (*Fucus vesiculosus*), egg wrack (*Ascophyllum nodosum*) and wrack siphon weed (*Vertebrata lanosa*). The invasive modest barnacle (*Austrominus modestus*), native common rock barnacle (*Semibalanus balanoides*), and *Littorina* spp were also identified. The biotope of the mid littoral therefore comprised **Fucoids on sheltered marine shores LR.LLR.F**. The lower littoral comprised the biotope ***Fucus serratus* on full salinity lower eulittoral mixed substrata LR.LLR.F.Fserr.X**, featuring Serrated wrack (*Fucus serratus*) and egg wrack. These habitats were also identified directly adjacent to the south of the slipway, also featuring horned wrack (*Fucus ceranoides*) (O).

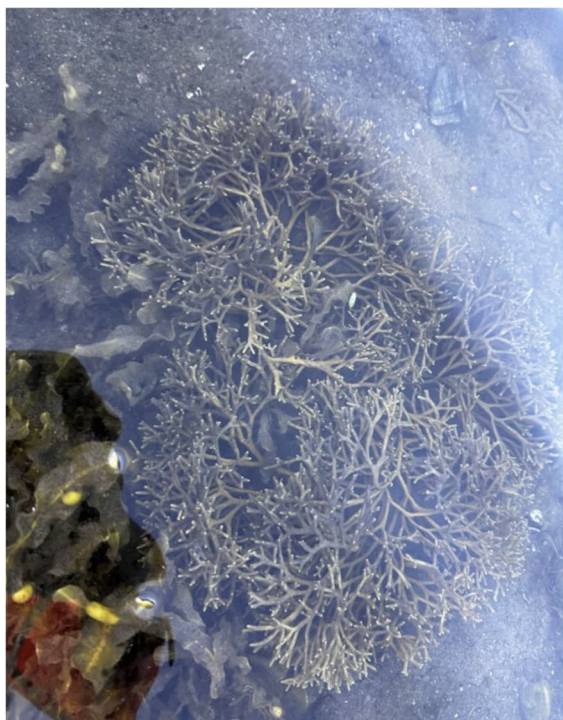
**Figure 3.3: *A. nodosum* ecad mackayi**

South of the rocky shore, between this and the slipway, the littoral zone comprised a mixed sediment of muddy gravels with boulders. Boulders on the upper littoral featured yellow lichen, with barnacles (*A. modestus* and *S. balanoides*) and *Littorina* spp in sheltered crevices. The upper littoral featured the biotope **Fucoids in variable salinity LR.LLR.FVS** (Figure 3.2). Egg wrack (*A. nodosum*) (A) and bladder wrack (*F. vesiculosus*) (C) were noted on cobbles throughout the mid to lower littoral, along with barnacles (*A. modestus* and *S. balanoides*), common limpet (*Patella vulgata*) and *Littorina* spp. The catworm (*Nephtys hombergii*) and casts, likely lugworm (*Arenicola marina*), were also noted within the muddy substrate at the lower littoral. Additionally, the non-attached growth form of egg wrack (*Ascophyllum nodosum* ecad *mackayi*) (O) was identified (Figure 3.3) extending from the mid to lower littoral. As such the biotope comprises **Ascophyllum nodosum ecad mackayi beds on extremely sheltered mid eulittoral mixed substrata LR.LLR.FVS.Ascmac**. Note, this habitat is a designated Habitat of Principal Importance (HPI)<sup>7</sup>, Habitat of Conservation interest (HCI), Annex 1 habitat<sup>8</sup>, UK Biodiversity Action Plan (BAP)<sup>9</sup> habitat and Priority Marine Feature (PMF)<sup>10</sup>.

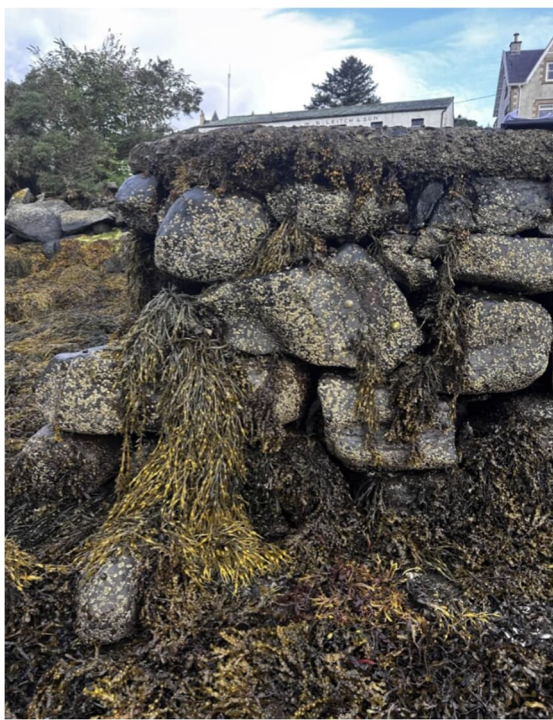
**Figure 3.4: Slipway, facing west from the intertidal area**

The small pontoon off the car park comprises **littoral rock LR**, featuring blue mussel (*Mytilus edulis*) (C), common limpet (*P. vulgata*) (R), dog whelk (*Nucella lapillus*) (R) and barnacles (*A. modestus* and *S. balanoides*) (O) (Figure 3.4). The mid to lower littoral in front of the pontoon featured egg wrack (*A. nodosum*) (C), bladder wrack (*F. vesiculosus*) (A), serrated wrack (*F.*

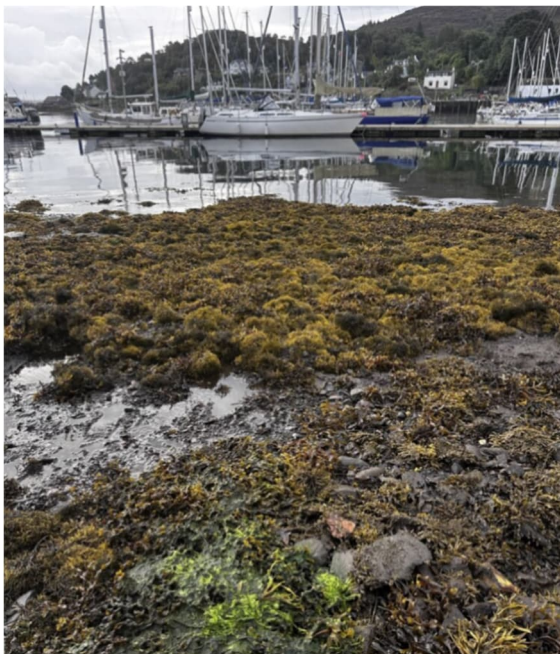
**Figure 3.5: *A. nodosum ecad mackayi* located between the slipway and pontoon**

The intertidal area to the south of the slipway was characterised by egg wrack (*A. nodosum*), its non-attached growth form (*ecad mackayi*) and serrated and spiralled wracks (*F. serratus* and *spiralis*), extending from the mid to lower littoral (Figure 3.5). This also comprised the designated habitat ***Ascophyllum nodosum ecad mackayi* beds on extremely sheltered mid eulittoral mixed substrata LR.LLR.FVS.Ascmac.**

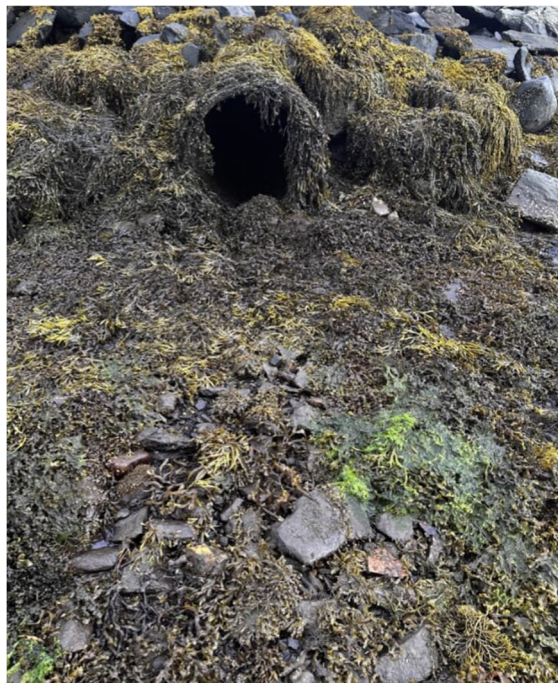
**Figure 3.6: Outfall**

An outfall (Figure 3.6) was located about halfway between the slipway and pontoon (TN1) on the upper littoral, horned wrack (*F. ceranoides*) (A), a tubular green seaweed (*Ulva* spp., likely *Blidingia* spp. or tubular *Ulva* spp.) (O), bladder wrack (*F. vesiculosus*) (C), egg wrack (*A. nodosum*) (S), spiralled wrack (*F. spiralis*) (F) and the non-attached growth form of egg wrack (*A. nodosum ecad mackayi*) (R).

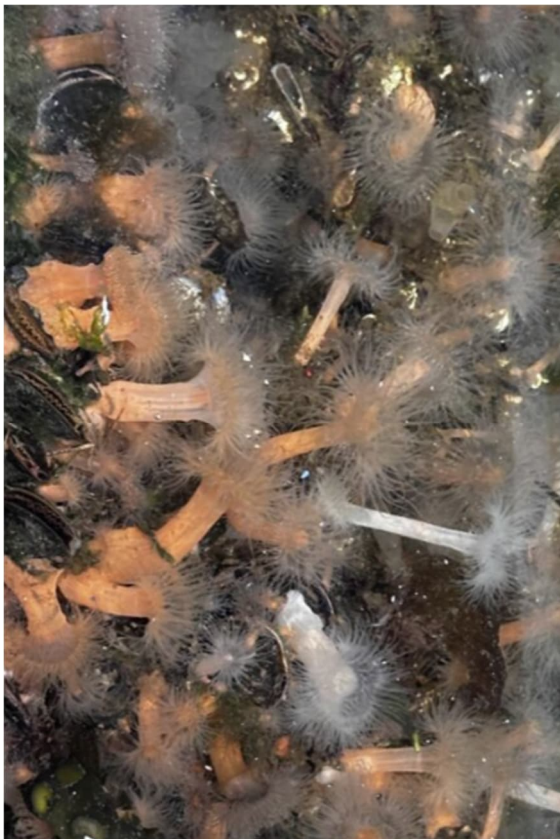
**Figure 3.7: *S. lacerata*, *M. edulis***

The fountain anemone (*Sagartia lacerata*), blue mussel (*M. edulis*), tunicates (Ascidiacea) and kelp (*Laminaria* spp.) were identified on the pontoon and mooring buoys (Figure 3.7 and Figure 3.8).

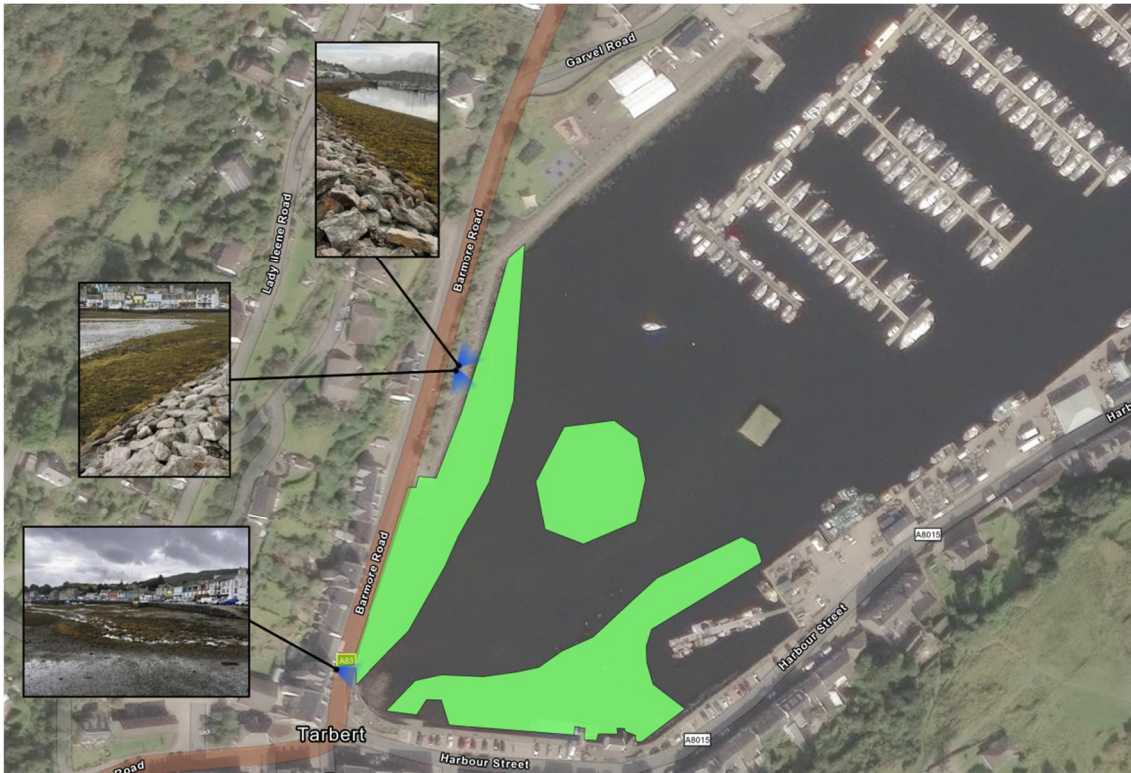
**Figure 3.9: Extent of *A. nodosum* ecad *mackayi* (green areas)**

The map showing the approximate extent of the habitat is provided in Appendix C, with an extract given in Figure 3.9. Photographs of the habitat are provided below (Figure 3.10, Figure 3.11 and Figure 3.12).

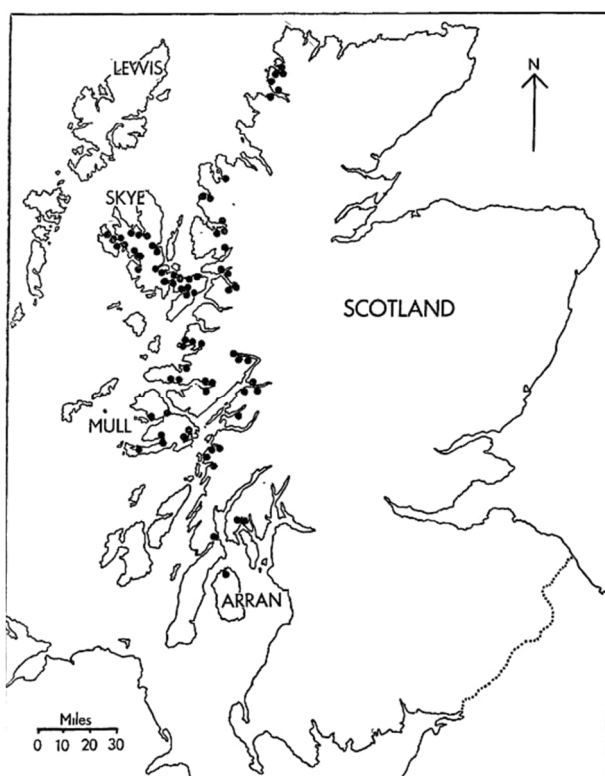
**Figure 4.1: Distribution of ecad *mackayi* (beach form) on the mainland of Scotland and the isles of Skye, Mull and Arran<sup>13</sup>**

Distribution of the habitat throughout the west coast of Scotland has been recorded frequently, and in abundance (Figure 4.1)<sup>13</sup>.

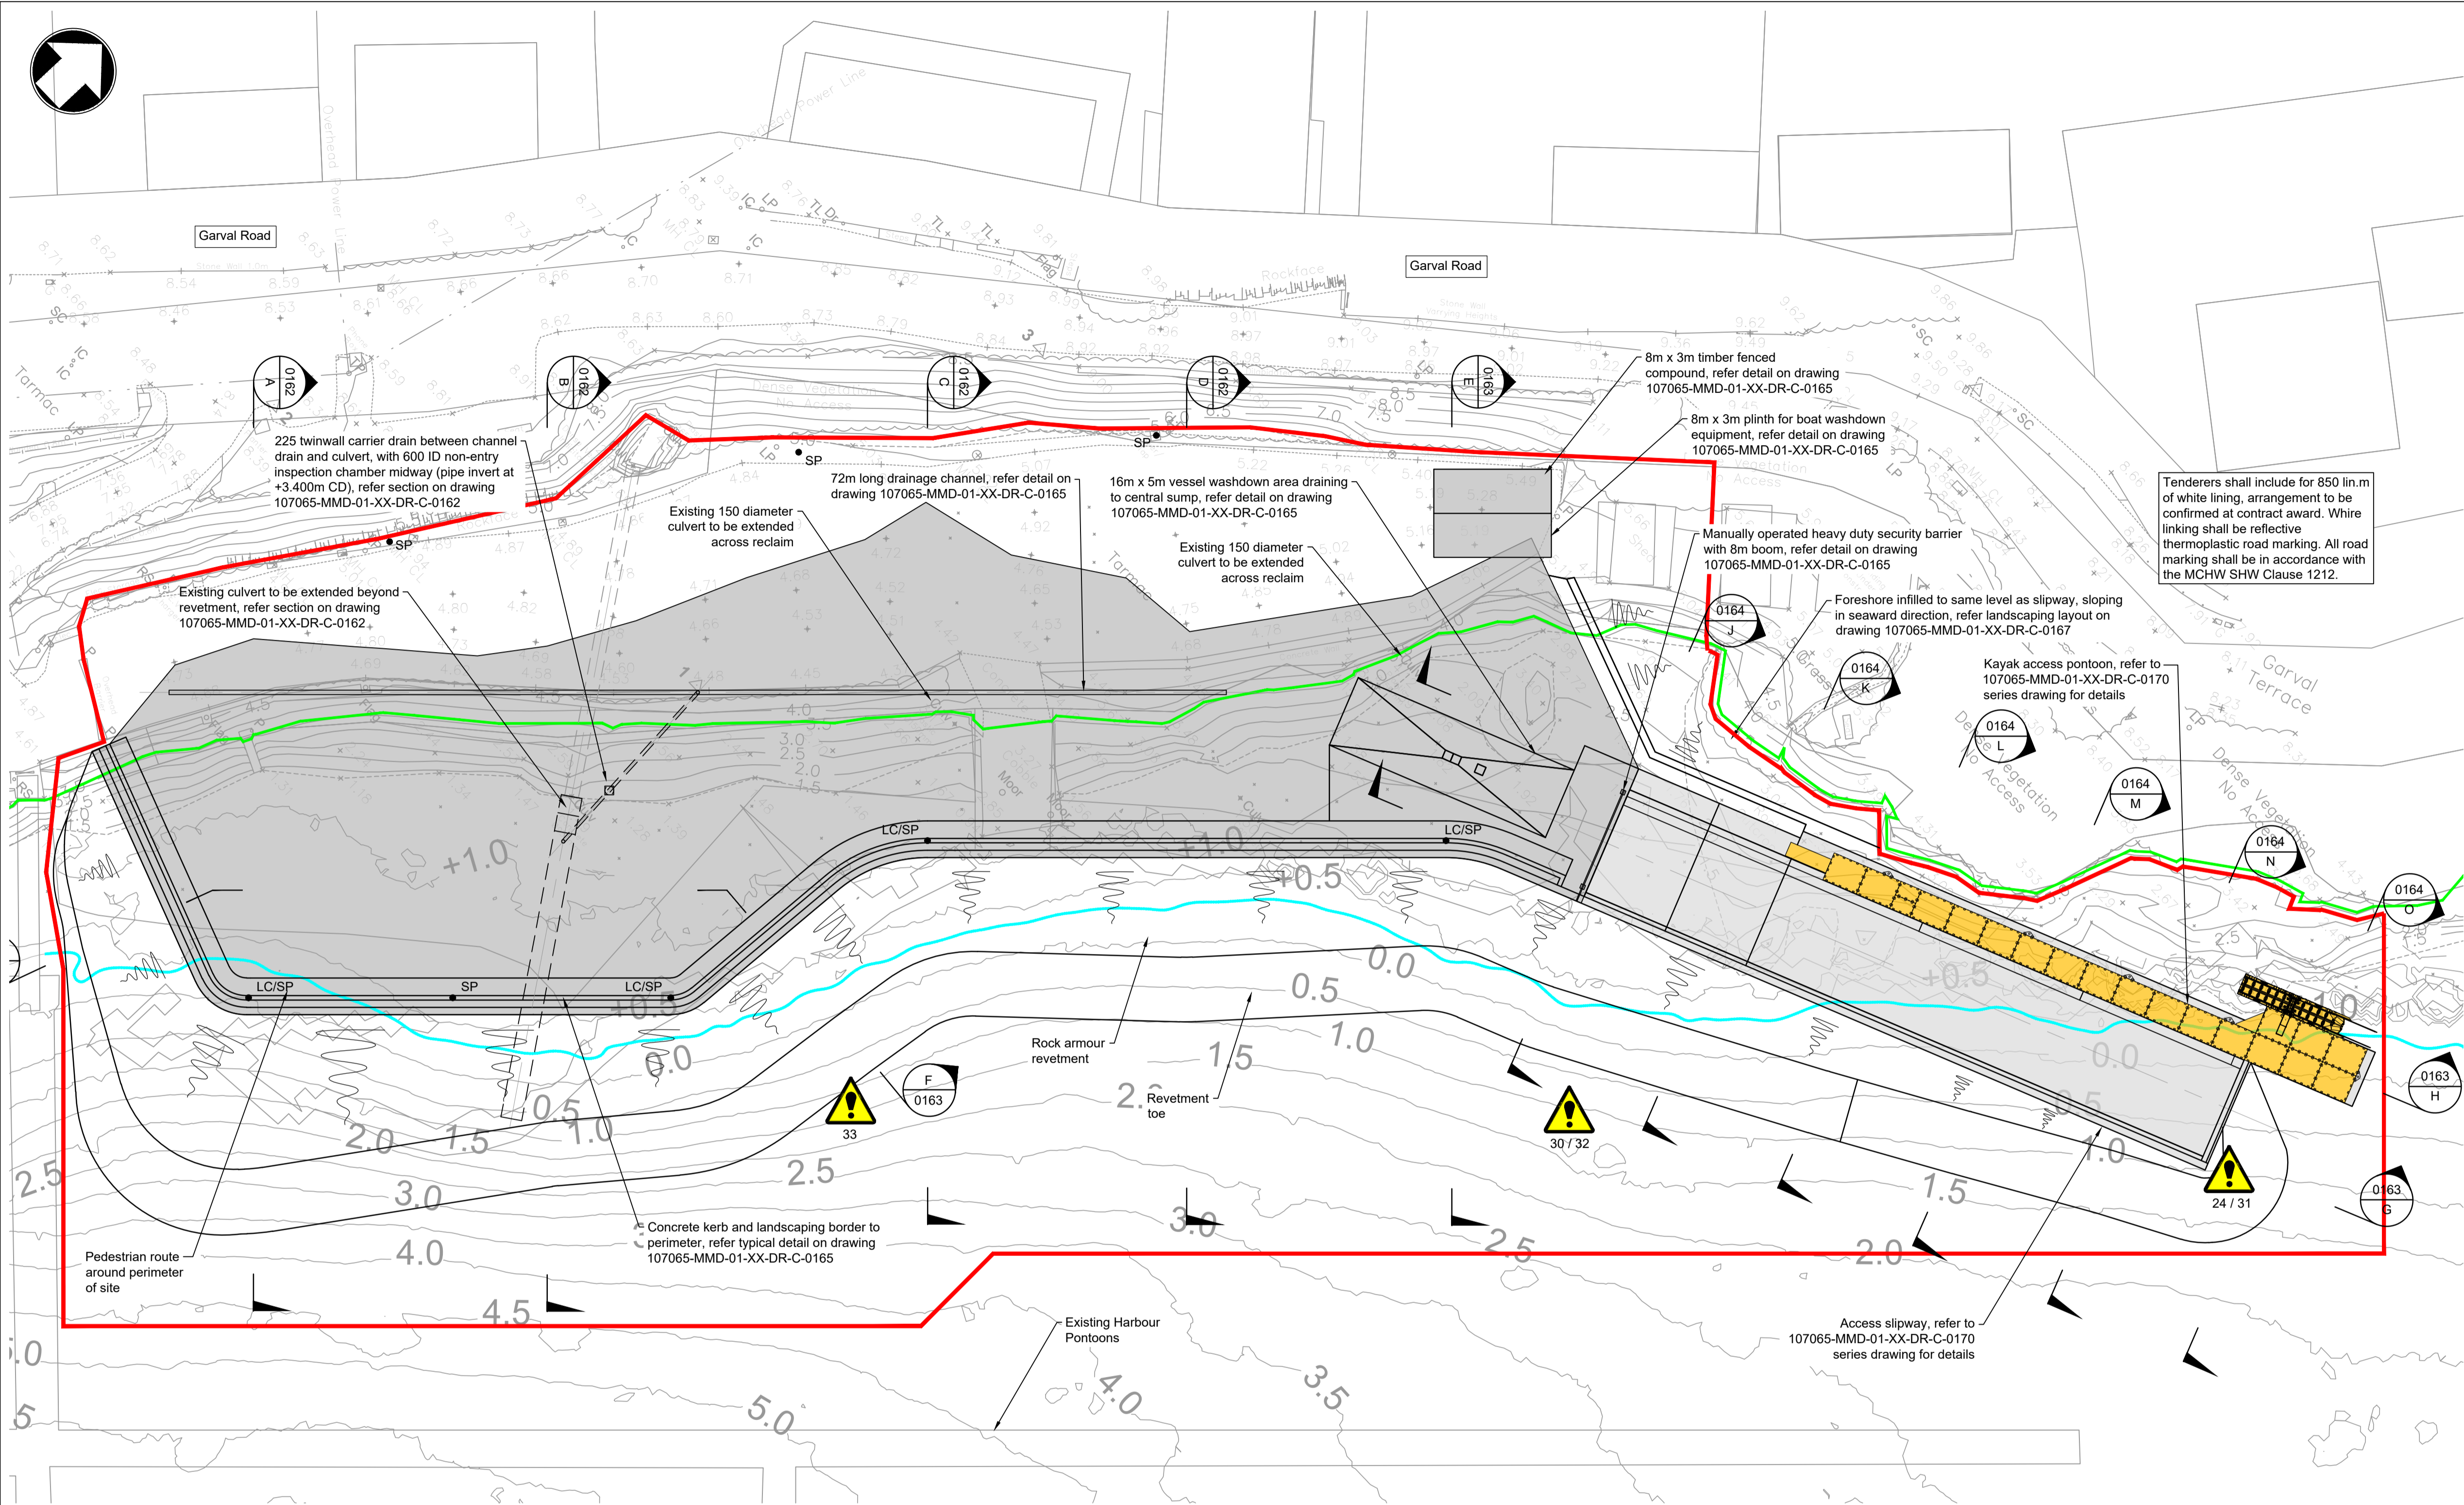
The Proposed Development is for the extension of an existing car park (via land reclamation) and construction of an adjacent concrete slipway for sea-sports and vessel access to and from the sea. The land reclaim shall be used to provide additional car parking or vessel dry berthing capacity dependant on season. Installation of a kayak / seasports access pontoon is also included in the proposals.

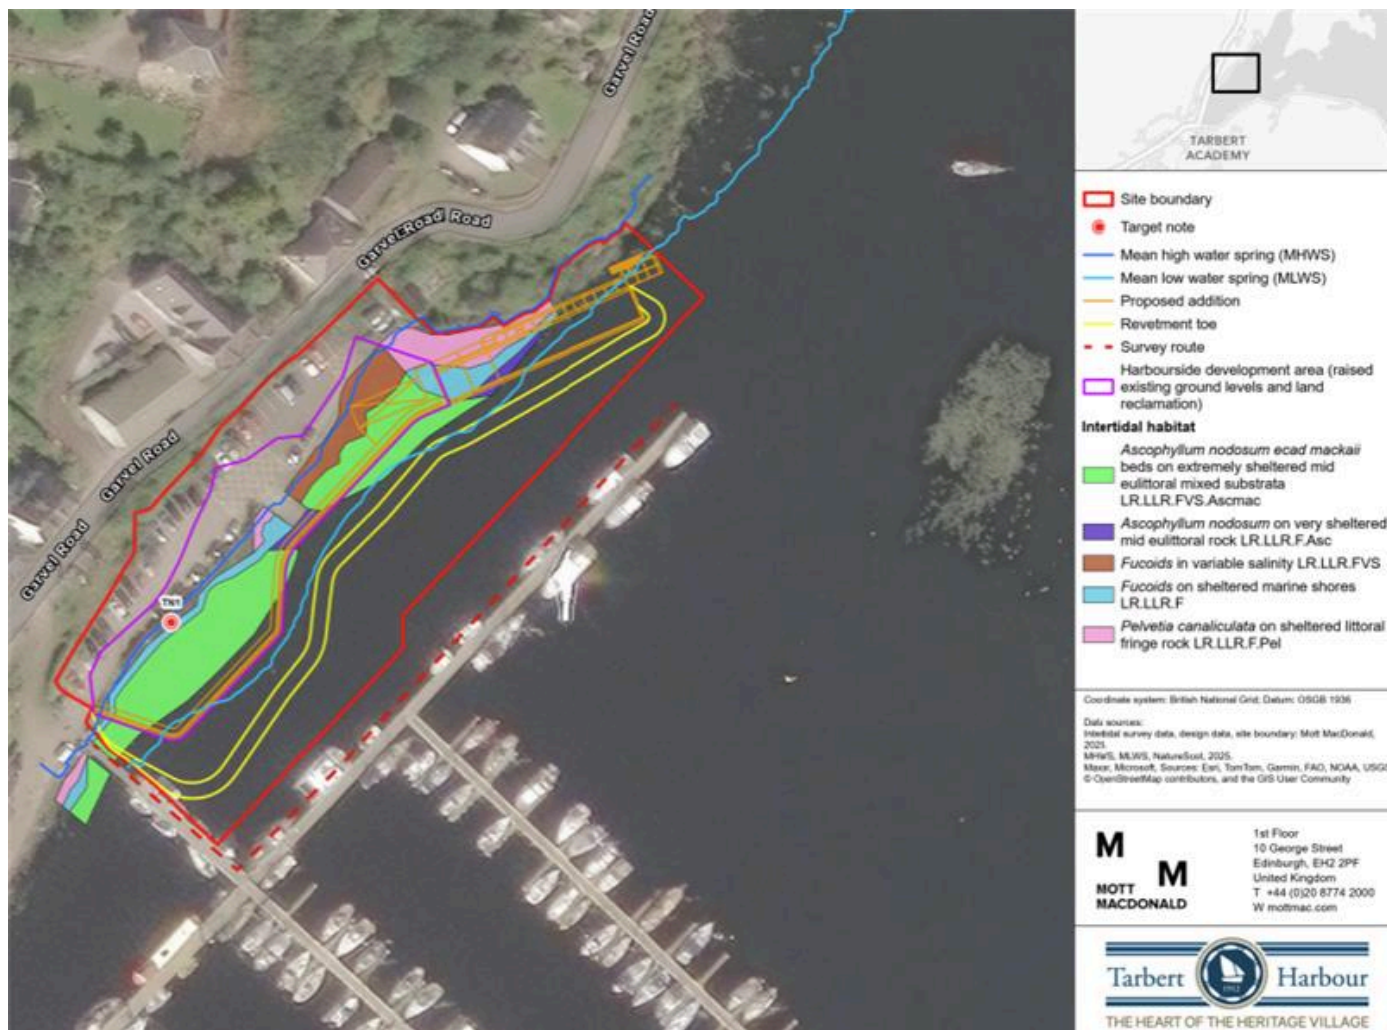
We undertook intertidal surveys of the area within and adjacent to the proposed land reclamation for the car park and slipway. We identified presence of the BAP priority habitat and Priority Marine Feature *Ascophyllum nodosum* ecad *mackayi* beds, which made up a large proportion of the intertidal area within the footprint of the proposed land reclamation, see the image below (green polygons). A higher resolution PDF has been provided on the file transfer site).

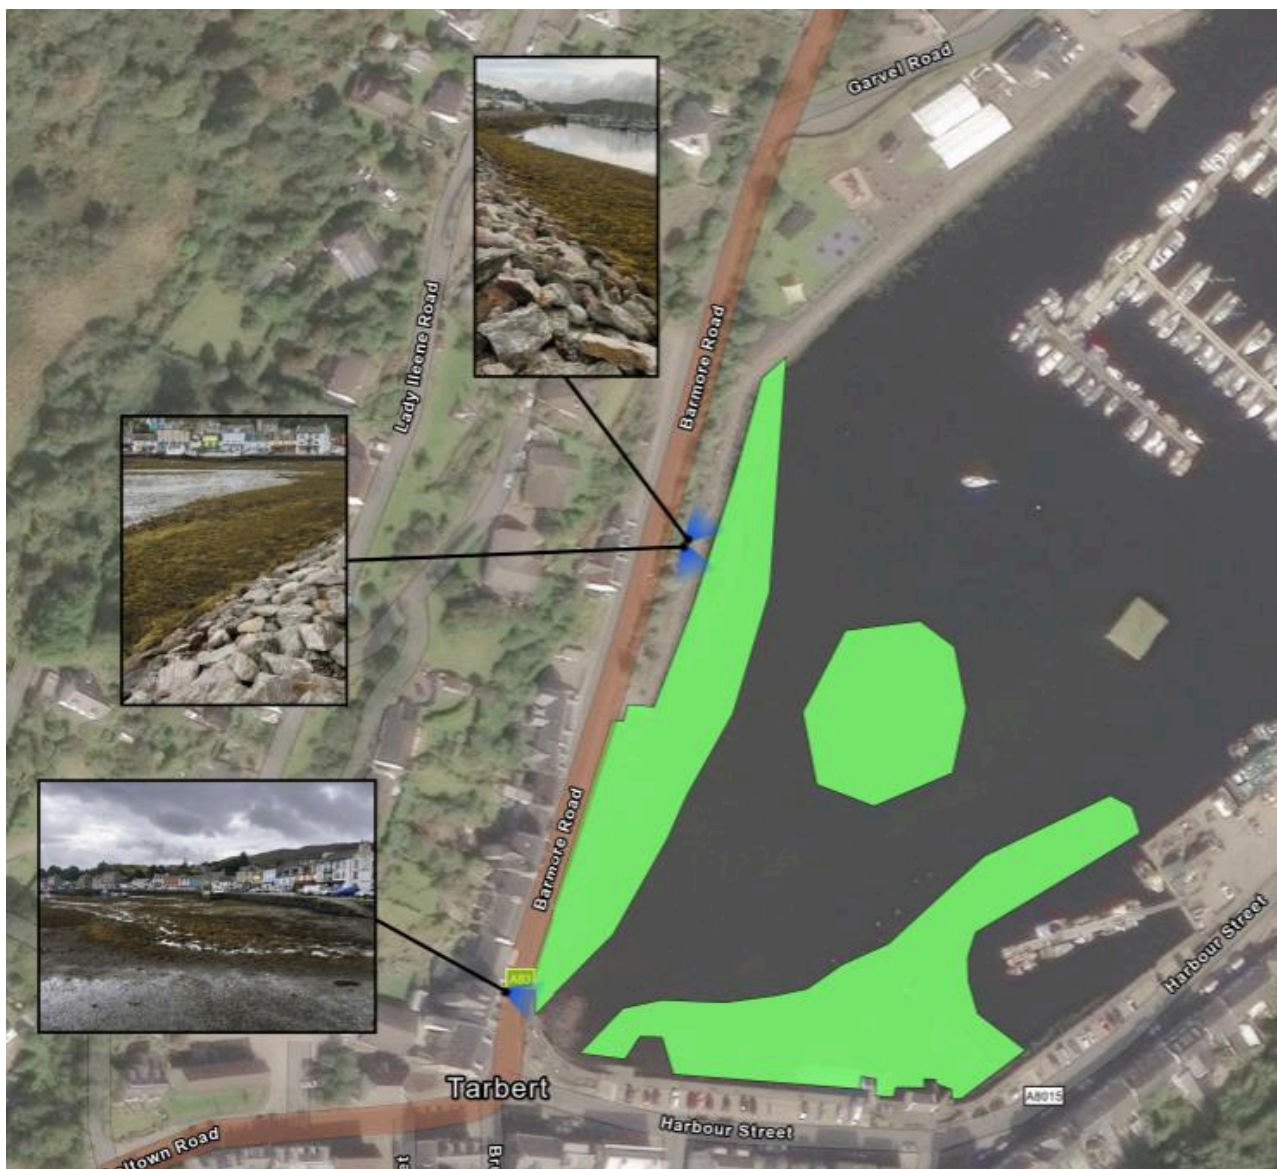
Outside of the targeted survey area for the project, we incidentally noticed that this habitat appears to be present throughout the south-western harbour area, we took photographs on site and mapped out the approximate areas from these, shown below:
