Method Statement – Buckhaven Shoreline Works

The following Method Statement describes how the Buckhaven Shoreline Works will be carried out. The works involve building a new gabion basket wall to protect the existing public facilities and landfill area from coastal erosion, with backfilling behind the new gabion wall to reinstate the eroded area and re-use of the existing rock armour to provide added protection along the face of the new gabion baskets. The works are required to prevent the public facilities (car park, picnic areas, and historical signage) from being damaged by coastal erosion and to prevent any loss of landfill material onto the foreshore. The extent and detail of the works are shown on the “Buckhaven Shoreline Works” drawing.

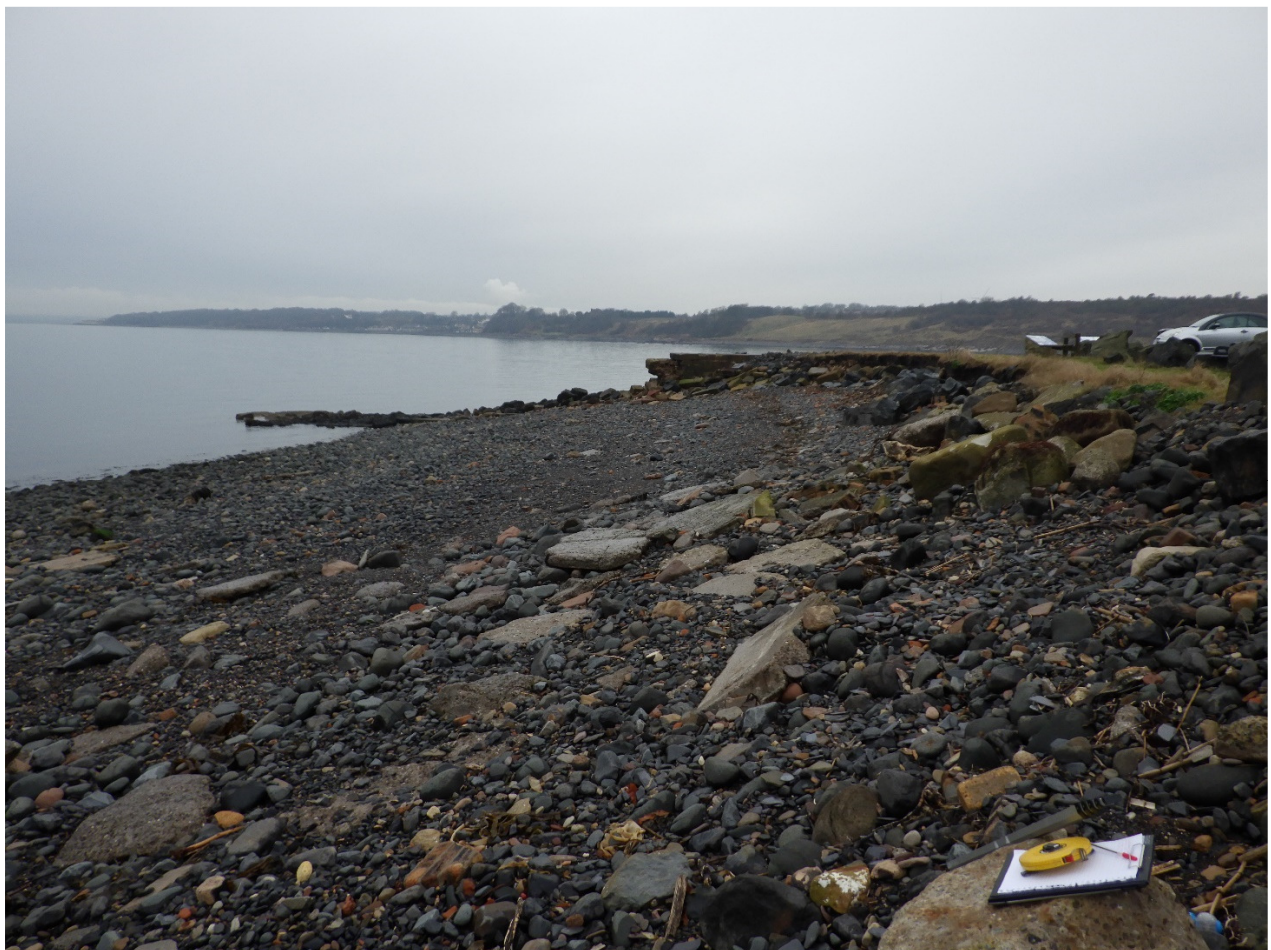
General View of the Eroding Section of Coast Looking in an Westerly Direction

A selection of photos of the existing area showing the current erosion are included below.

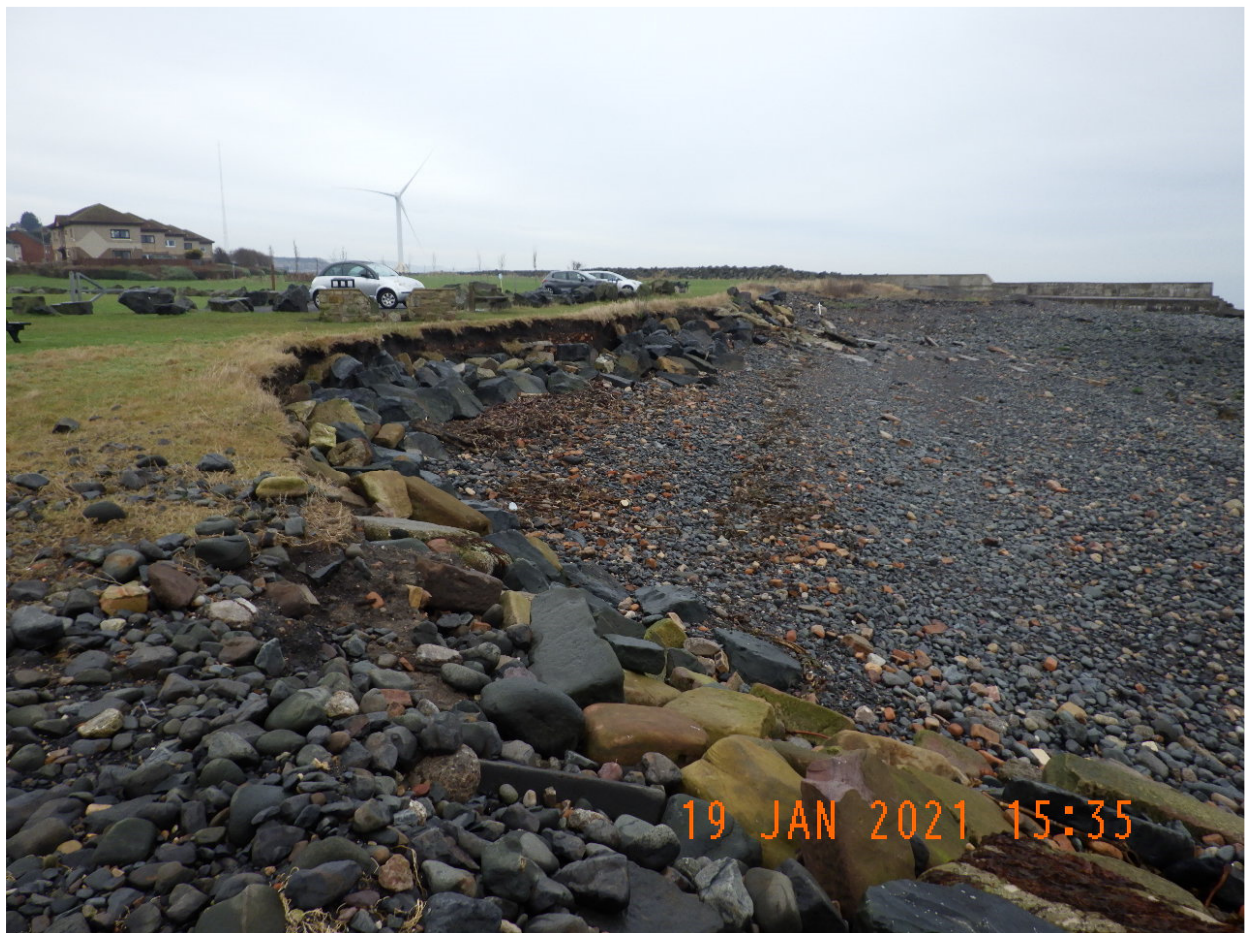
General View of the Eroding Section of Coast Looking in an Easterly Direction

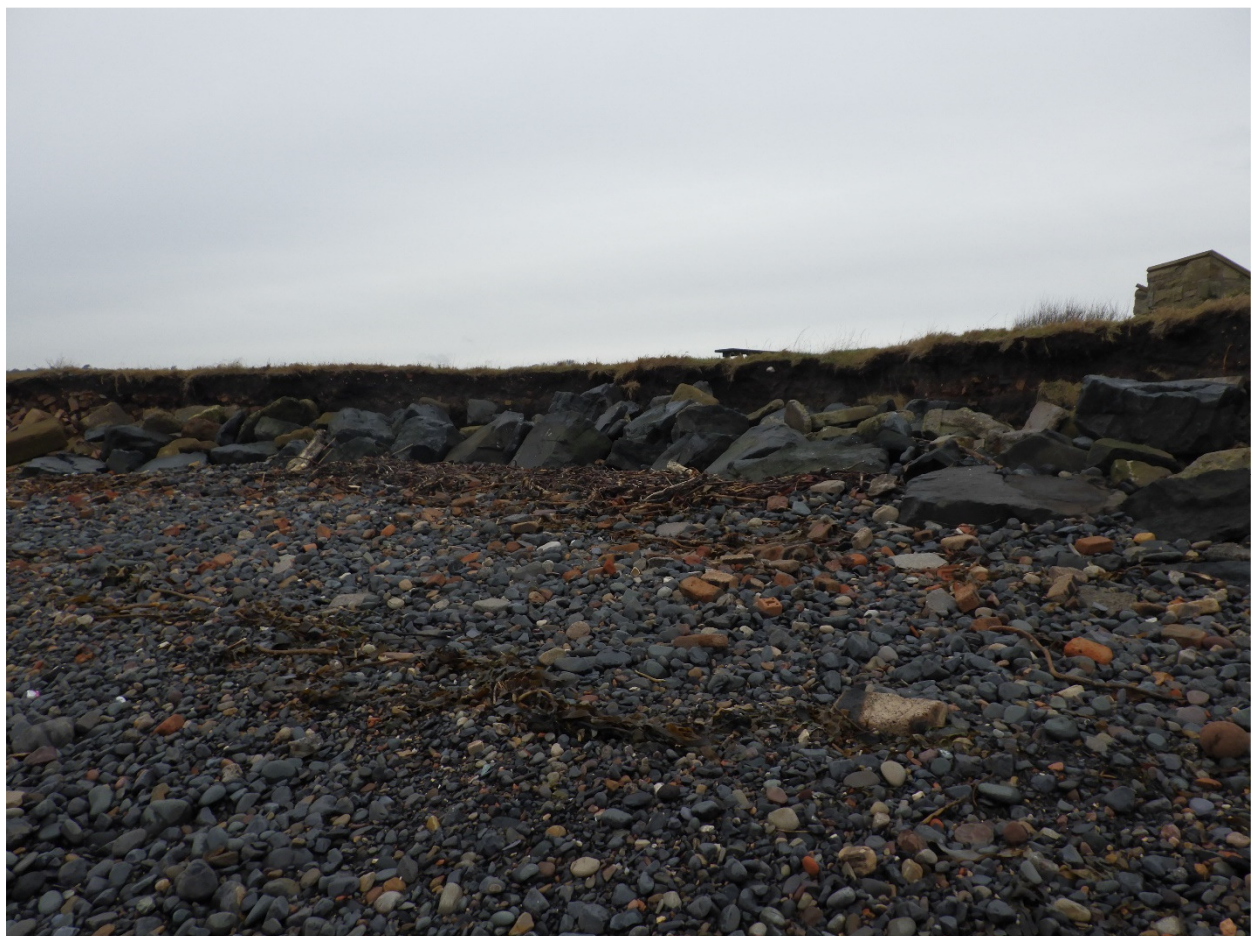
General View of the Eroding Section of Coast Looking from the Foreshore

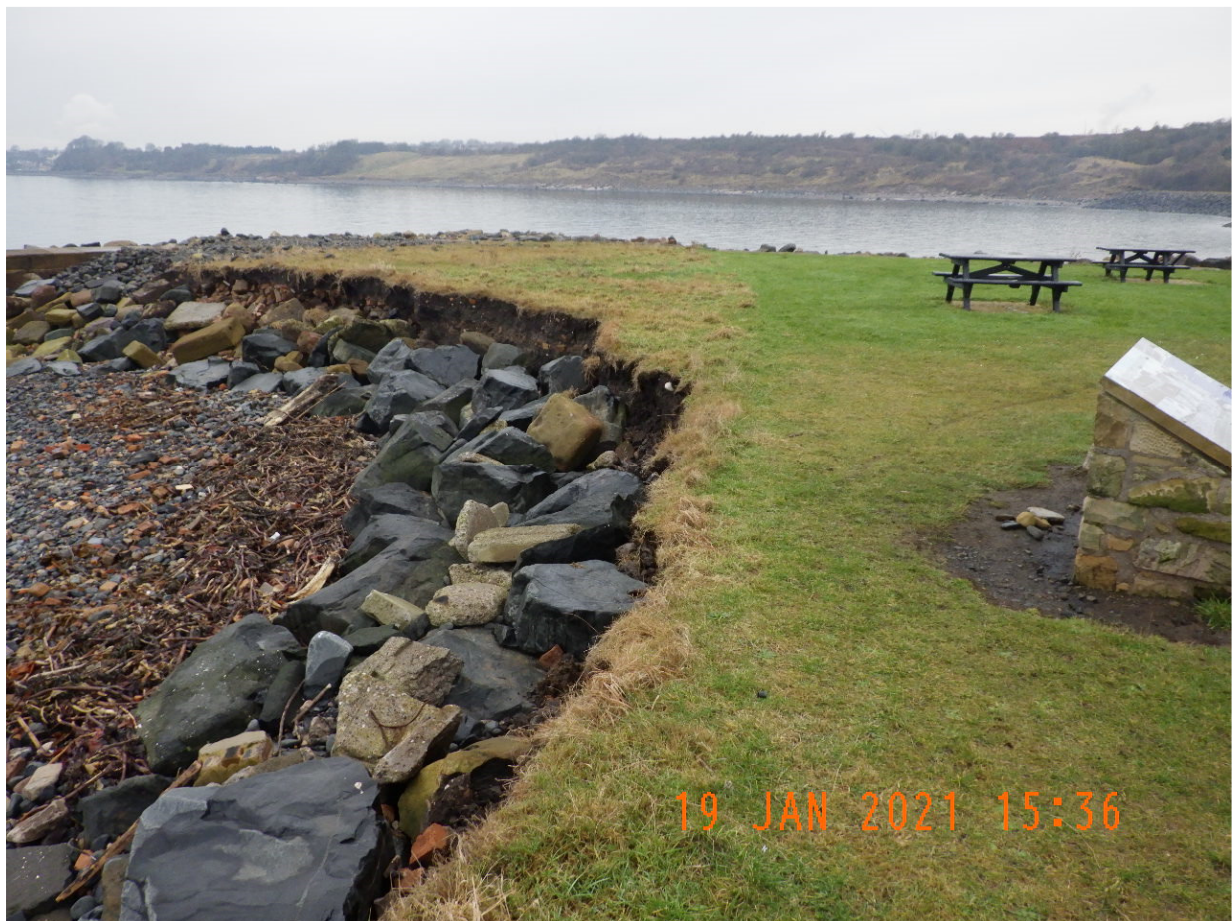
General View of the Eroding Section of Coast Looking in an Westerly Direction Showing the Proximity to the Historical Information Sign and Picnic Area (January 2021)

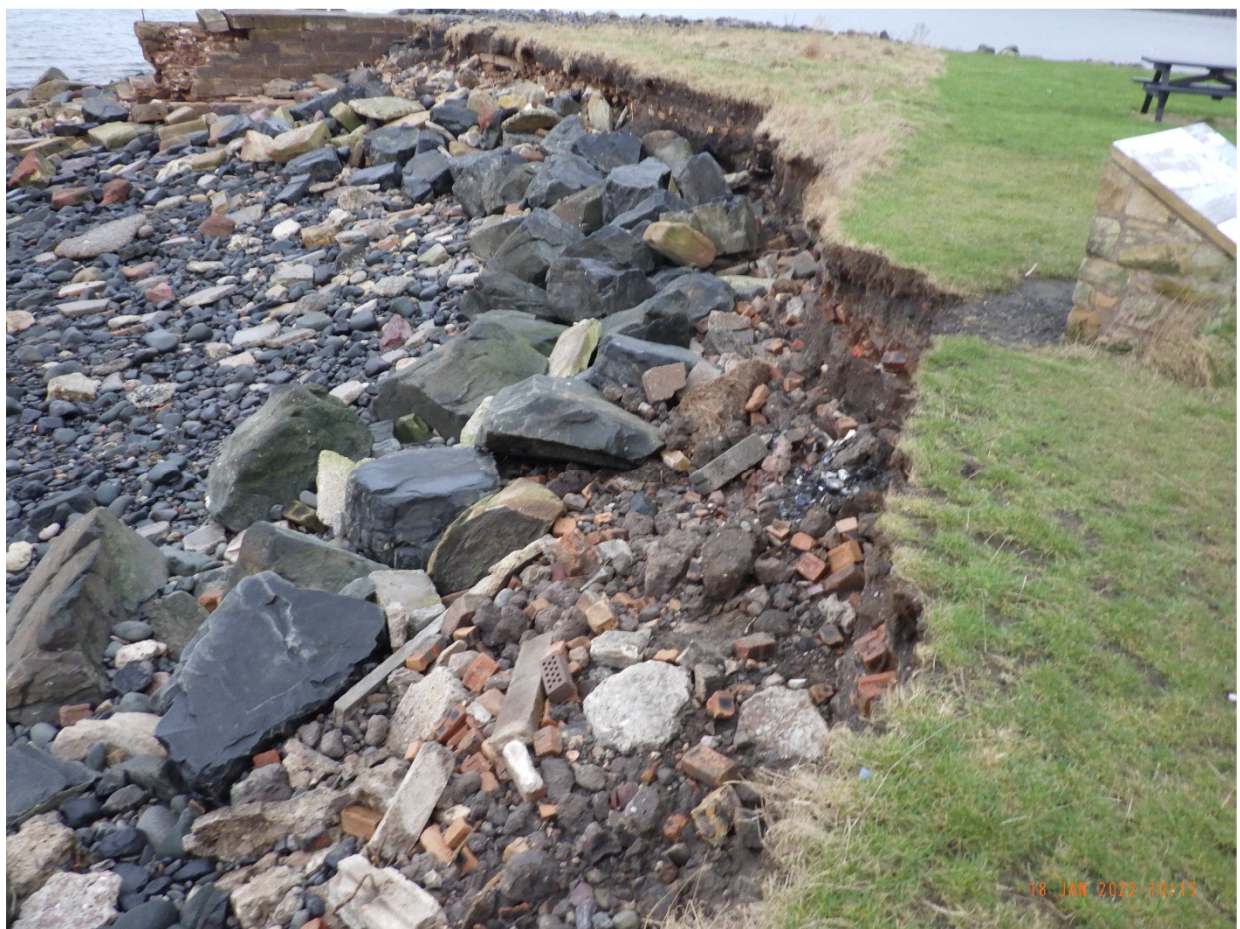
General View of the Eroding Section of Coast Looking in an Westerly Direction Showing the Proximity to the Historical Information Sign and Picnic Area (January 2022)
