CLIENT: EDINBURGH MARINA GRANTON HARBOUR LTD

DOCUMENT TITLE: NAVIGATIONAL RISK ASSESSMENT

DOCUMENT NUMBER: 2252A-062-GM R01 01

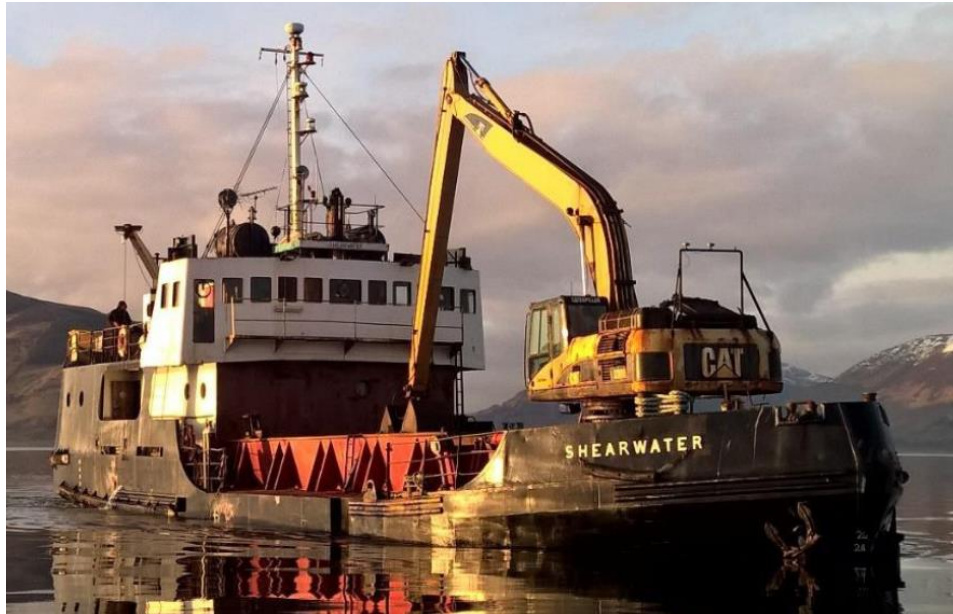
Figure 3 Shearwater (Backhoe Dredger)

from the seafloor by the BHD. Figure 3, below shows the typical backhoe dredger arrangement with a long reach excavator positioned on the barge; it also shows the self-propelled disposal barge that is used to take the dredged material to the disposal ground.

The marine plant shall consist of MV Shearwater, or similar, which is a self-contained, self-propelled, bottom dumping hopper vessel with a Caterpillar excavator mounted on its bow.

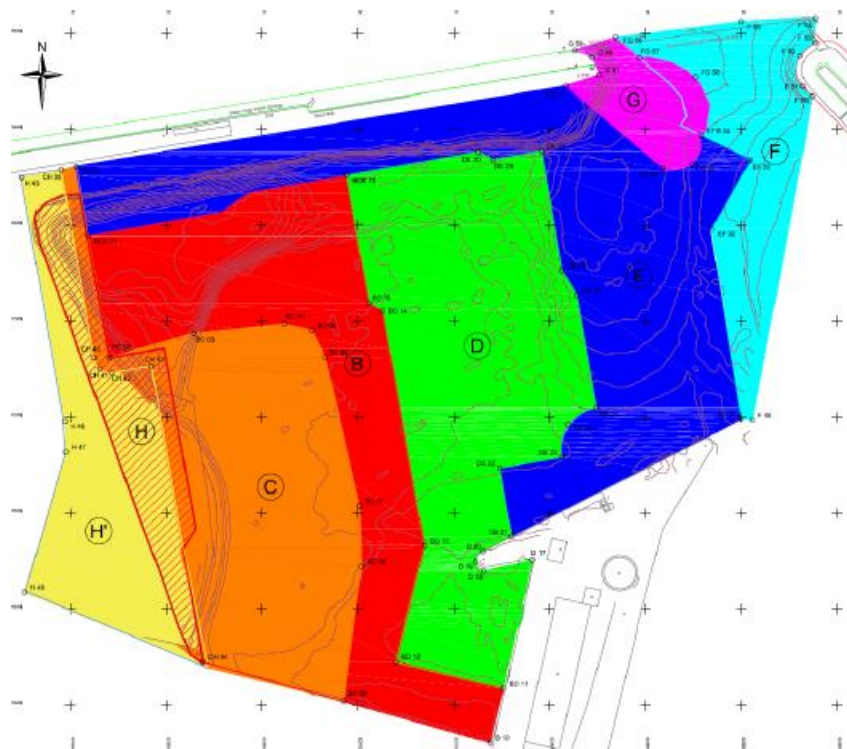
Figure 4 Marine Dredge Areas

Zone (refer to Figure 4)	Volume for Disposal at Sea (top 1.2m ³)	Volume for Disposal on Land (m ³)	Net Volume dredged (m ³)
A	N/A		
B	20344	7936	28280
C		47094	47094
D	25698	20620	46318
E	27349	40928	68277
F	10073	21400	31472
G	3516	16408	19924
H (infill)			19322

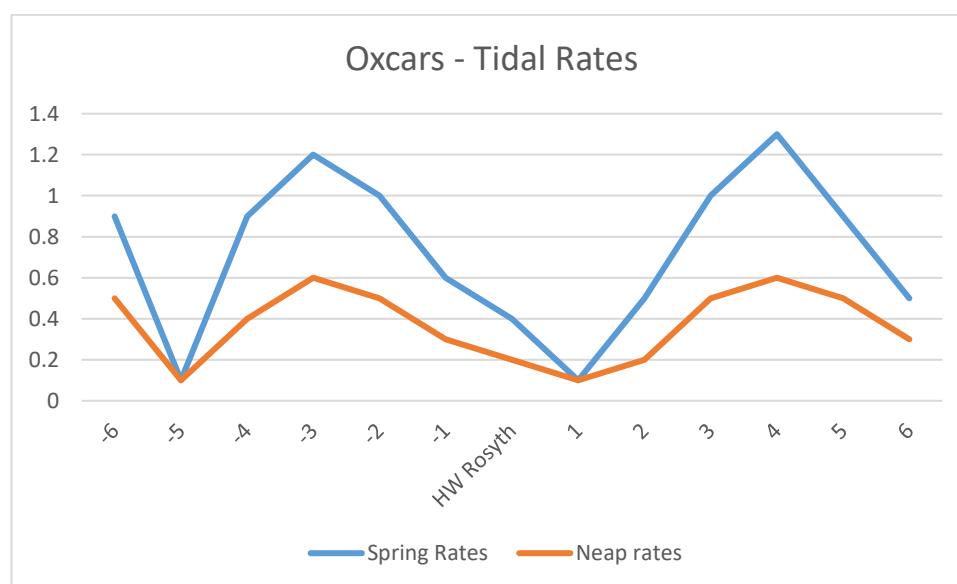
Figure 8 Oxcars Tidal Curve (Flood / Ebb)

Time relative to HW Rosyth	Direction (to)	Spring Rate (kts)	Neap Rate (kts)
-6	077	0.9	0.5
-5	248	0.1	0.1
-4	260	0.9	0.4
-3	259	1.2	0.6
-2	254	1.0	0.5
-1	264	0.6	0.3
HW Rosyth	255	0.4	0.2
+1	280	0.1	0.1
+2	075	0.5	0.2
+3	082	1.0	0.5
+4	076	1.3	0.6
+5	080	0.9	0.5
+6	077	0.5	0.3

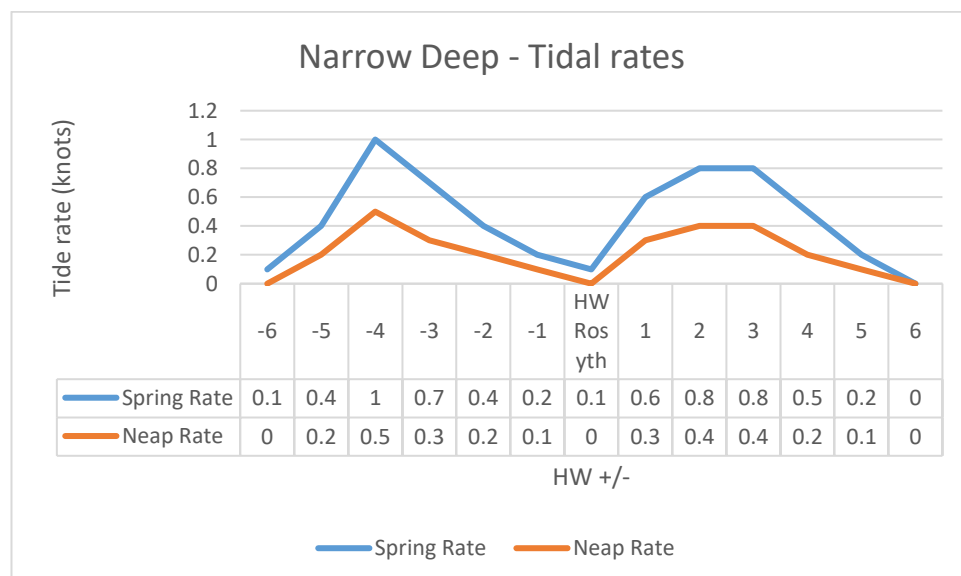
Figure 9 Narrow Deep Tidal Curve (Flood / Ebb)

Time relative to HW Rosyth	Direction (to)	Spring Rate (kts)	Neap Rate (kts)
-6	290	0.1	0.0
-5	272	0.4	0.2
-4	260	1.0	0.5
-3	264	0.7	0.3
-2	263	0.4	0.2
-1	250	0.2	0.1
HW Rosyth	225	0.1	0.0
+1	077	0.6	0.3
+2	080	0.8	0.4
+3	085	0.8	0.4
+4	092	0.5	0.2
+5	095	0.2	0.1
+6		0.0	0.0
