Scottish Isles Fibre Optic Cable Project Orkney Routes

Historic Environment Baseline and Impact Appraisal
Technical Report

January 2022

Project No: 907

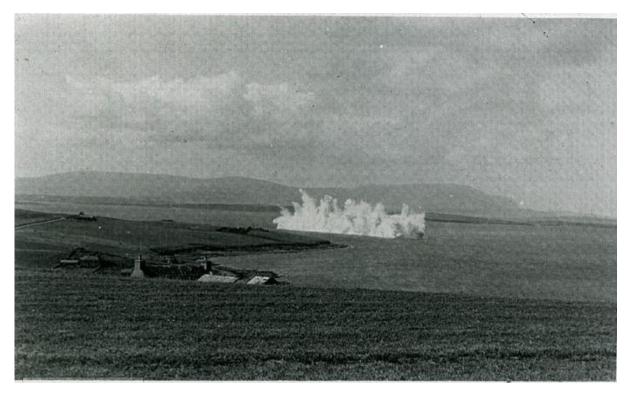
These depressions are most likely the result of the WW2 remote minefields being detonated at the end of the war. The photo below shows the mines going off in the very area of these depressions. Although the photo shows two lines of mines there is only one line of depressions bet one mine line would have been set deep and the second shallower so this would be the result of the deep field.

WW2 mine line being exploded off Hoxa. Courtesy of Bobby Forbes collection, held by SULA Diving.

There are also some linear contacts that could relate to boom net, mine lines or detection loops, both of which were used heavily in the area during both World Wars. A linear feature made up of a number of depressions in the seabed was noted on both the SSS and MBES (Figure HEA 2.12b) and in the Fugro report (124376-R-010- Flotta - South Ronaldsay Results Report - 2.12, Fig 3.13).
