Fall of Warness Berth 2: Removal of Tripod Foundation – Marine Licence Extension Supporting Documentation

August 2018

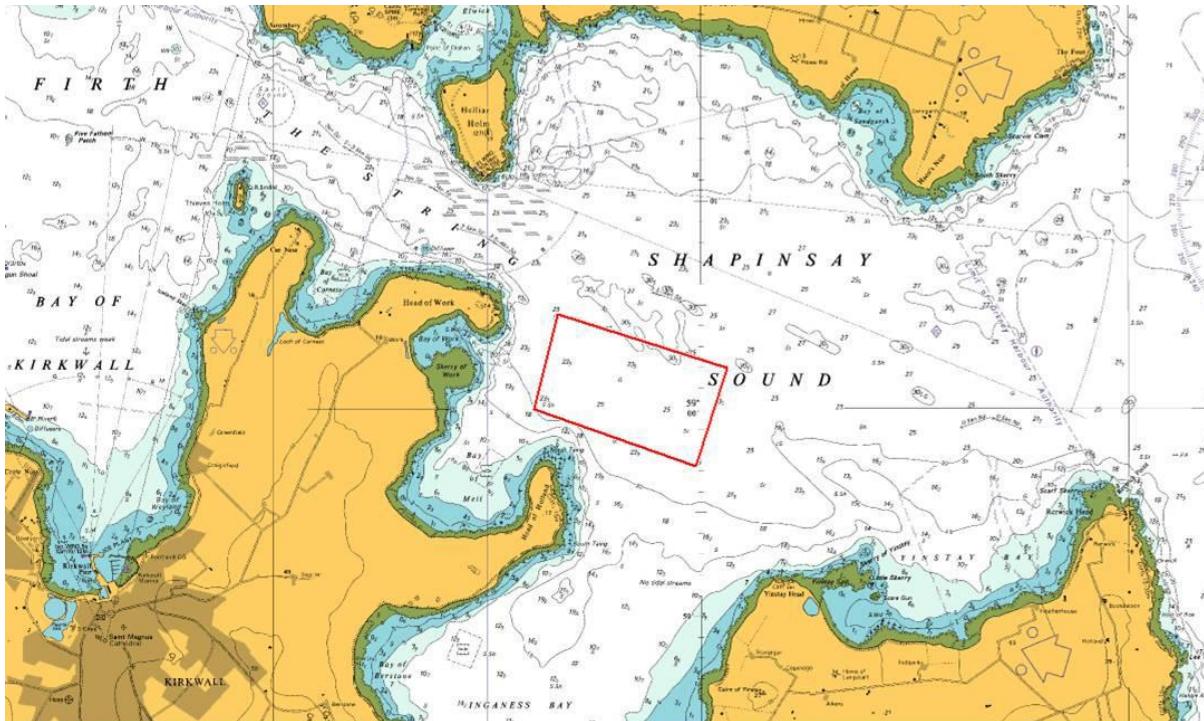
Figure 3 below shows the location and depth range of the test site.

Figure 3. Crown Estate leased area for Shapinsay Sound scale test site (marked in red)

In addition, it may be necessary to use EMEC's Shapinsay Sound scale tidal test site, as an area to conduct further dismantling of the tripod substructure. The area selected within the site to conduct such work will be agreed with the regulator prior to conducting the work. Table 3 provides the boundary coordinates of the scale tidal test site which is situated adjacent to Orkney Mainland, within Shapinsay Sound.

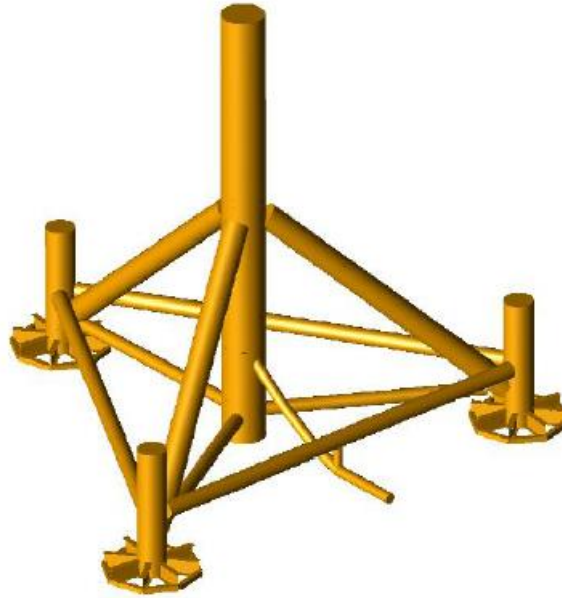
The turbine structure is illustrated schematically in Figure 4, which shows the J-tube that guides the turbine umbilical to the seabed.

Figure 4. Tripod structure showing J-tube and rock mats

In accordance with standard offshore structural practices, the foundation is of welded steel construction with an internal concrete ballast. The tripod is approximately 19m high to the hub attachment section. The structure is protected by a cathodic protection system comprising aluminium sacrificial anodes. The tripod structure was attached to the seabed at its feet by three piles grouted into rock sockets. The piles have been attached through pile attachment sleeves (i.e. the cylindrical feet at the three corners) and are less than 1.00m in diameter embedded 3.5m into the seabed.

The main parameters of the support structure are provided in Table 4. The foundation structure has a seabed footprint of 129.6m², with gaps of exposed seabed within this area, as the foundation is not a solid base covering the seabed.

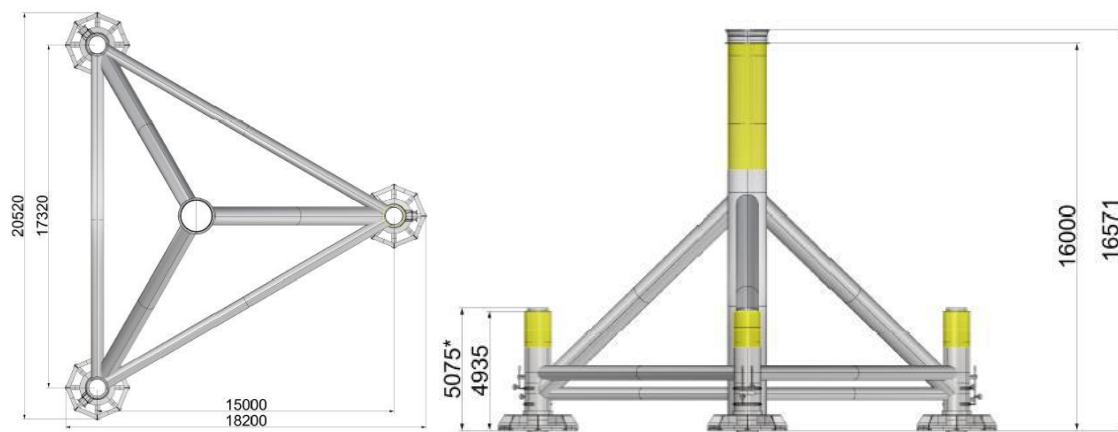
Further diagrams of the tripod structure are provided below.

Figure 5. Plan and elevation view of the tripod

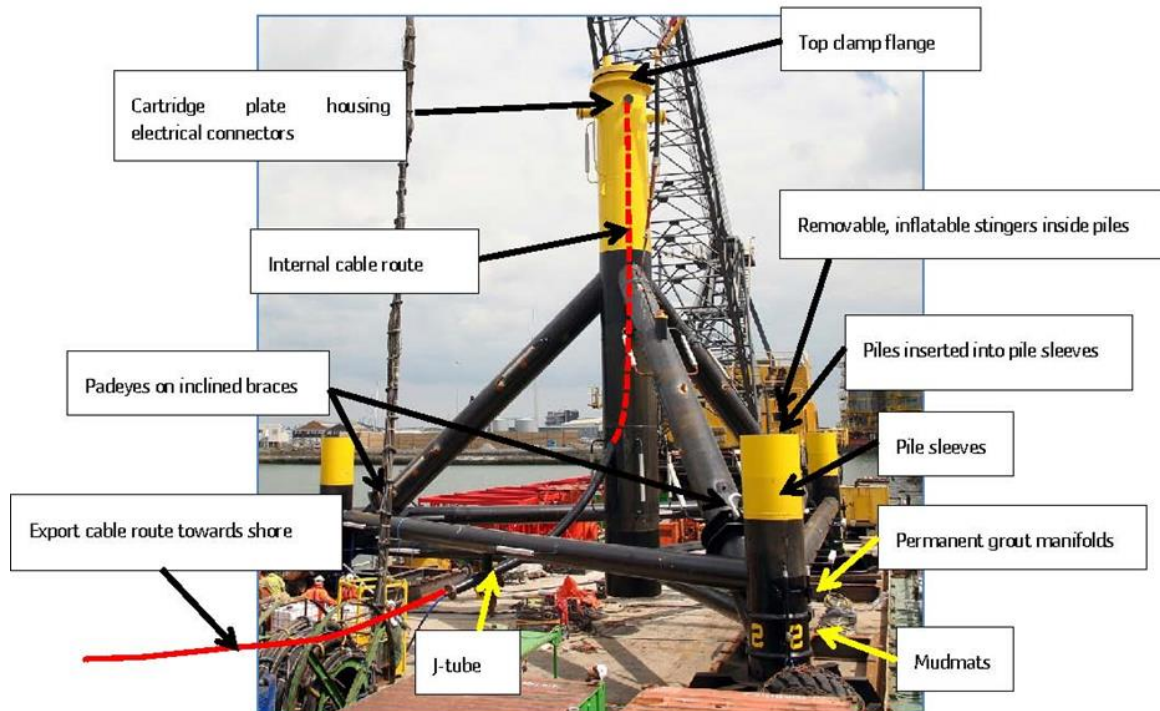
The following diagram, Figure 6, shows the key features of the tripod foundation.

Figure 6. Tripod foundation key structures

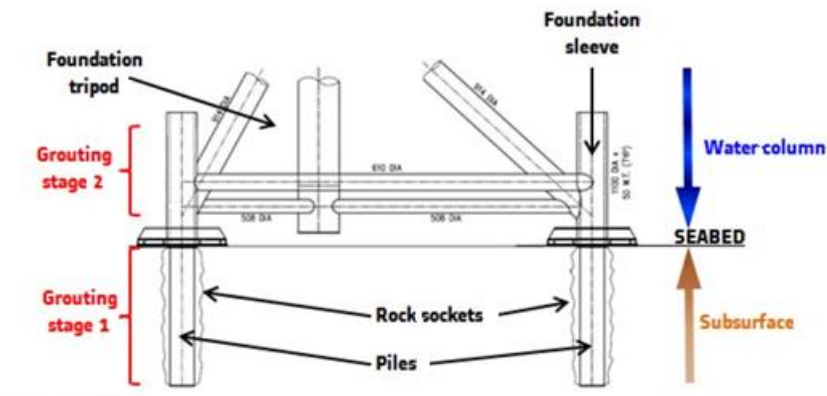
The following diagrams provide an overview of the pile design, showing the first and second stage grouting.

Figure 7. Pile design

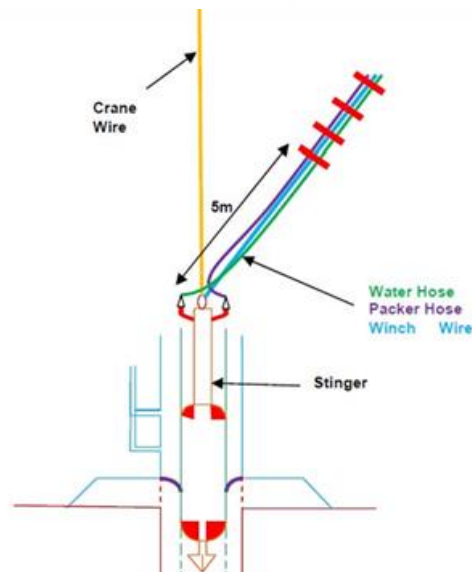
Figure 8. First stage grouting (rock socket)

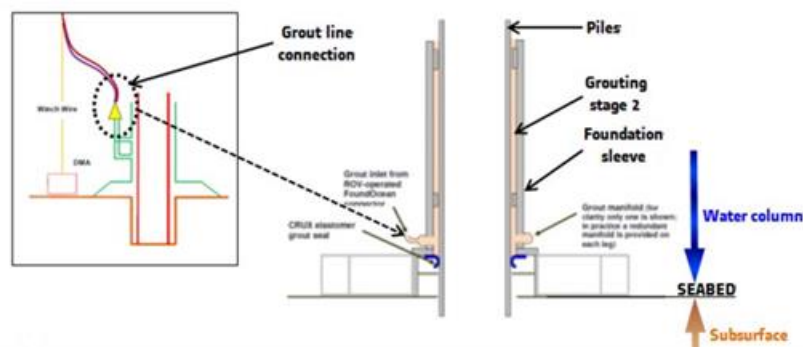
Figure 9. Second stage grouting (pile sleeve annulus)

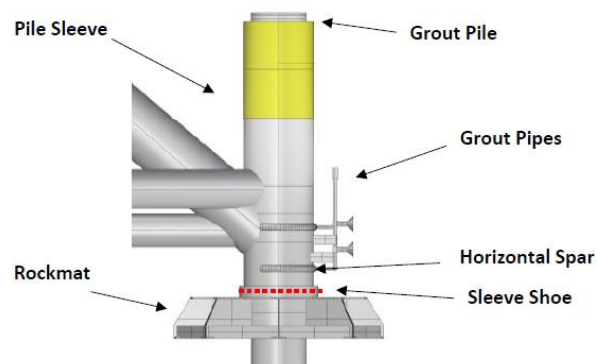
Over the last year progress has been made on the removal works. In order to remove the tripod structure, the pile sleeves have been cut above the rockmat, below the horizontal spar and grout pipes.

Figure 10. Pile section marked with cut location (red line)

The original proposed cutting option was to conduct an internal cut however, this was dependent on successfully removing the 3 grout delivery stingers. Due to a structural failure, it was only possible to partially remove the stingers and therefore, it was not possible to insert internal pile cutting equipment. A proportion of each stinger remains protruding inside each pile. Instead, the external cutting tool was used to cut through shaft of each stinger. An external Diamond Wire Saw (DWS) tool was used to the pile from the outside. The tool was clamped around the pile at the pre-set location and then the pile was cut.

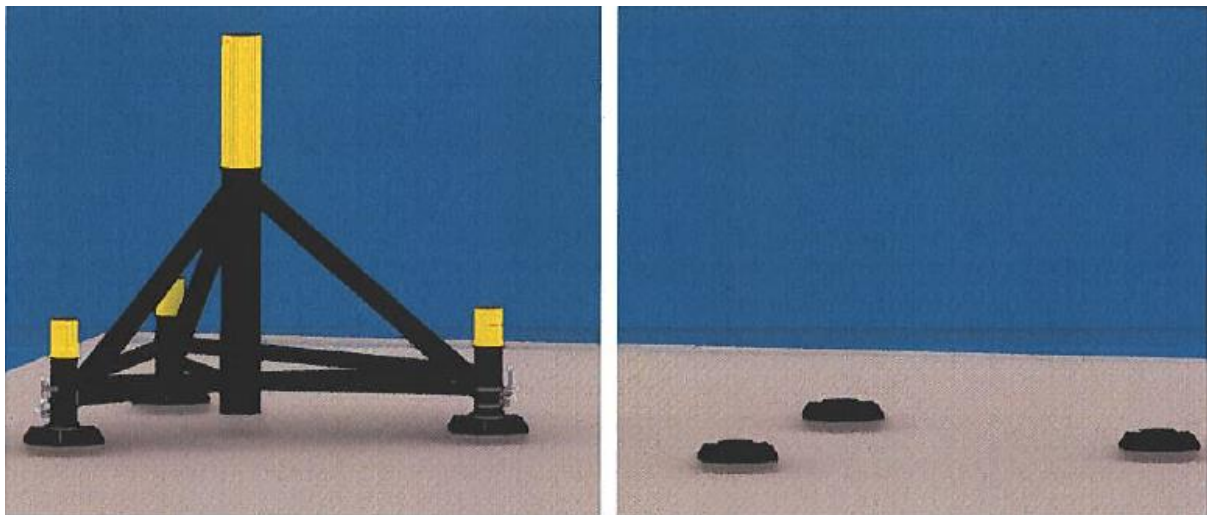
The following diagrams provide a schematic comparison of the as-found condition compared to the as-left. The as-left condition of the tripod will pose no hazard to shipping or navigation. Bottom trawling is not carried out in the Fall of Warness and, therefore, there is not expected to be any impact on fisheries. As the seabed is comprised of exposed bedrock and large boulders, the parts of the piles that are left are expected to be now larger obstructions than those naturally found within site.

Figure 12. Comparison isometric view of the as-found and as-left condition

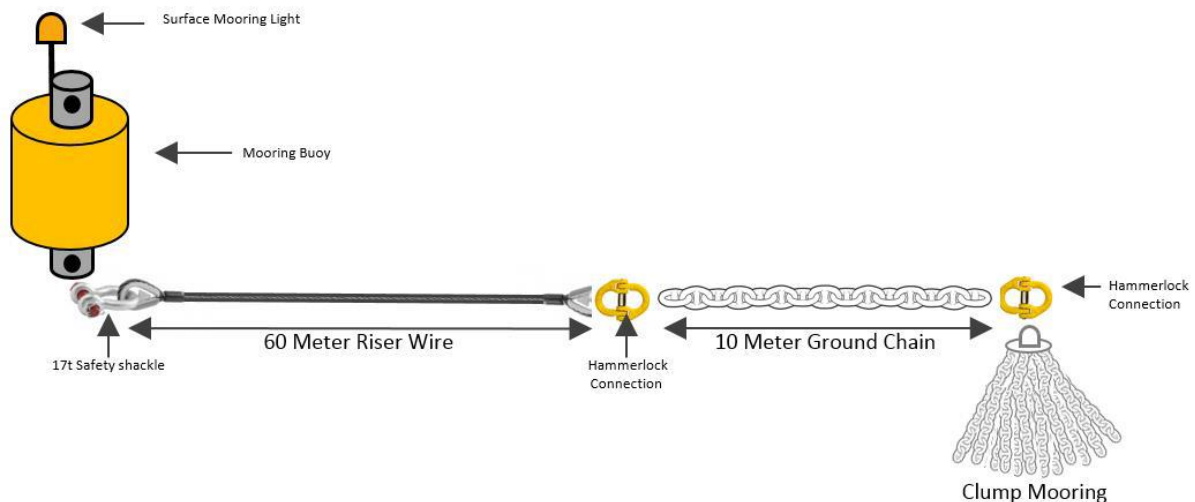
Each mooring will be composed of a chain clump (24T) with Hammerlock connection. This will be connected to 10 meters 36 mm stud link chain with an additional Hammerlock connection to 30 meter 38mm wire riser. A 17Tt safety shackle will attach the 750kg subsea marker buoy (yellow) (YF.4). A diagram of this is provided in Figure 14.

Figure 14. Single mooring specification

The mooring lines will connect the vessel to the mooring buoy. The mooring lines are composed of 220meters of 48mm Euro steel. There are four mooring lines in total.
