Burghead & Hopeman Harbours Best Practicable Environmental Option (BPEO) Report

| Client: | Arch Henderson LLP / The Moray Council |
|---|---|
| Project Title: | Burghead & Hopeman Harbours |
| Report Title: | Best Practicable Environmental Option (BPEO) Report |

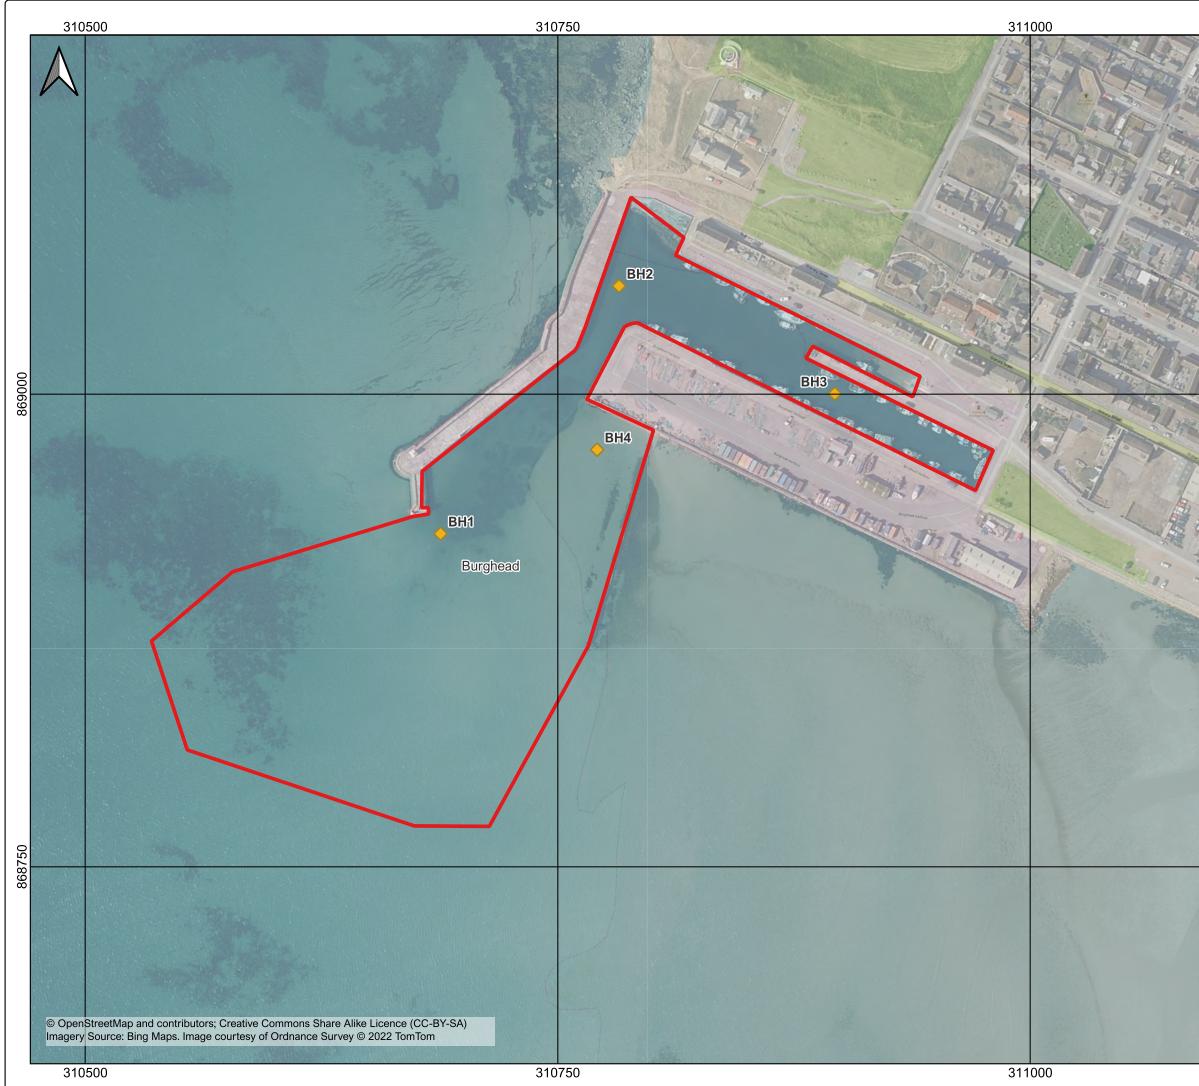
| Sum C | | Legend | |
|---|---|--|---|
| AT LOSS PER | | Dredge Areas Sediment Samples Grab | |

Sediment sampling was recently undertaken at both harbours with sample locations detailed in the drawings in Appendix A.

The proposed dredge areas and volumes are detailed in Table 1-1 below with the dredge areas presented in Appendix A.

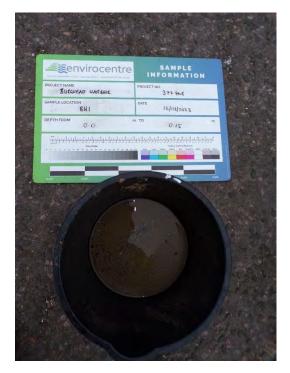
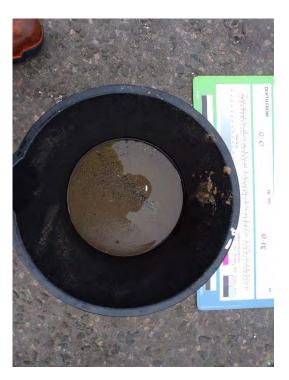
| ≣≋env | irocentre | Project Name | Moray Harbours - Pre Support | Location ID | | |
|---|---|---|---|---|---|--|
| Remarks: Biota: | Dark grey/bla None noted. | ack fine sandy silt. F | requent rounded cobble | es. Rare vegetation a | nd leaf litter. | |

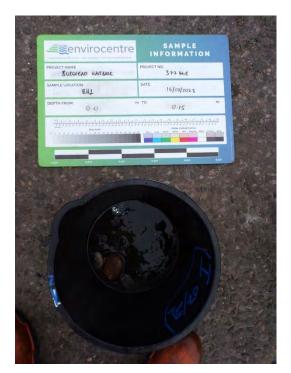
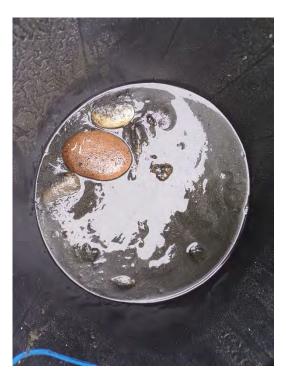
| ≣≋envi | rocentre | Project Name Moray Harbours - I Support | | Predge Licensing | Location ID | |
|---|---|--|---|---|---|--|
| | Street, | Project No. | 377468 (Burghead) | | BH3 | |

| ≣≋envi | rocentre | Project Name Moray Harbours - I Support | | Predge Licensing | Location ID | |
|---|---|--|---|---|---|--|
| Remarks: Biota: | Soft dark gre None noted. | ey silt with occasion | | | | |

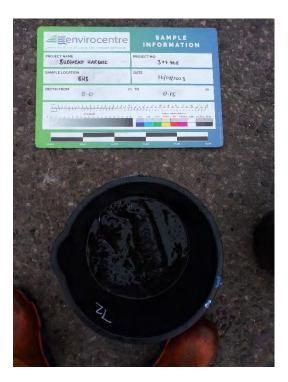
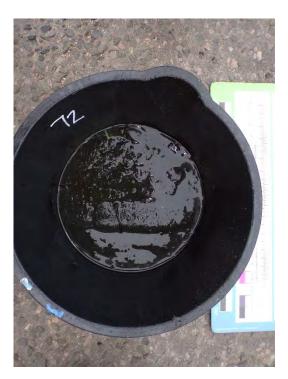
| ≣≋env | irocentre | Project Name | roject Name Moray Harbours - Pre-Dred Support | | Location ID | |
|---|--|---|--|---|---|--|
| | e Street, | Project No. | 377468 (Burghead) | | BH4 | |

| Dredge Area | Burghead | | Longitude | -3.4988273 | | |
| | - | | | | | |
| Method Remarks: | 0.045m² Van Veen C Light brown/ fragments. | yellow brown silty fi | | | d and shell | |

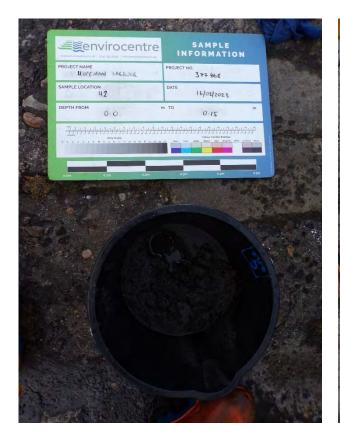
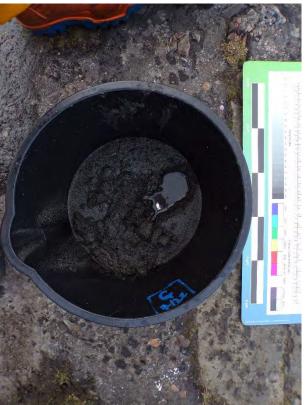
| ≣≋envi | irocentre | Project Name | Moray Harbours - Pre-D Support | Predge Licensing | Location ID | |
|---|---|---|---|---|---|--|
| Remarks: Biota: | Soft dark gre None noted. | ey silt with frequent s | eaweed. | | | |
