Buckie, Findochty, Portknockie, Cullen Best Practicable Environmental Options (BPEO) Report

Client:	Arch Henderson LLP / The Moray Council
Project Title:	Buckie, Findochty, Portknockie, Cullen
Report Title:	Best Practicable Environmental Options (BPEO) Report
Document number:	13349
Project number:	377468

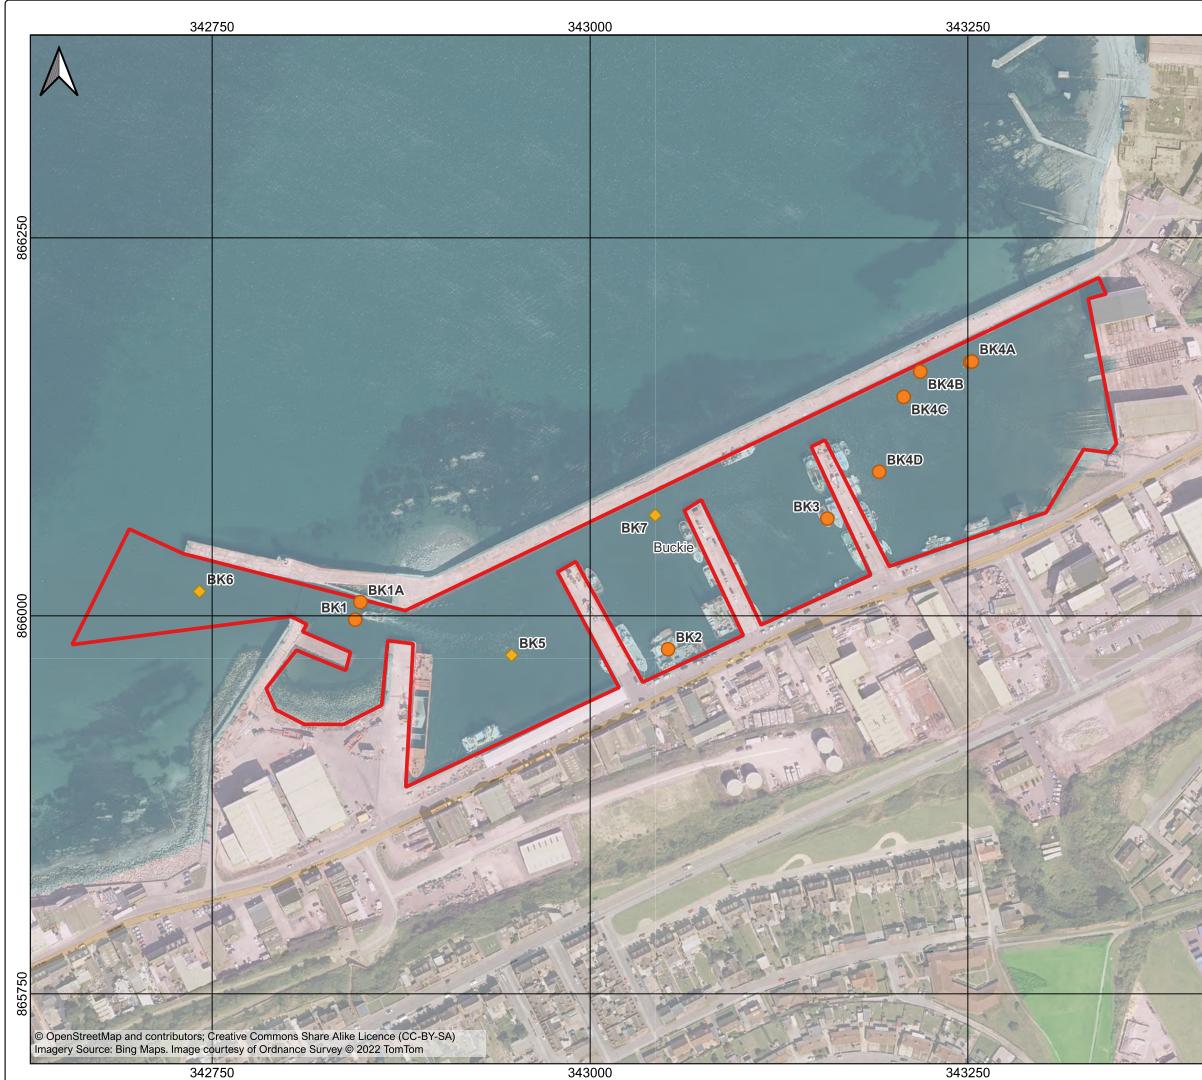
Lege	nd					
		See	Dredg diment S Grab Vibroc	Sa	amples			
	866250							
A Martine		analy: samp	e following sis due to l le stations ve deeper	in re	ocations were not hited sediment re e-located in an at ores: BK1, BK4, E	covery tempt t	r, with to	
and a state of the	8	Do not scale this map Client Arch Henderson LLP						
and a start of the	66000	Project Moray Council Dredging Buckie Harbour						
1		Bucki	e Harbour	S	ediment Sample	Locatio	ons	
1		Status			Final			
2		Drawin	g No. 3-QGIS003	F	Revision	Date	or 2023	
1		Drawn	FR	(Checked GD	Approv		
		Scale 1:2,50)0 @ A3					
1		Rev	Date		Amendment		Initials	
P	8	-	-		-		-	
1 million	865750		Banchory Banc	Bu hoi	siness Centre, Burn o' Be ry, AB31 5ZU. T: 01330 8 entre.co.uk W:www.envir	ennie Roac 26596	ł,

Sediment sampling was recently undertaken at the four sites with sample locations detailed in the drawings in Appendix A.

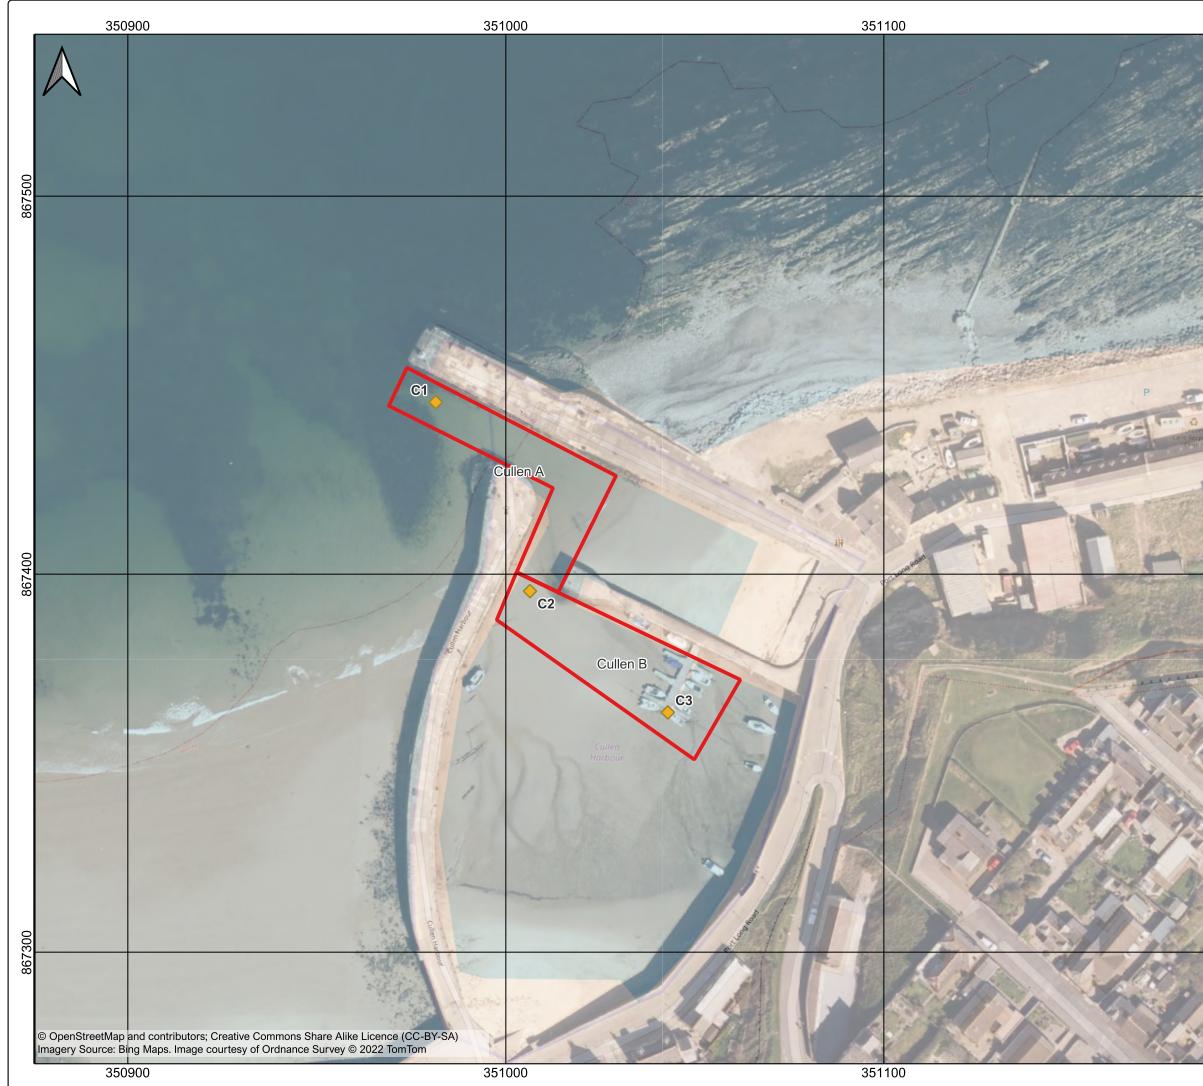
1		Legei	na					
			Dred	ae	Areas			
					amples			
1		0 00	Grab					
ð	867500							
	500							
1								
N								
T								
) ling								
C.A.								
T								
202	80							
and the	867400	Do not sca Client	ale this ma	р				
0.00	0	Arch H	enderso	n L	LP			
2019		Project		_				
			Council Harbou		edging			
and a		Title						
X		Cullen	Harbou	r S	ediment Sample	Location	S	
~		Status						
		otatus			Final			
-		Drawing 377468-	j No . -QGIS006		Revision -	Date 05 Apr 2	2023	
		Drawn	FR	1	Checked GD	Approved CC/		
N.		Scale 1:1,000 @ A3						
			Date		Amendment		Initials	
-	ω	-	-		-		-	
-	867300							
1	ð							
Y			\approx	91	nviro	cen	tre	
1			Bancho	ry Bu	siness Centre, Burn o' E ry, AB31 5ZU. T: 01330	Bennie Road,		
R					entre.co.uk W:www.env		<

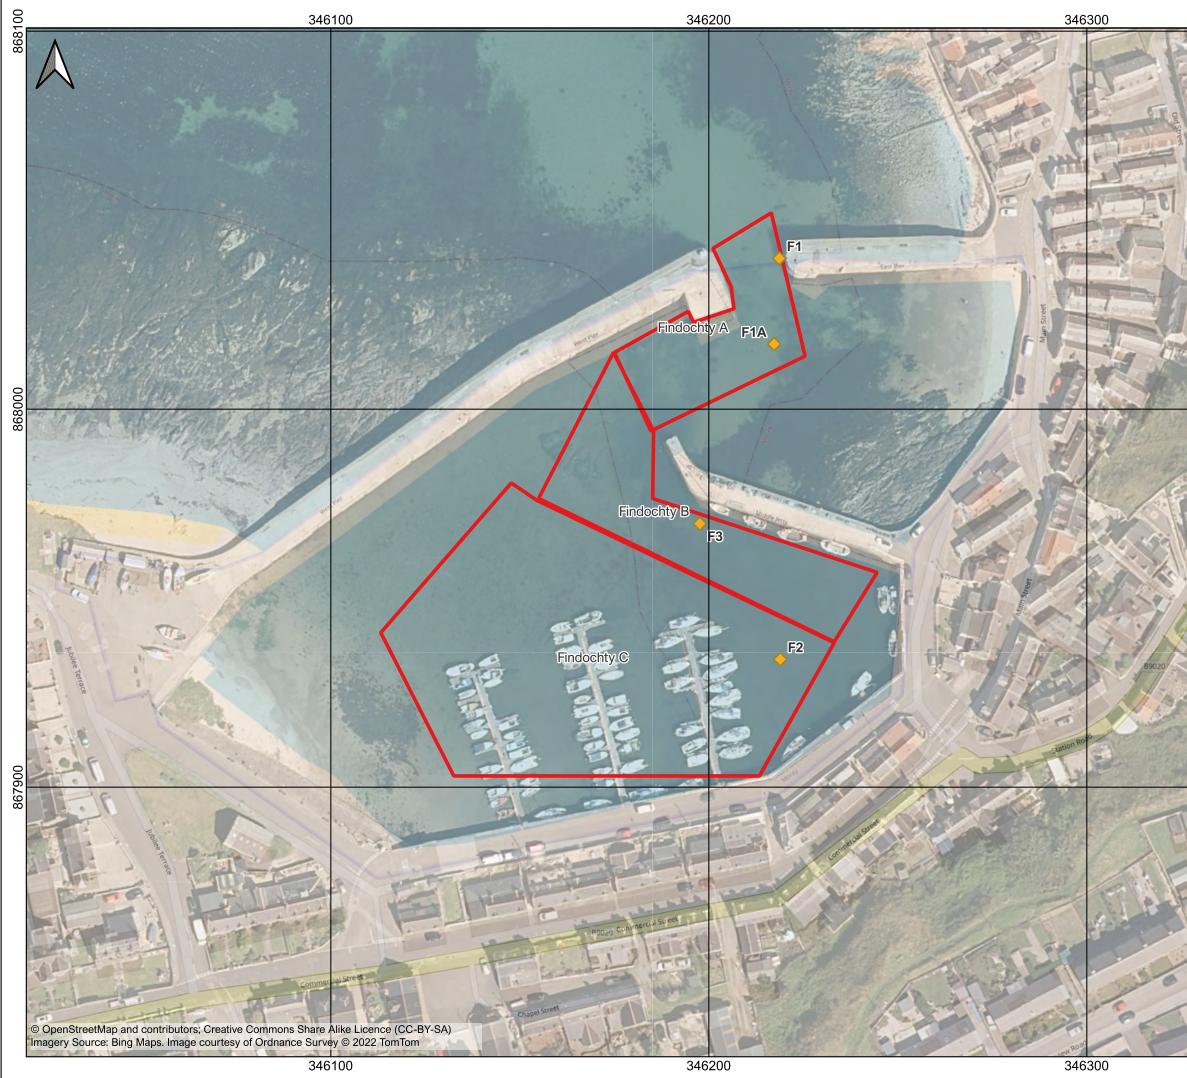
(A)	868100	Legend					
	00	Dredge Sediment S					
	000898	location F1, as o were recovered.	s submitted for an nly coarse and gra This location was uitable for analysis	evel and cobbles re-sited to F1A			
1 1 1 1 1 1 1 1 1 1 1 1 1 1 1 1 1 1 1		Project Moray Council Dredging Findochty Harbour Title Findochty Harbour Sediment Sample Locations					
	86	Status	Final				
15	867900	Drawing No.	Revision	Date			
EL .	8	377468-QGIS004	- Checked	05 Apr 2023 Approved			
1-1-		Drawn FR	GD	CCAS			
Cas	Scale 1:1,000 @ A3						
and the		Rev Date	Amendment -	Initials -			
1		Banchory E Banch	NVIROC Business Centre, Burn o' Be lory, AB31 5ZU. T: 01330 8 pcentre.co.uk W:www.envir	ennie Road, 26596

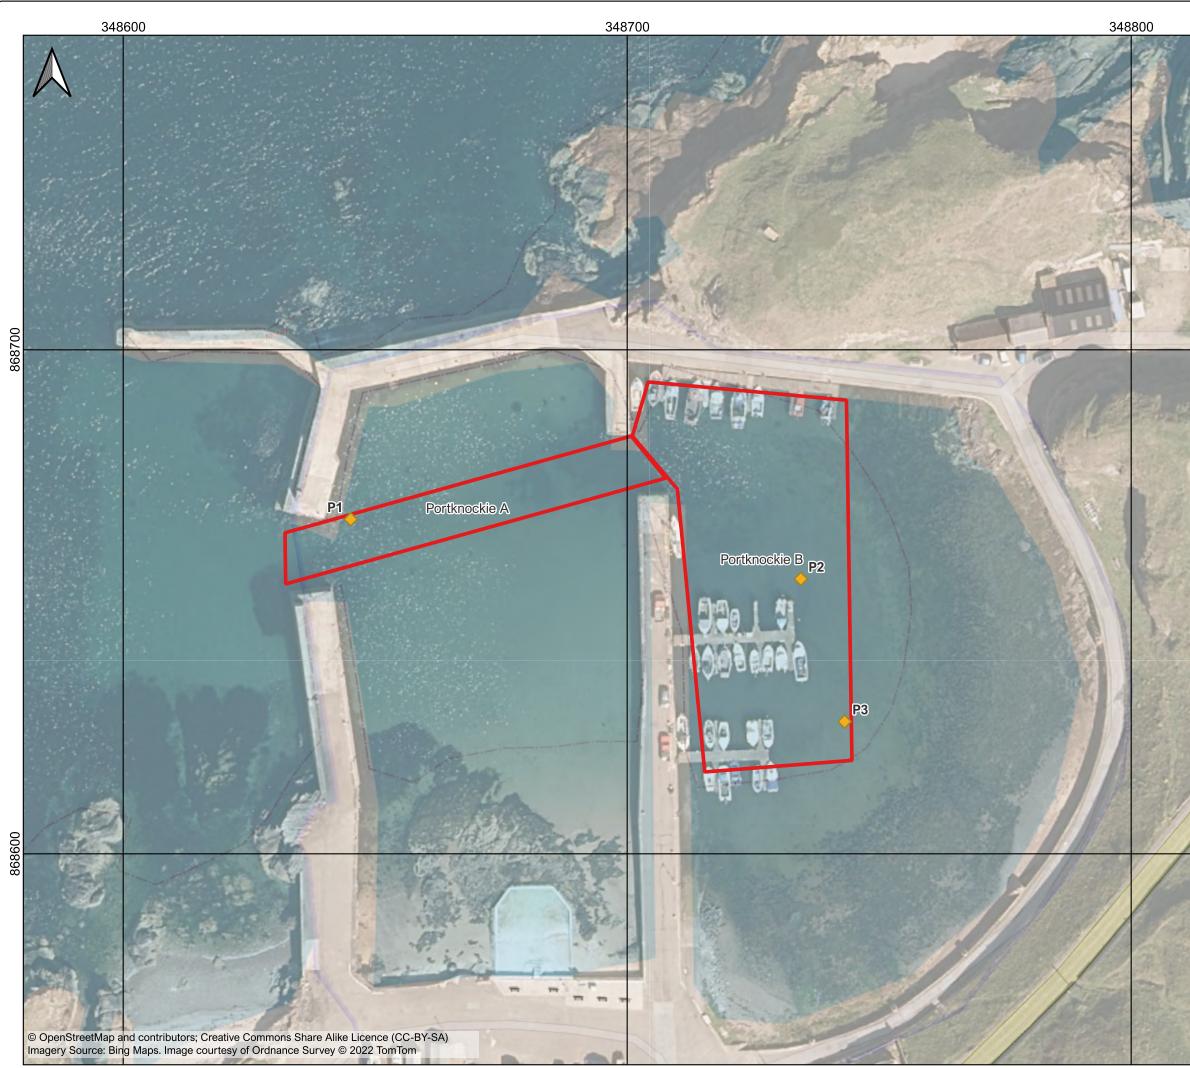
7.67		Legend			
State of the second	868700	Dredg Sediment S			
	700				
11		Do not scale this map			
1		Client Arch Henderson	LLP		
行うの		Project Moray Council I Portknockie Har			
1000		Title Portknockie Har	bour Sediment Sa	ample Locations	
1		Status	Final		
		Drawing No.	Revision	Date	
1	~	377468-QGIS005	- Checked	05 Apr 2023 Approved	
1	868600	FR	GD	CCAS	
	00	Scale 1:750 @ A3			
の日本に		Rev Date 	Amendment -	Initials -	
and the second		Banchory Banc	Business Centre, Burn o' B hory, AB31 5ZU. T: 01330 & ocentre.co.uk W:www.env	326596

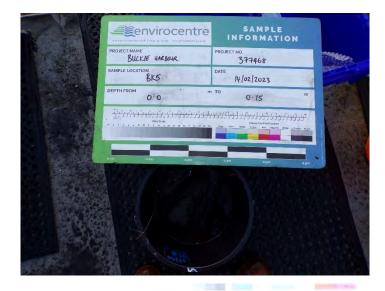
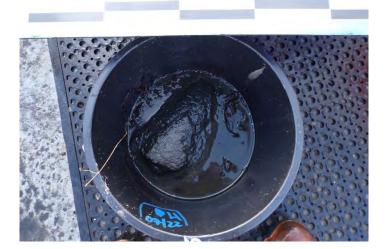
1	1		
≣≋envi	∎≋envirocentre		Moray Harbours - Pre-Dredge Licensing Support		Location ID
	8 Eagle Street, Craighall Business Park,		377468 (Buckie)		BK5
	v, G4 9XA	Client	Arch Henderson		DKJ
		GRAB SA	MPLE LOG		
Date/Time	14/02/2022		Latitude	57.679985	
Dredge Area	Buckie		Longitude	-2.9583288	
Method	0.045m ² Van Veen G	rab Sampler	Sampled/logged by	FR/AK	
Remarks:	0.0 – 0.15m Soft dark gre vegetation an		on surface) fine slightly s	andy silt. Occasior	nal seaweed,
Biota:	None noted.				
Odours:	None noted.				
Anthropogenic Inputs:	None noted.				
Notes:	-

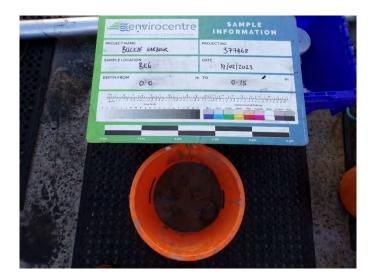
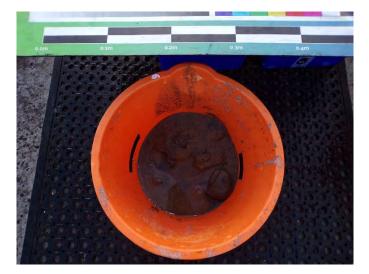
≡≋envirocentre		Project Name	Moray Harbours - Pre-Dredge Licensing Support		Location ID
8 Eagle Street,		Project No.	377468 (Buckie)		DVC
Glasgo	Business Park, w, G4 9XA	Client	Arch Henderson		BK6
		GRAB SA	MPLE LOG		
Date/Time	14/02/2022		Latitude	57.680337	
Dredge Area	Buckie		Longitude	-2.9618005	
Method	0.045m ² Van Veen 0	Grab Sampler	Sampled/logged by	FR/AK	
Remarks:	0.0 – 0.15m Light brown/	grey silty fine to med	ium sand.		
	0				
Biota:	None noted.				
Biota: Odours:	-				
	None noted.

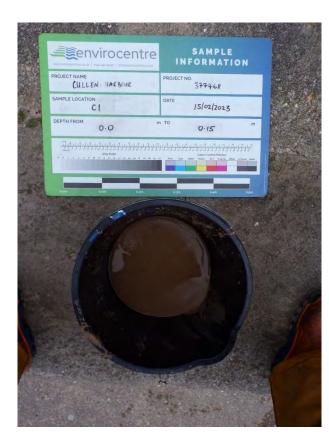
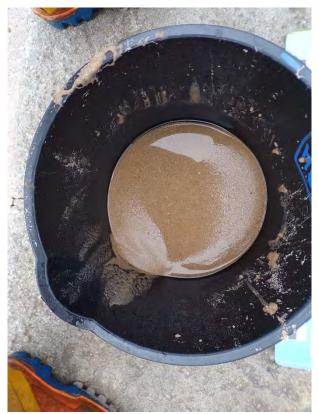
≡≋envirocentre		Project Name	Moray Harbours - Pre-D Support	redge Licensing	Location ID
8 Eagle Street,		Project No.	377468		01
	usiness Park, v, G4 9XA	Client	Arch Henderson		C1
		GRAB S	AMPLE LOG		
Date/Time	15/02/2023		Latitude	57.694150	
Dredge Area	Cullen A		Longitude	-2.8239387	
		ab Sampler Sampled/logged by		FR/AK	
Method	0.045m ² Van Veen G	Grab Sampler	Sampled/logged by	FR/AK	
Remarks:	Light brown	silty fine to medium		FR/AK	
Remarks: Biota:	Light brown s Singular dea	silty fine to medium		FR/AK	
Remarks:	Light brown	silty fine to medium		FR/AK

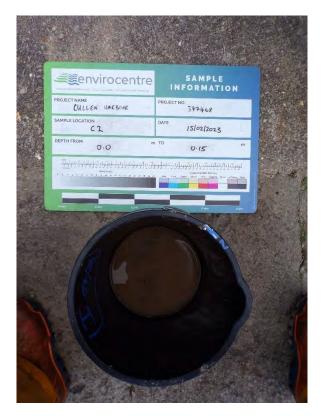
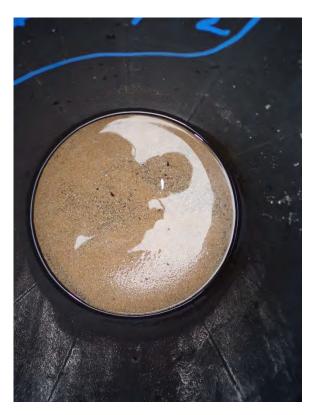
≡≋envirocentre		Project Name	Moray Harbours - Pre-D Support	Predge Licensing	Location ID	
8 Eagle Street,		Project No.	377468		00	
	usiness Park, /, G4 9XA	Client	Arch Henderson		C2	
		GRAB S	AMPLE LOG			
Date/Time	15/02/2023		Latitude	57.693704		
Dredge Area	Cullen B		Longitude	-2.8235102		
Method	0.045m ² Van Veen G	Grab Sampler	rab Sampler Sampled/logged by FR/Al		/AK	
Remarks:	seaweed frag		ne to medium sand. Black	material likely to be	plankton /	
Biota:	seaweed frag		ne to medium sand. Black	material likely to be	plankton /	
	seaweed frag		ne to medium sand. Black	material likely to be	plankton /

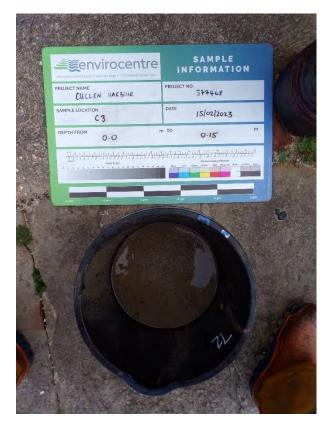
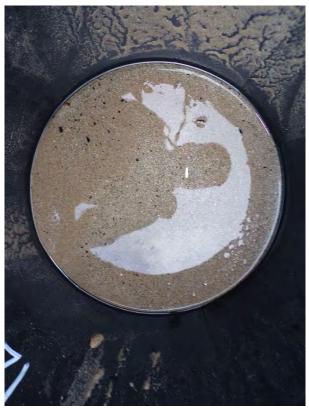
≣≋env	■≋envirocentre		Moray Harbours - Pre-D Support	Moray Harbours - Pre-Dredge Licensing Support	
8 Eagle Street,		Project No.	377468		00
0	Business Park, w, G4 9XA	Client	Arch Henderson		C 3
		GRAB SA	MPLE LOG		-
Date/Time	15/02/2023		Latitude	57.693420	
Dredge Area	Cullen B		Longitude	-2.8228918	
		b Sampler Sampled/logged by		FR/AK	
Method	0.045m ² Van Veen G	rab Sampler	Sampled/logged by	FR/AK	
Method Remarks:	Light brown s		Sampled/logged by		derlain by
	Light brown s	silty fine to medium s			derlain by
Remarks:	Light brown s grey silty fine	silty fine to medium s			derlain by
Remarks: Biota:	Light brown s grey silty fine None noted.	silty fine to medium s			derlain by

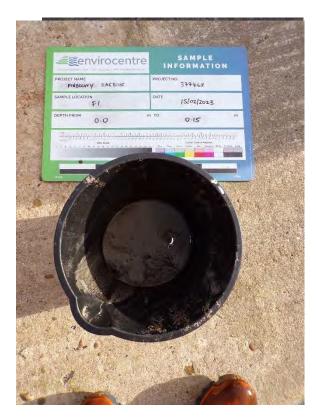
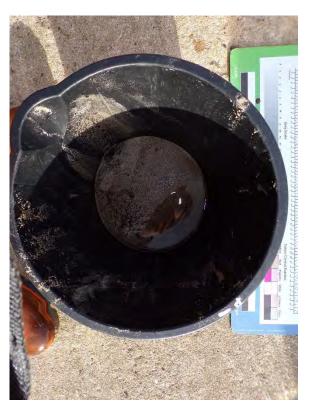
≡≋envirocentre		Project Name	Moray Harbours - Pre-Dredge Licensing Support		Location ID
8 Eagle Street,		Project No.	377468 (Findochty)		
	usiness Park, v, G4 9XA	Client	Arch Henderson		F1A
		GRAB S	AMPLE LOG		
Date/Time	15/02/2023		Latitude	57.69872	
Dredge Area	Findochty A		Longitude	-2.90397	
Method	0.045m ² Van Veen G	Grab Sampler	Sampled/logged by	FR/AK	
Remarks: Biota:	Light brown : None noted.	silty fine to medium	sand with rare black seav	veed/plankton fragr	nents.
Odours:	None noted.				
Ouburs.					
Anthropogenic Inputs:	None noted.

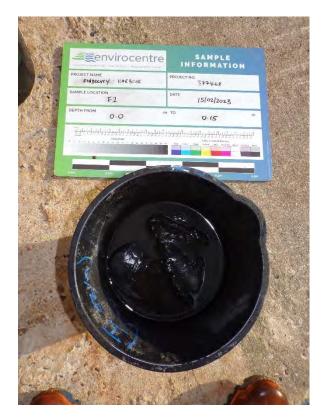
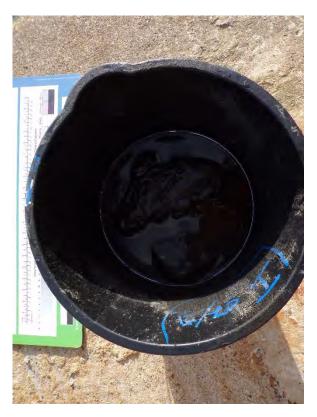
≣≋env	rirocentre	Project Name	Moray Harbours - Pre-D Support	Dredge Licensing	Location ID					
	le Street,	Project No.	377468 (Findochty)		БО					
	Business Park, w, G4 9XA	Client	Arch Henderson		- F2					
		GRAB S	AMPLE LOG							
Date/Time	15/02/2023		Latitude	57.697990						
Dredge Area	Findochty B		Longitude	-2.9039286						
Method	0.045m ² Van Veen 0	Grab Sampler	Sampled/logged by							
Remarks:	Soft dark gre	ey silt.								
Biota:	None noted.									
Odours:	Strong H ₂ S of	odour.								
Anthropogenic	None noted.									
Inputs:				ained from pontoon as there was no access to location during low tide.

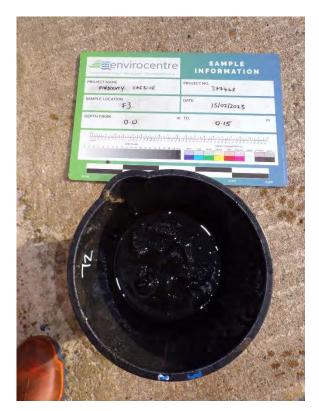
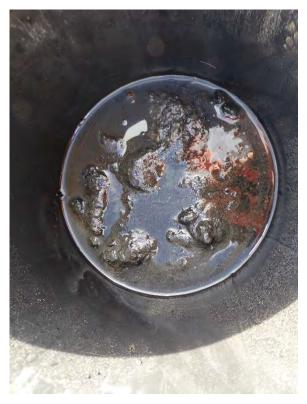
≣≋env	irocentre	Project Name	Moray Harbours - Pre-E Support	Predge Licensing	Location ID	
	e Street,	Project No.	377468 (Findochty)		Γ2	
	usiness Park, v, G4 9XA	Client	Arch Henderson		- F3	
		GRAB SA	AMPLE LOG			
Date/Time	15/02/2023		Latitude	57.698413		
Dredge Area	Findochty C		Longitude	-2.9043398		
Method	0.045m ² Van Veen G	Grab Sampler	Sampled/logged by	FR/AK		
Remarks:	Soft sark gre	y slight sandy (fine)	silt. Occasional vegetatic	n/rootlets.		
Remarks: Biota:	Soft sark gre None noted.	y slight sandy (fine)	silt. Occasional vegetatio	n/rootlets.		
	Ŭ		silt. Occasional vegetatio	n/rootlets.		
Biota:	None noted.		silt. Occasional vegetatio	n/rootlets.

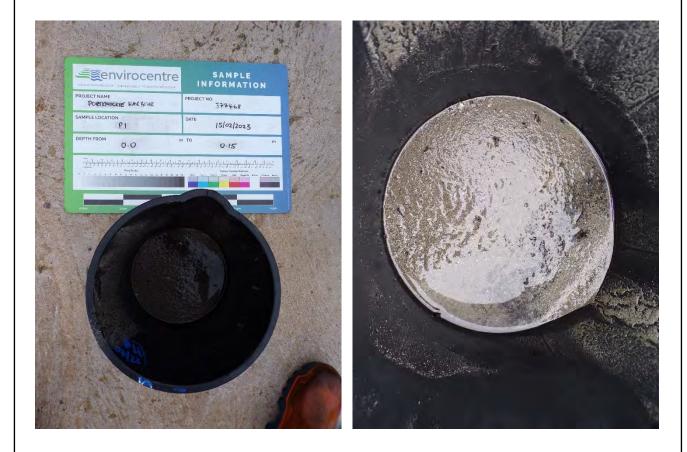
≣≋envi	irocentre	Project Name	Moray Harbours - Pre-D Support	Predge Licensing		
	e Street,	Project No.	377468 (Portknockie)		
Craighall Bu Glasgow	usiness Park, v, G4 9XA	Client	Arch Henderson		P1	
		GRAB S	AMPLE LOG			
Date/Time	15/02/2023		Latitude	57.704864		
	Dantin a alvia A		Longitude	-2.8633887		
Dredge Area	Portknockie A		-			
Dredge Area Method Remarks:	0.045m ² Van Veen G		Sampled/logged by	FR/AK		
Method	0.045m ² Van Veen G					
Method Remarks:	0.045m ² Van Veen G		Sampled/logged by			
Method Remarks: Biota:	0.045m ² Van Veen G Grey silty find None noted.		Sampled/logged by

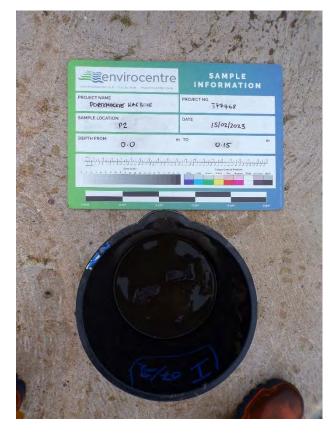
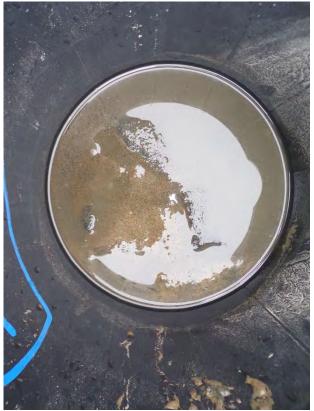
≣≋env	irocentre	Project Name	Moray Harbours - Pre-D Support	Predge Licensing	Location ID
	e Street,	Project No.	377468 (Portknockie)	DO
	usiness Park, v, G4 9XA	Client		P2	
		GRAB SA	MPLE LOG		
Date/Time	15/02/2023		Latitude	57.704757	
Dredge Area	Portknockie B		Longitude	-2.8618871	
Method	0.045m ² Van Veen 0	Grab Sampler	Sampled/logged by	FR/AK	
Remarks:	Soft dark gre	ey silt (grey-brown on	surface).		
Biota:	None noted.				
	None noted. Moderate H_2	S odour.			
Biota:		S odour.

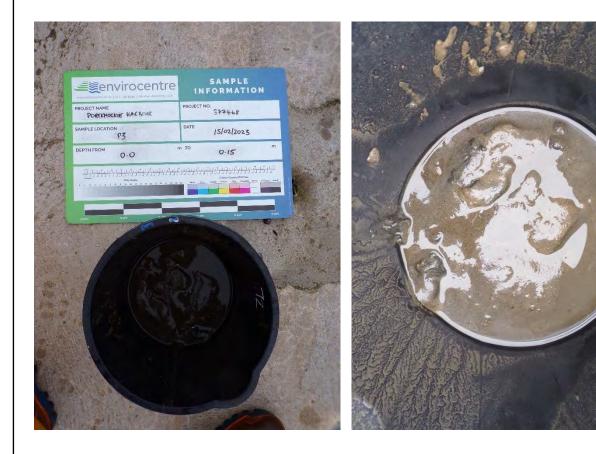
≣≋env	virocentre	Project Name	Moray Harbours - Pre-D Support	Predge Licensing	Location ID	
	le Street,	Project No.	377468 (Portknockie)	D2	
0	Business Park, w, G4 9XA	Client	Arch Henderson		P3	
		GRAB S	AMPLE LOG			
Date/Time	15/02/2023		Latitude	57.704501		
Dredge Area	Portknockie C		Longitude	-2.8617392		
Method	0.045m ² Van Veen 0	Grab Sampler	Sampled/logged by	FR/AK		
			•			
Remarks: Biota:	Soft dark gre None noted.	ey silt (grey-brown o	n surface).	•		
	-		n surface).	•		
Biota:	None noted.		n surface).
