Dales Voe and Lerwick Harbour North Best Practicable Environmental Option

Client: Arch Henderson LLP
 Project Title: Dales Voe and Lerwick Harbour North
 Report Title: Best Practicable Environmental Option
 Document number: 14356
 Project number: 679749

This Best Practicable Environmental Option report (BPEO) has been prepared by EnviroCentre Ltd in relation to capital dredging works for two sites in the Shetland Isles. One dredge site is located at Dales Voe and the other within Lerwick Harbour. Site works were undertaken at the locations detailed as per the sampling plan EnviroCentre Report 14173, May 2024.

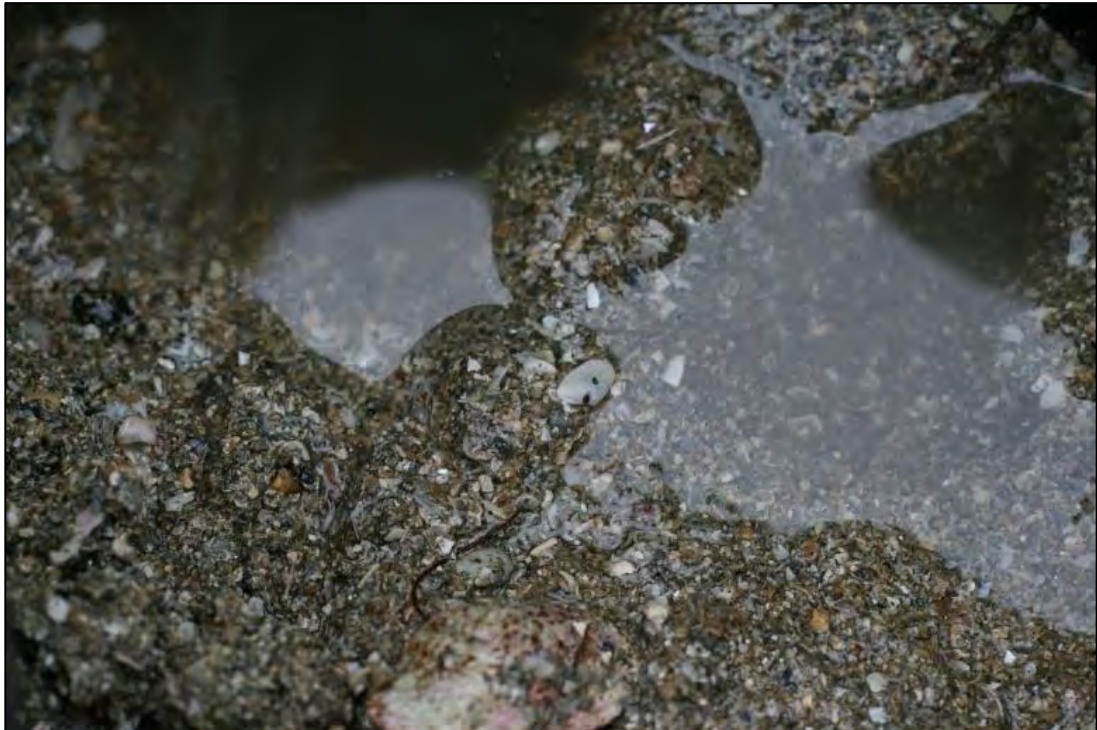
Project Name	Lerwick North Harbour & Dales Voe	Location ID 24-DV-02A
Project No.	679749	
Client	Lerwick Port Authority

Notes: Sample complete after 10 deployments of grab sampler.

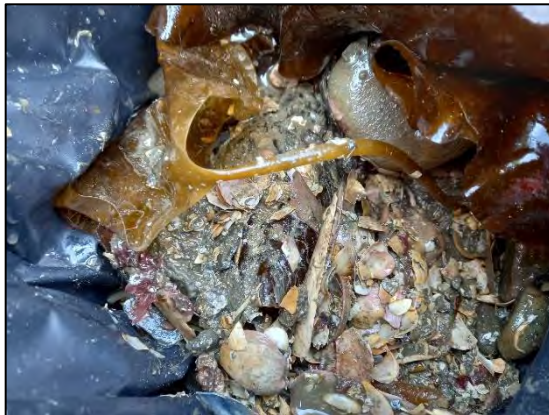
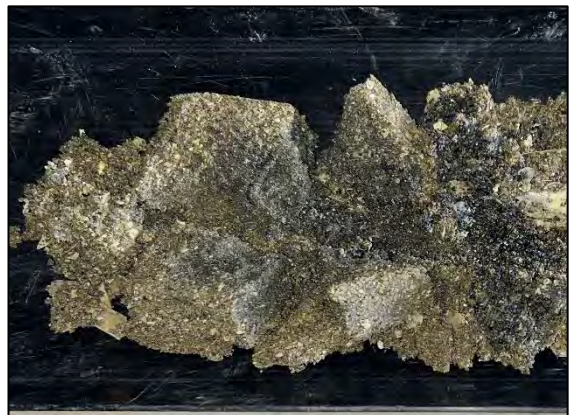
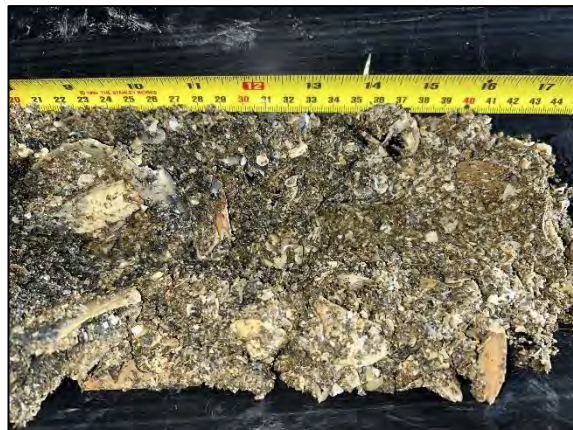
Grab sample complete after five deployments of grab sampler.

Two attempts made at retrieving a core sample using the vibrocorer. Maximum core length achieved was 0.33m (progressed to refusal in dense sand). Core was initially frozen upon return from site and sub-sampled on 24/09/2024.

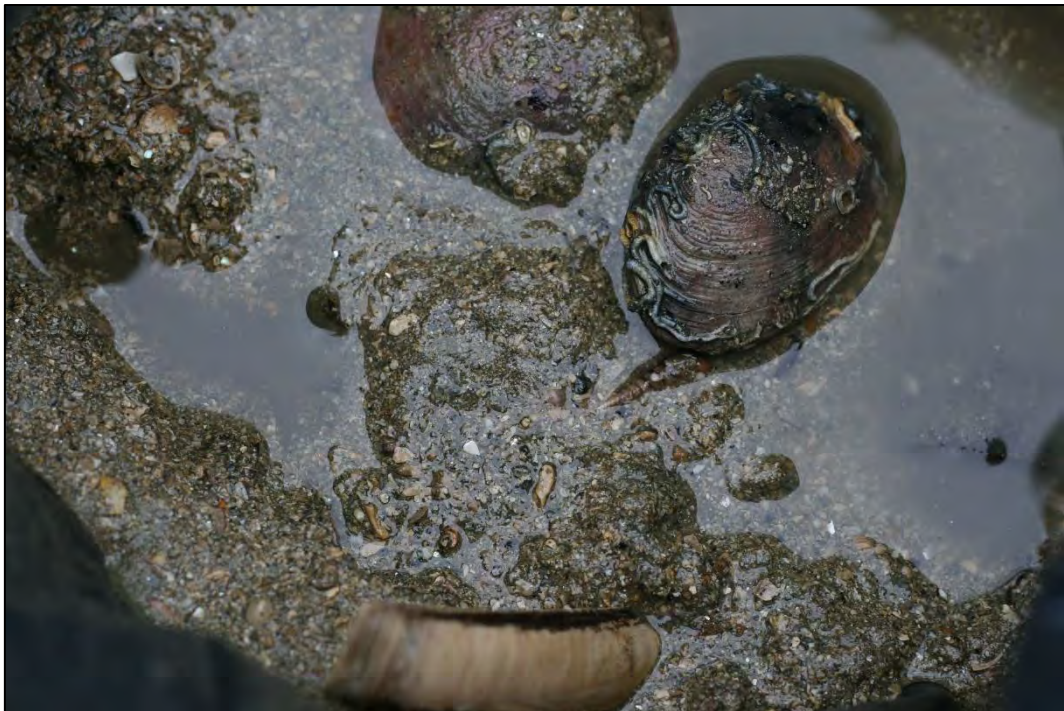
Project Name	Lerwick North Harbour & Dales Voe	Location ID 24-DV-04
Project No.	679749	
Client	Lerwick Port Authority

Notes: Sample complete after two deployments of grab sampler.

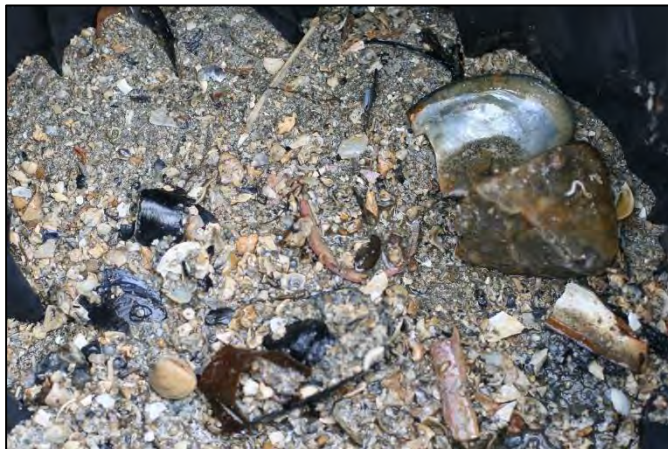
Grab sample complete after four deployments of grab sampler.

Two attempts made at retrieving a core sample using the vibrocorer. Maximum core length achieved was 0.29m (progressed to refusal in dense sand). Core was initially frozen upon return from site and sub-sampled on 24/09/2024.

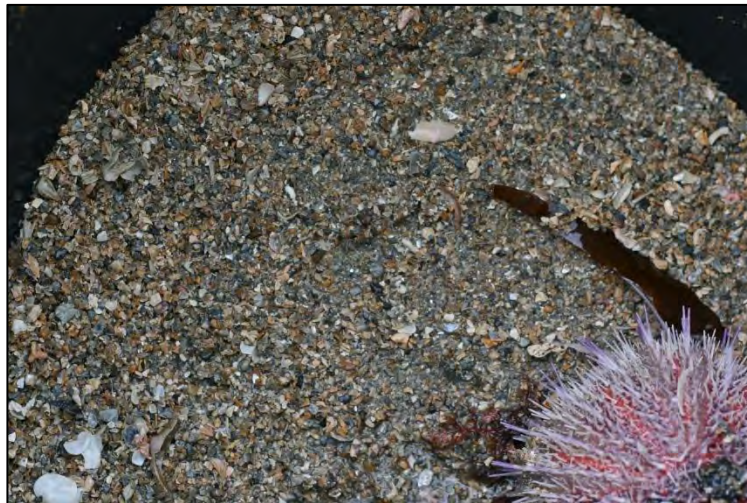
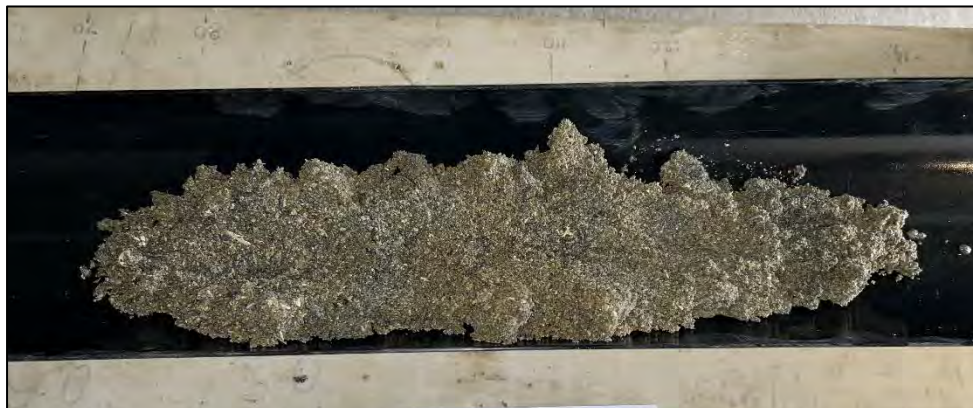
Project Name	Lerwick North Harbour & Dales Voe	Location ID 24-DV-05
Project No.	679749	
Client	Lerwick Port Authority

Grab sample complete after two deployments of grab sampler.

Two attempts made at retrieving a core sample using the vibrocorer. Maximum core length achieved was 0.37m (progressed to refusal in dense sand). Core was initially frozen upon return from site and sub-sampled on 24/09/2024.

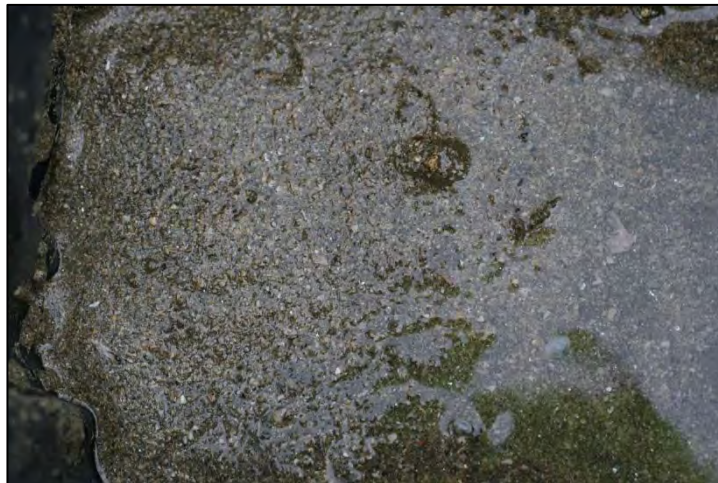
Project Name	Lerwick North Harbour & Dales Voe	Location ID 24-DV-06
Project No.	679749	
Client	Lerwick Port Authority

Notes: Grab sample complete after two deployments of grab sampler.

Two attempts made at retrieving a core sample using the vibrocorer. Maximum core length achieved was 0.22m (progressed to refusal in dense sand). Core was initially frozen upon return from site and sub-sampled on 24/09/2024.

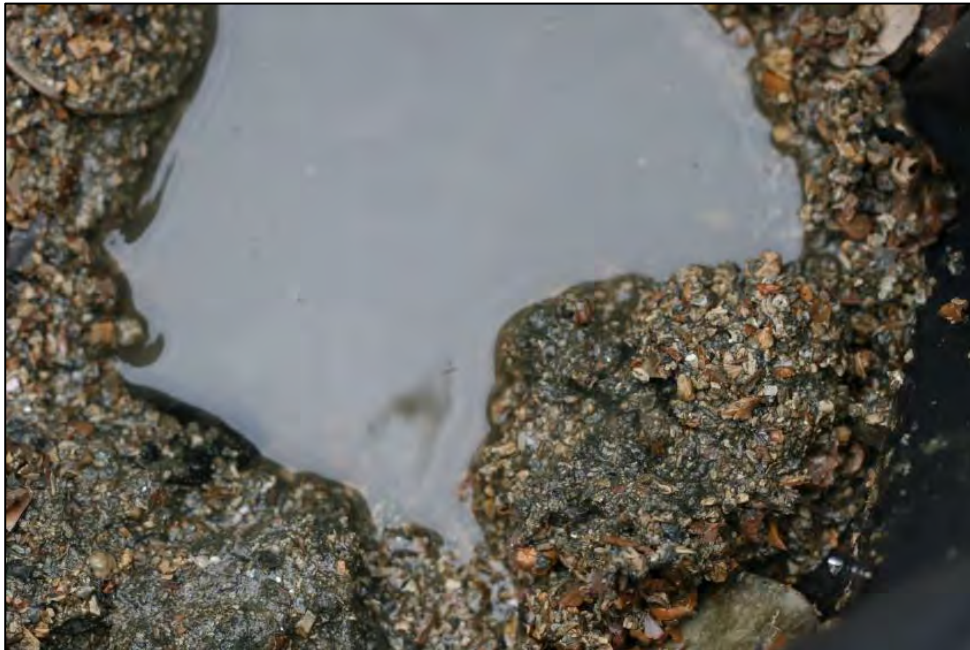
Project Name	Lerwick North Harbour & Dales Voe	Location ID 24-01
Project No.	679749	
Client	Lerwick Port Authority

Notes: Sample complete after four deployments of grab sampler.

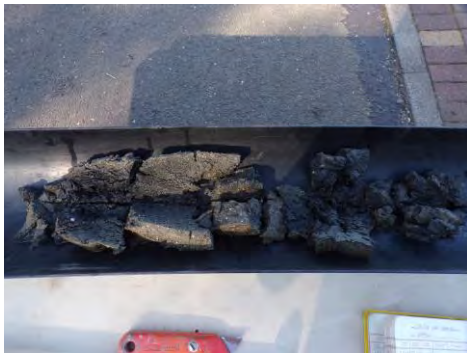
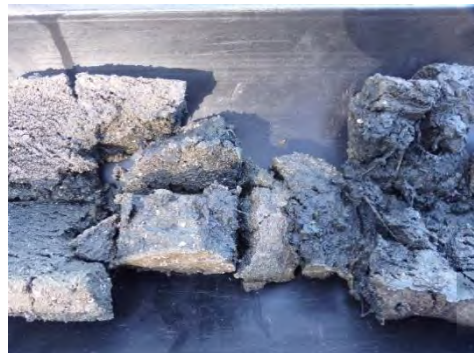
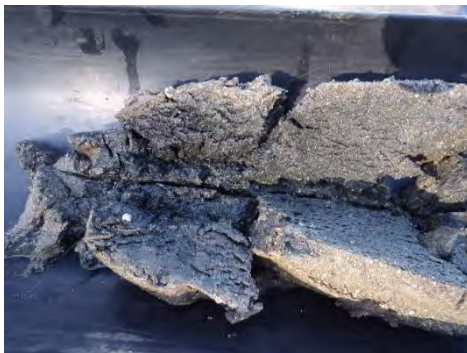
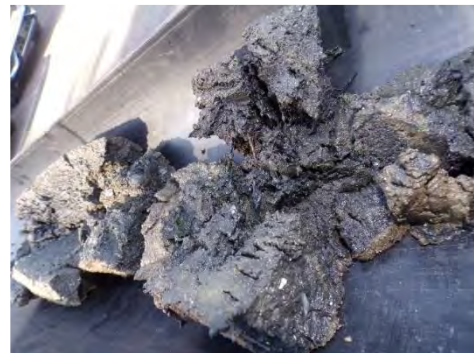
Biota: One ragworm noted in grab.

Notes: Grab sample complete after one deployment of grab sampler.
 Two attempts made at retrieving a core sample using the vibrocorer. Maximum core length achieved was 0.42m (progressed to refusal progressed to refusal in dense sand).
 Core was initially frozen upon return from site and sub-sampled on 17/09/2024.

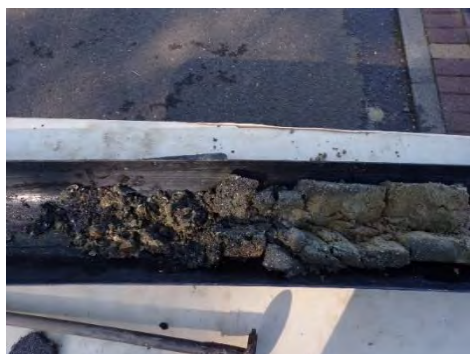
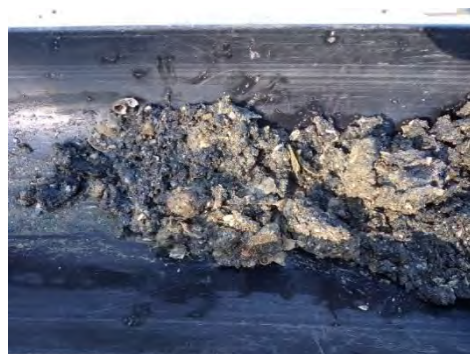
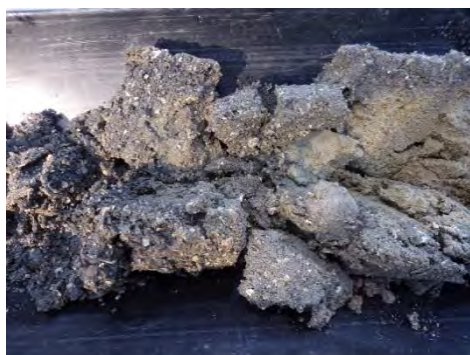
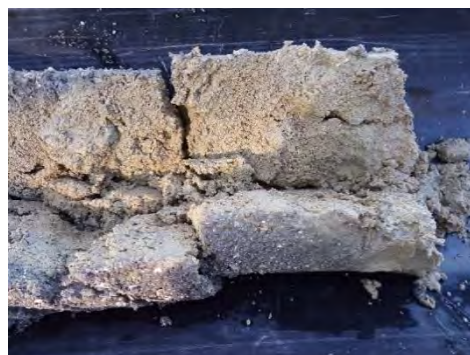
Project Name	Lerwick North Harbour & Dales Voe	Location ID 24-02
Project No.	679749	
Client	Lerwick Port Authority

Biota: A few small crabs noted in grab.

Five attempts in total were made at retrieving a core sample using the vibrocorer (over two days). Maximum core length achieved was 0.55m (progressed to refusal in dense sand).

Core was initially frozen upon return from site and sub-sampled on 17/09/2024.

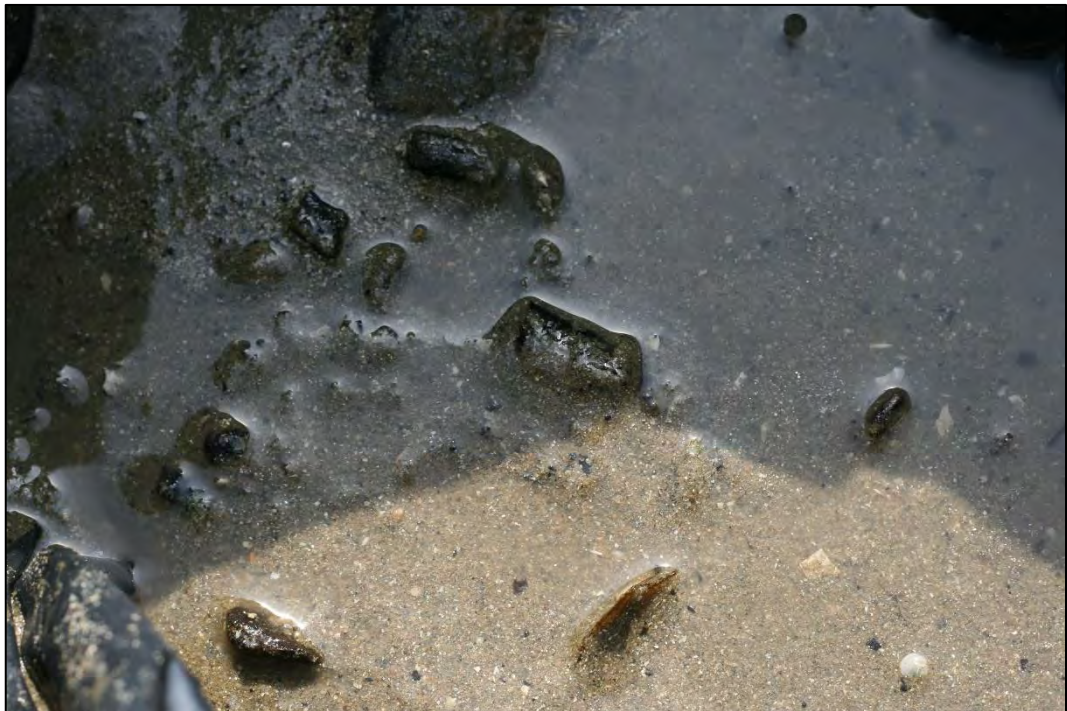
Project Name	Lerwick North Harbour & Dales Voe	Location ID 24-04
Project No.	679749	
Client	Lerwick Port Authority

Notes: Sample complete after five deployments of grab sampler.

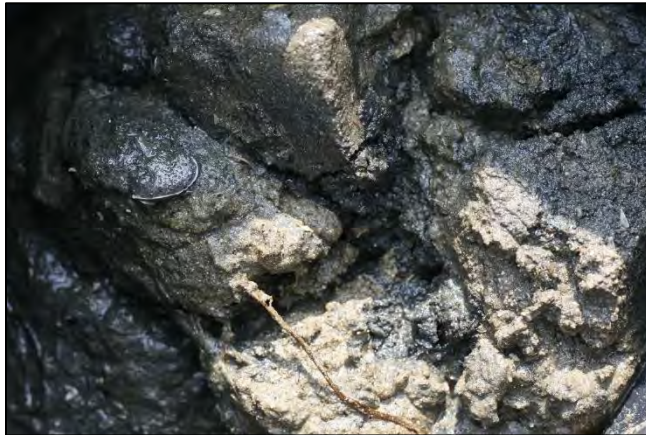
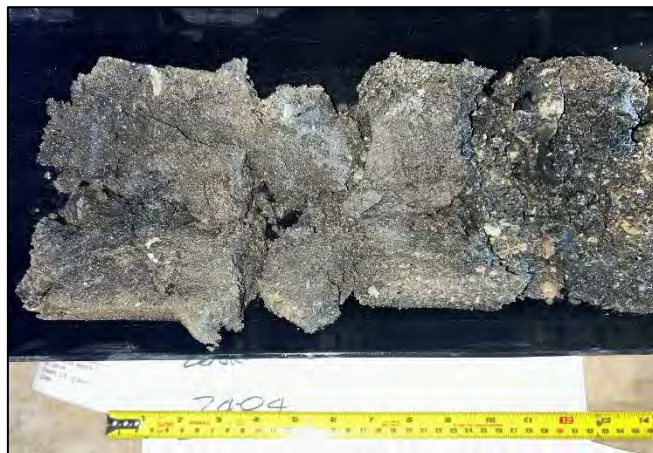
Grab sample complete after two deployments of grab sampler.

Two attempts were made at retrieving a core sample using the vibrocorer. Maximum core length achieved was 0.35m (progressed to refusal in dense sand). Core was initially frozen upon return from site and sub-sampled on 24/09/2024.

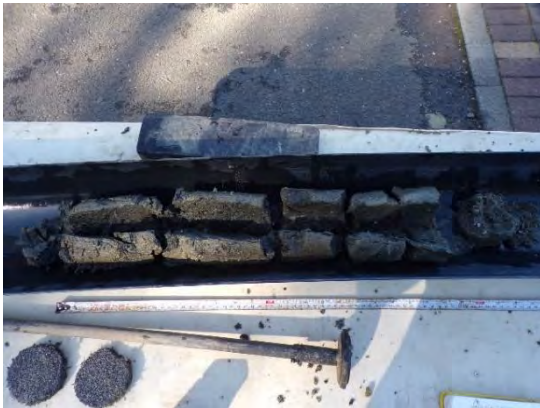
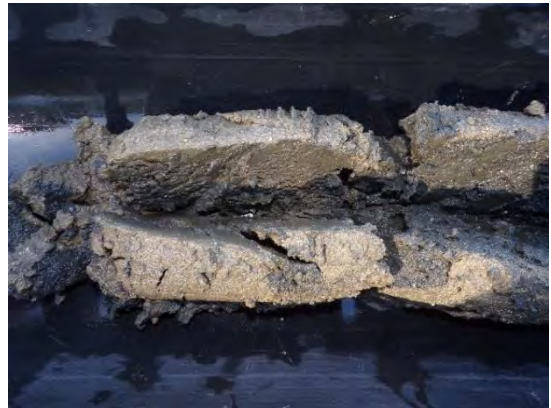
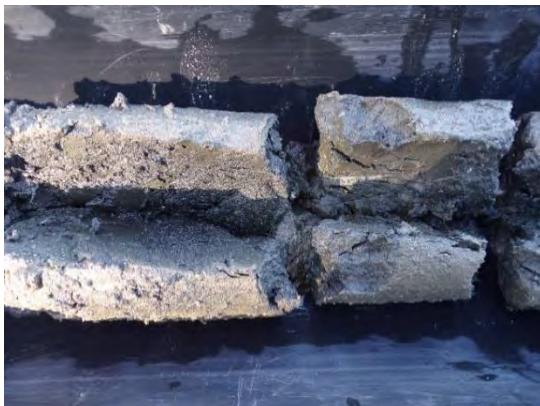
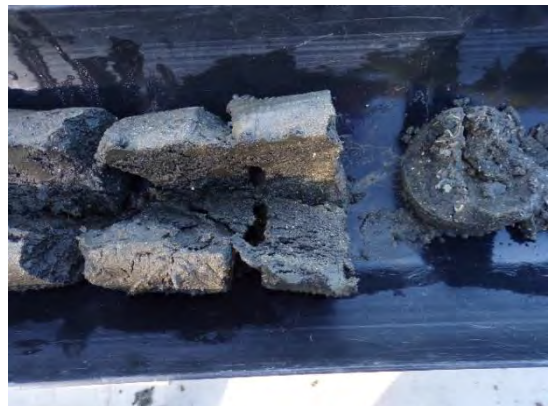
Project Name	Lerwick North Harbour & Dales Voe	Location ID 24-05
Project No.	679749	
Client	Lerwick Port Authority

Two attempts were made at retrieving a core sample using the vibrocorer. Maximum core length achieved was 0.55m (progressed to refusal).

Core was initially frozen upon return from site and sub-sampled on 17/09/2024.

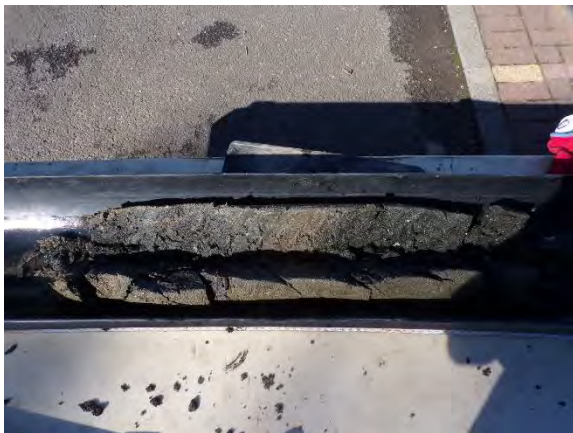
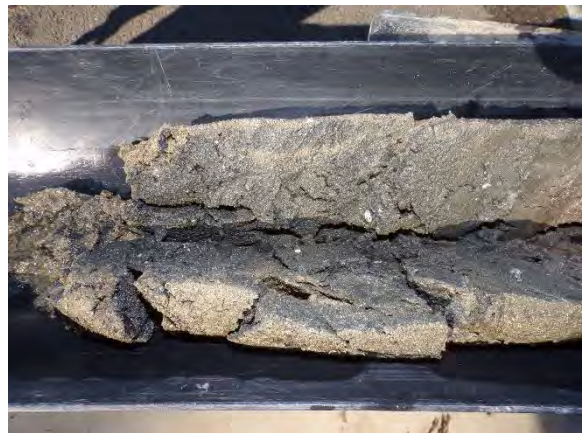
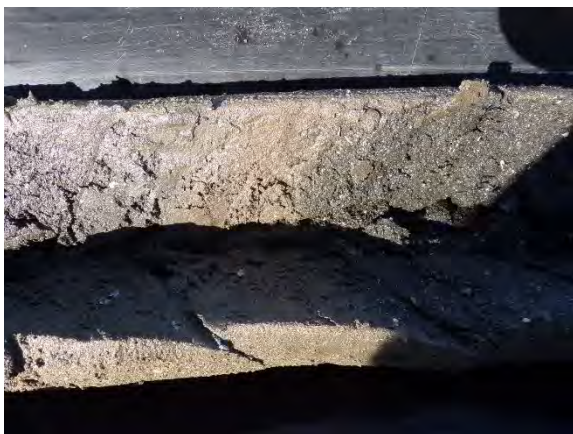
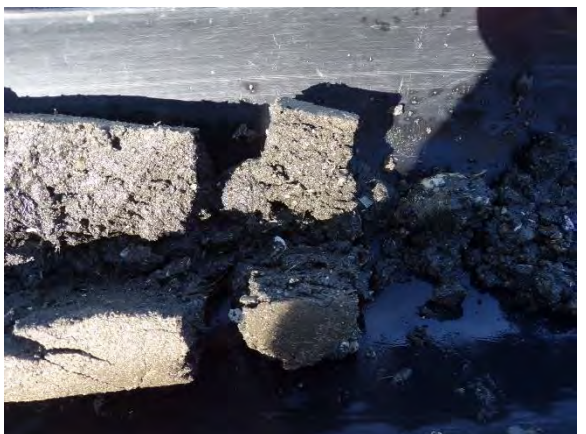
Project Name	Lerwick North Harbour & Dales Voe	Location ID 24-06
Project No.	679749	
Client	Lerwick Port Authority

Two attempts were made at retrieving a core sample using the vibrocorer. Maximum core length achieved was 0.64m (progressed to refusal).

Core was initially frozen upon return from site and sub-sampled on 17/09/2024.

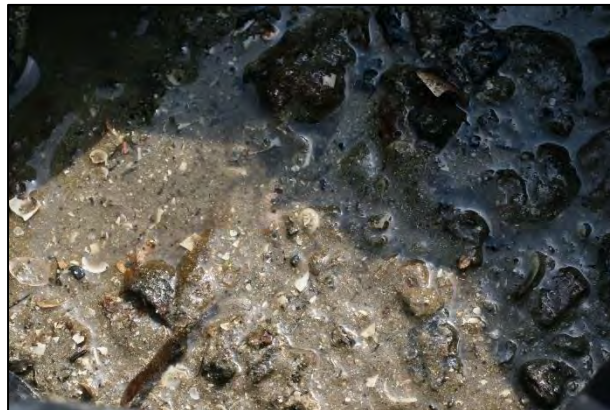
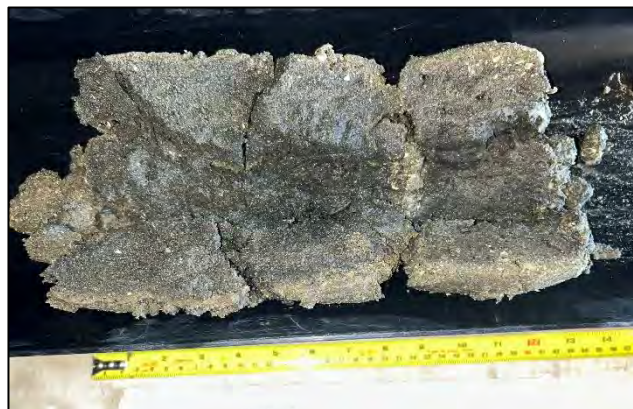
Project Name	Lerwick North Harbour & Dales Voe	Location ID 24-07
Project No.	679749	
Client	Lerwick Port Authority

Grab sample complete after three deployments of grab sampler.

Four attempts were made at retrieving a core sample using the vibrocorer. Maximum core length achieved was 0.36m (progressed to refusal in dense sand). Core was initially frozen upon return from site and sub-sampled on 24/09/2024.

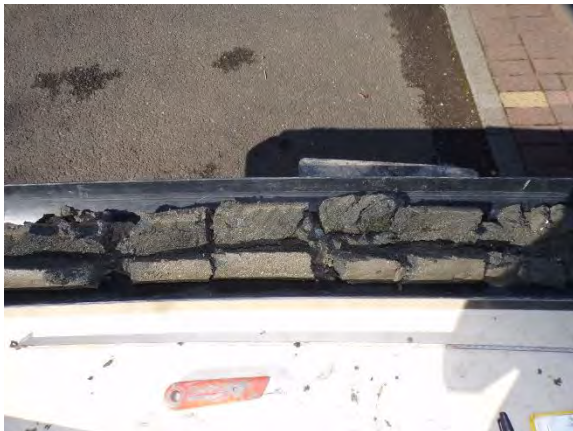
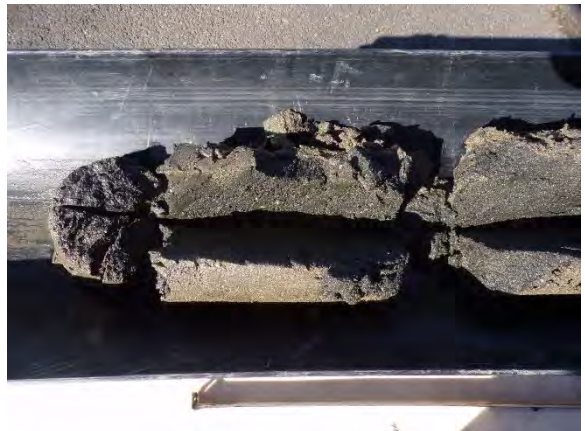
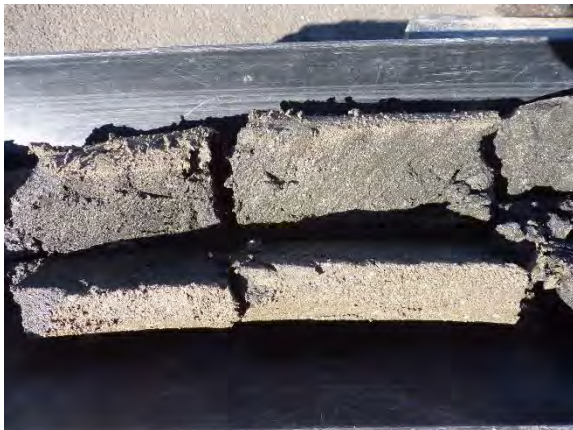
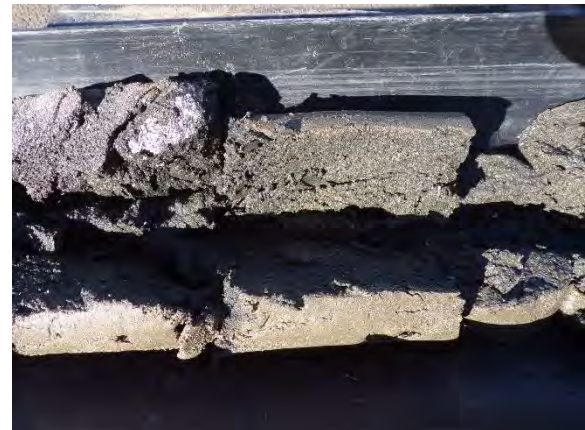
Project Name	Lerwick North Harbour & Dales Voe	Location ID 24-08
Project No.	679749	
Client	Lerwick Port Authority

Two attempts were made at retrieving a core sample using the vibrocorer. Both attempts achieved a core length of 0.7m (progressed to refusal in dense sand).

Core was initially frozen upon return from site and sub-sampled on 17/09/2024.

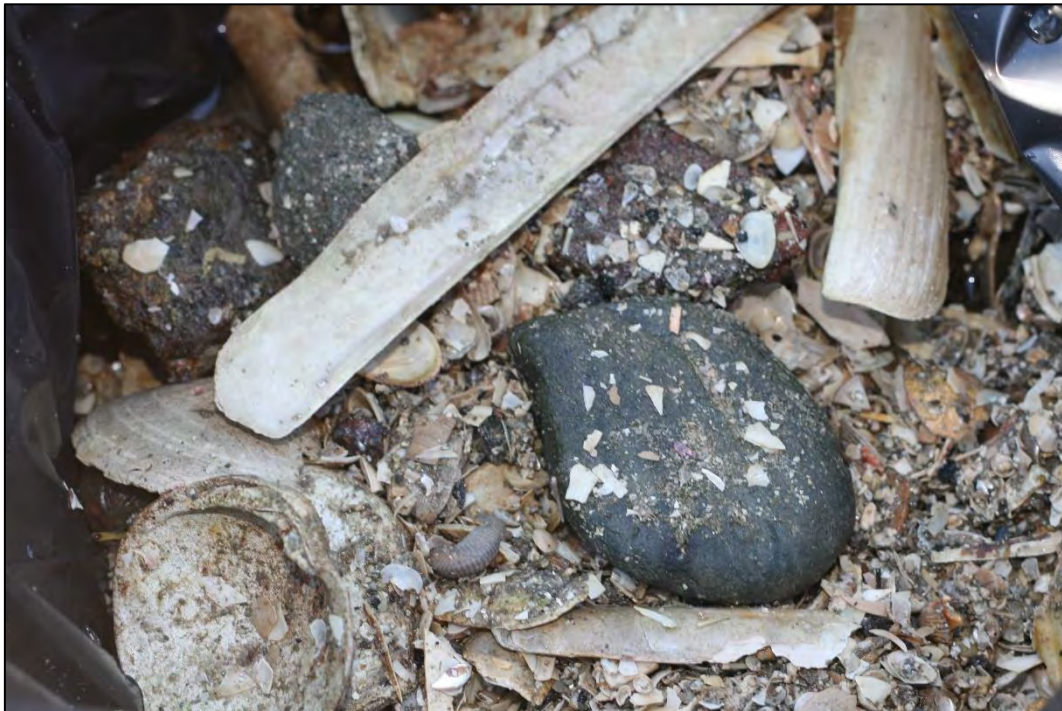
Project Name	Lerwick North Harbour & Dales Voe	Location ID 24-10
Project No.	679749	
Client	Lerwick Port Authority

Notes: Sample complete after three deployments of grab sampler.

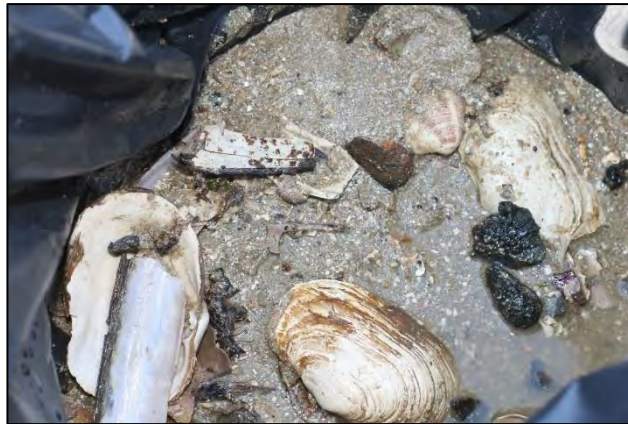
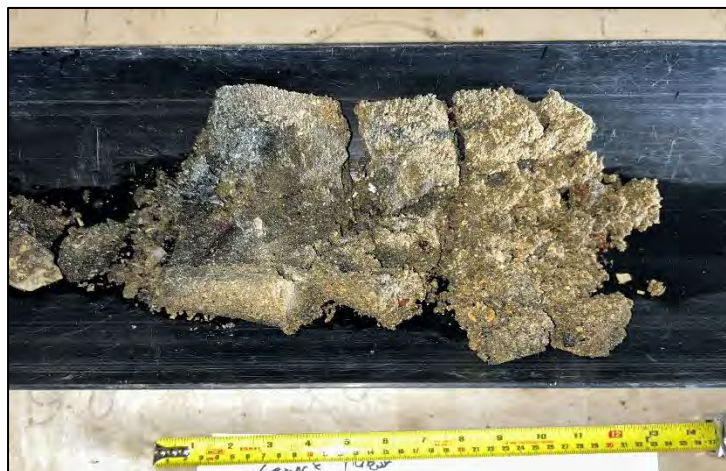
Grab sample complete after two deployments of grab sampler.

Two attempts were made at retrieving a core sample using the vibrocorer. Maximum core length achieved was 0.28m (progressed to refusal in dense sand). Core was initially frozen upon return from site and sub-sampled on 24/09/2024.

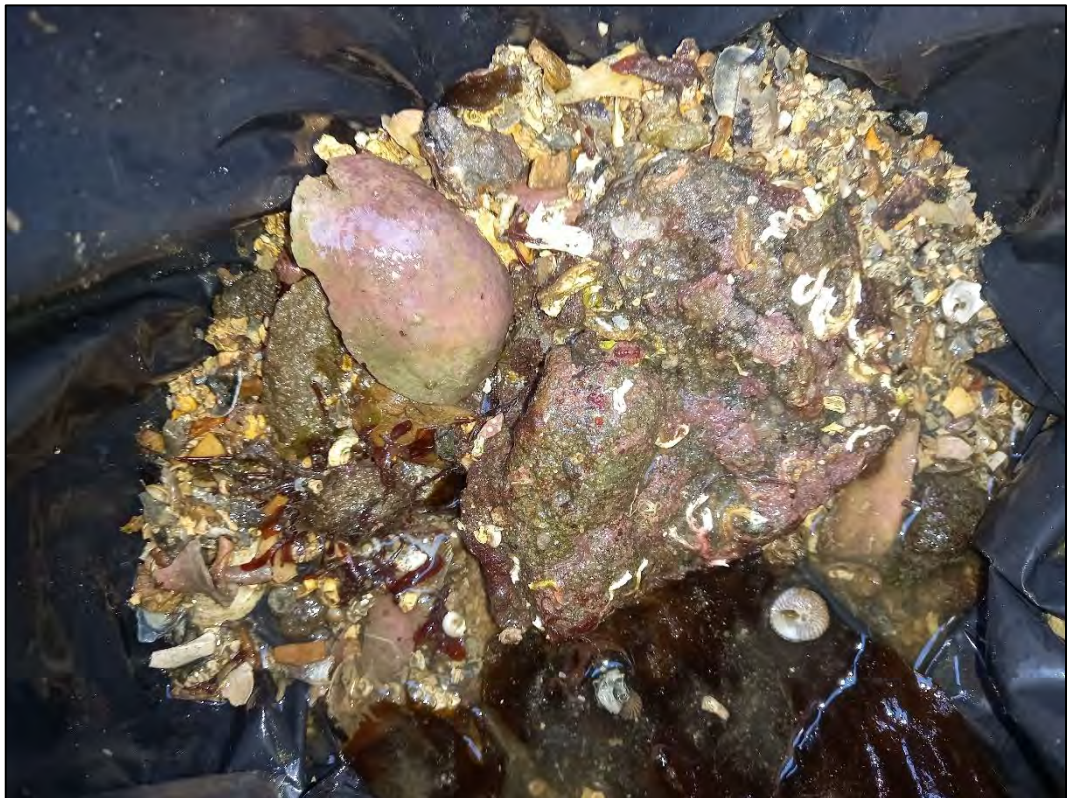
Project Name	Lerwick North Harbour & Dales Voe	Location ID 24-11
Project No.	679749	
Client	Lerwick Port Authority

Notes: Six attempts were made within the vicinity of the proposed sampling station.

A core sample was proposed for this location but was not progressed as the presence of cobbles and kelp on the surface would prevent penetration of the core barrel into the seabed.

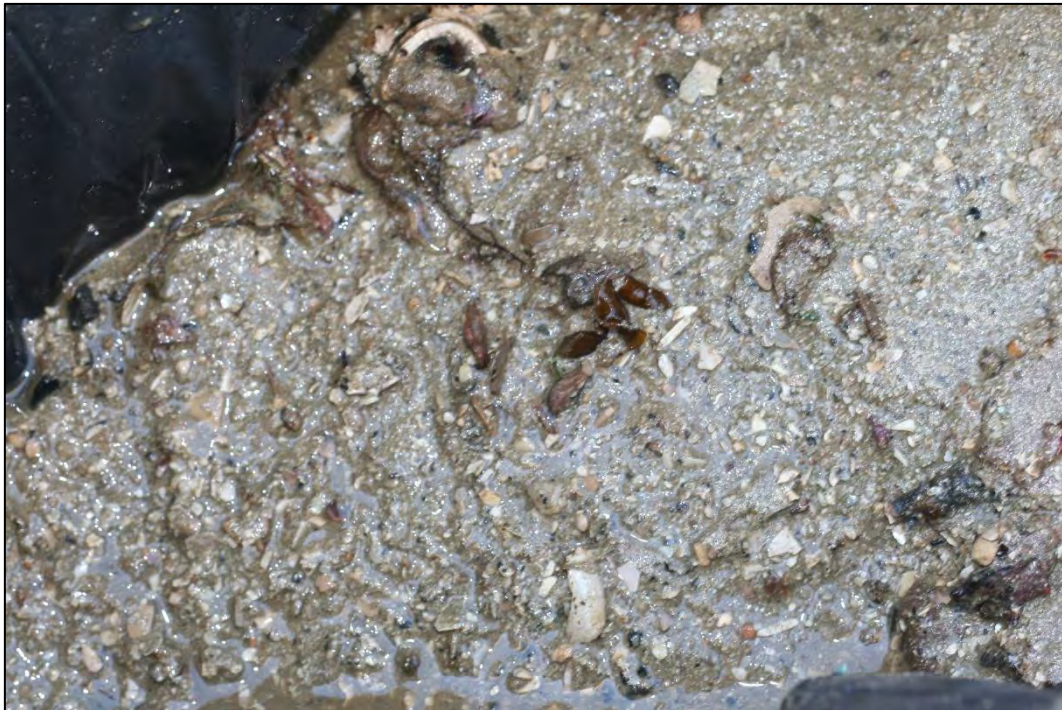
Project Name	Lerwick North Harbour & Dales Voe	Location ID 24-12
Project No.	679749	
Client	Lerwick Port Authority

Notes: Grab sample complete after four deployments of grab sampler.

Two attempts were made at retrieving a core sample using the vibrocorer. Maximum core length achieved was 0.46m, with 0.2m achieved in the other. Both were progressed to refusal in dense sand. The contents of both cores were combined and sub-sampled. The sample was not submitted for analysis but has been retained in frozen storage.

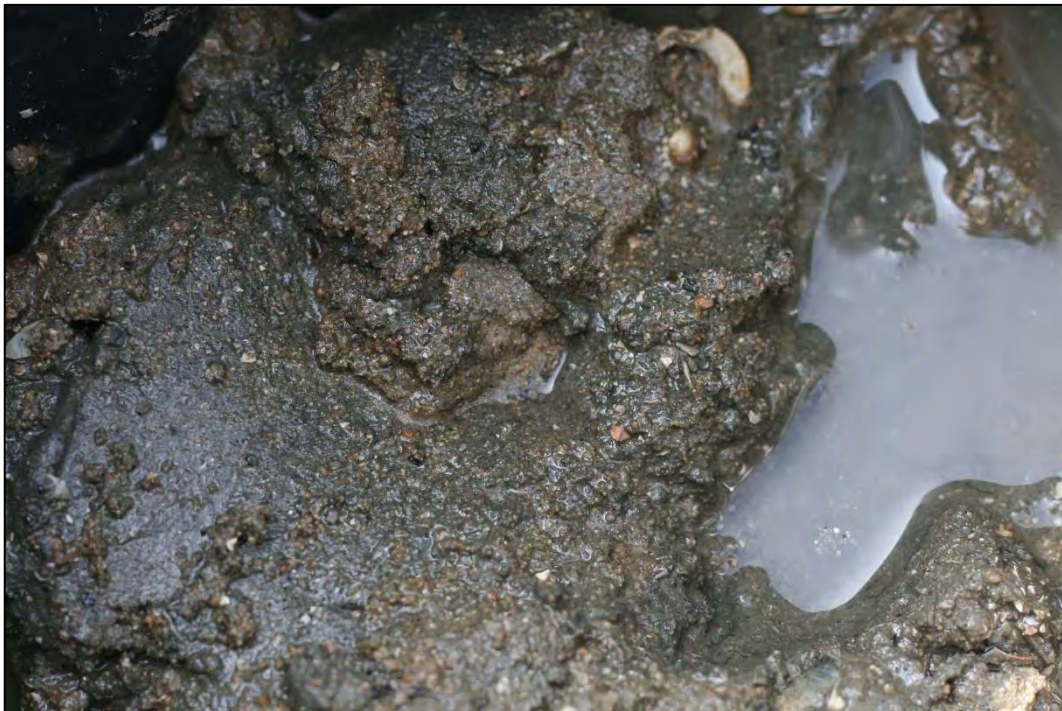
Project Name	Lerwick North Harbour & Dales Voe	Location ID 24-DS-02
Project No.	679749	
Client	Lerwick Port Authority

Notes: Sample complete after three deployments of grab sampler.

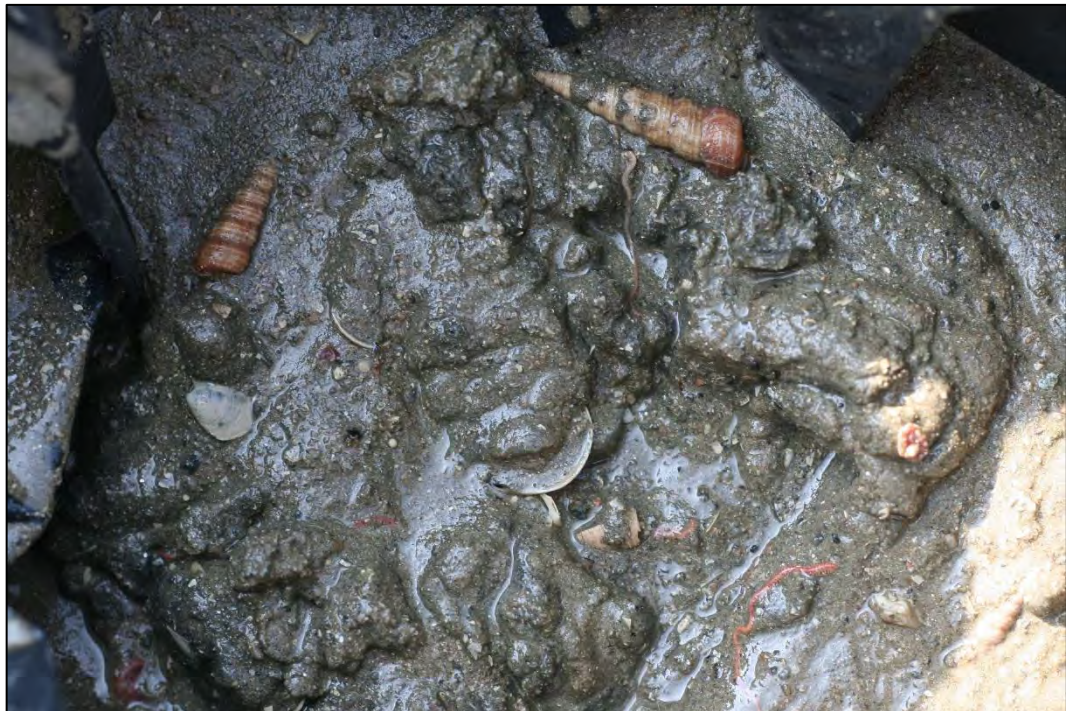
Project Name	Lerwick North Harbour & Dales Voe	Location ID 24-DS-03
Project No.	679749	
Client	Lerwick Port Authority

Notes: Sample complete after three deployments of grab sampler.

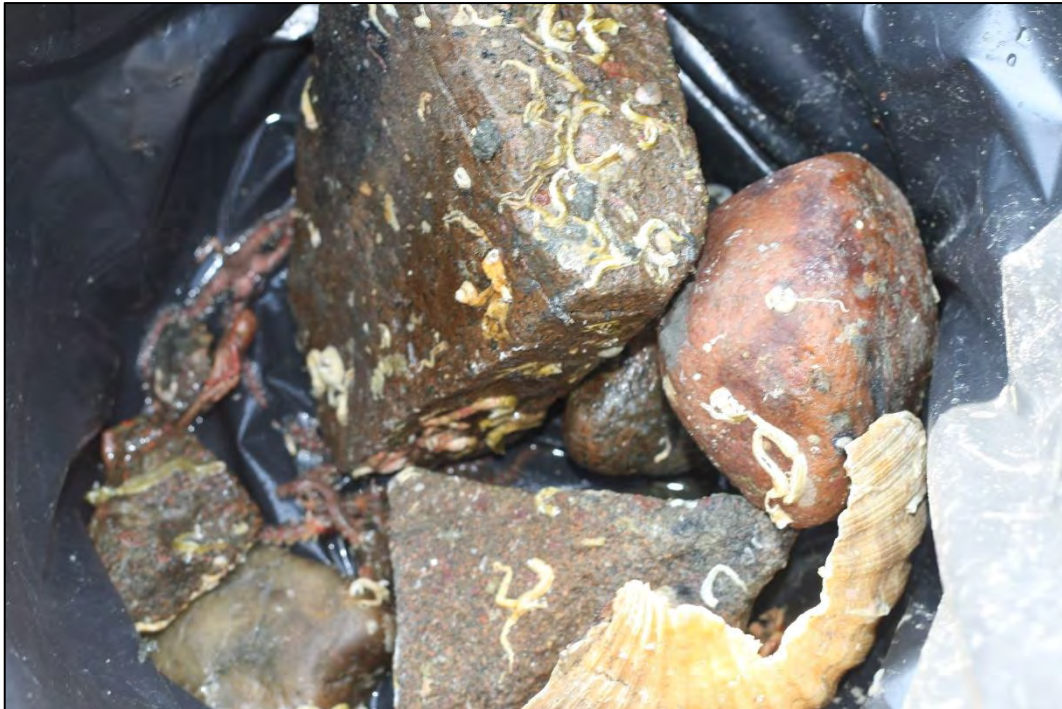
Notes: Several attempts made at two separate locations within the vicinity of the proposed sampling station.
 The material obtained is unsuitable for analysis and therefore not submitted to the laboratory.

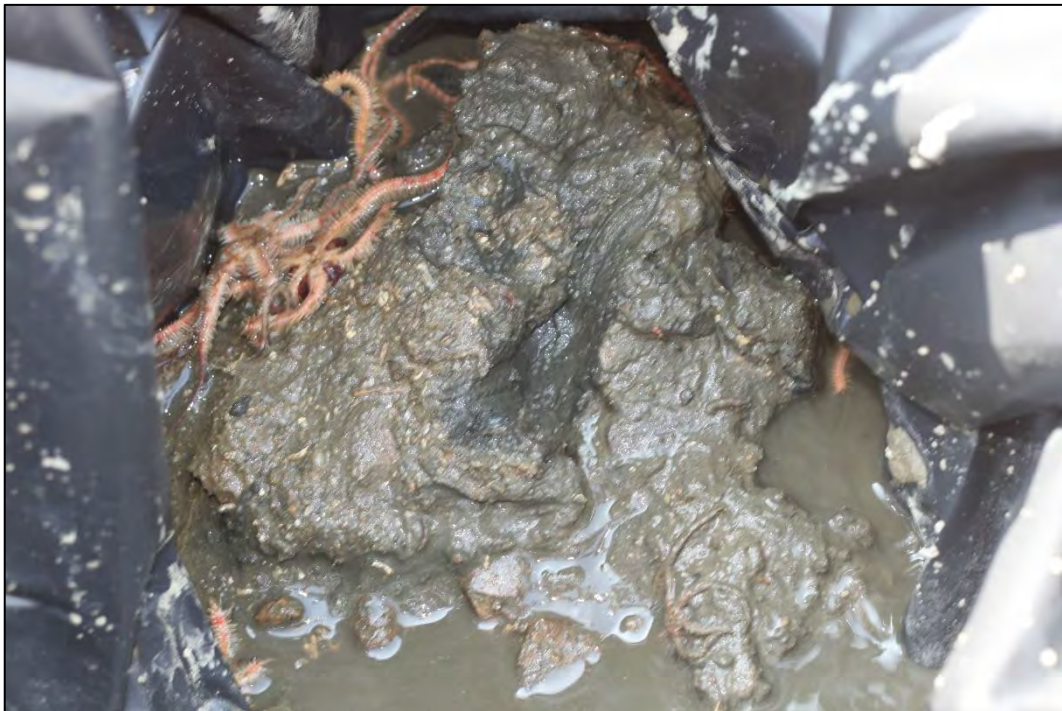
Notes: Sample complete after three deployments of grab sampler.
