Fair Isle Harbour Improvement Works

Appendix 18 Fair Isle Best Practicable Environmental Options for Dredge Disposal

On behalf of **Shetland Isle Council (SIC)**

Project Ref: 11168 | Rev: Version 1.0 | Date: April 2023

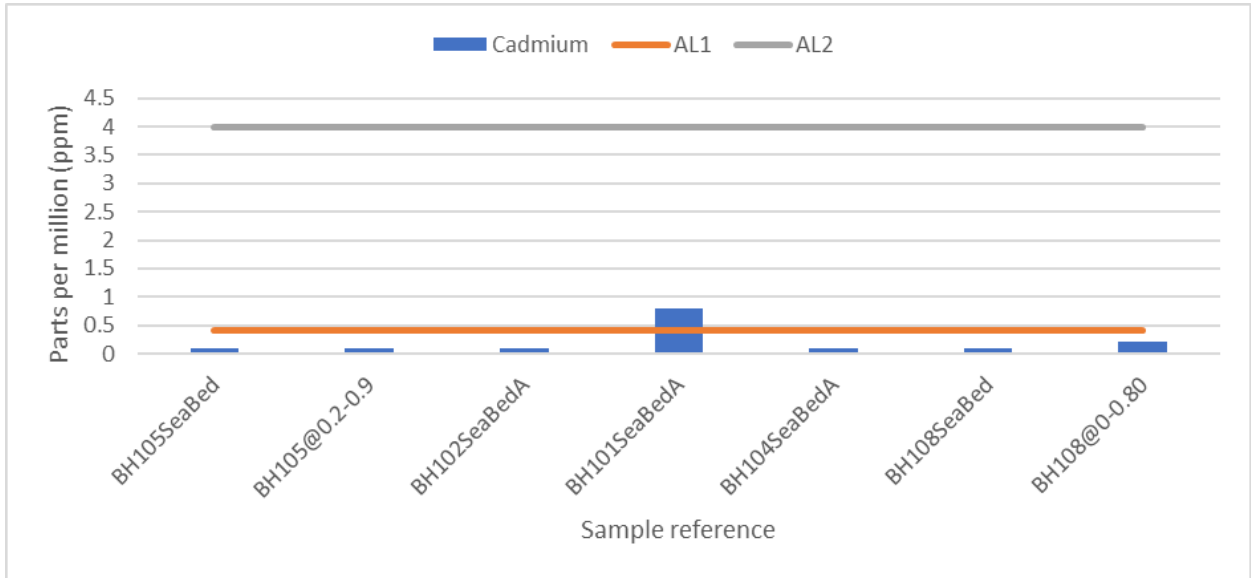
Figure 2 Cadmium levels in samples in 2023

It can be seen from Figure 2 that although there is cadmium exceedance of AL1 in one of the samples, all remaining samples have very low concentrations well below AL1.

Figure 2, Figure 3 and Figure 4 show the levels of cadmium, chromium and mercury identified in the sediment samples in 2023 against AL1 and AL2.

The presence of AL1 exceedances of cadmium and chromium in the sediment from surface samples could potentially indicate that elevated concentrations of these metals are from a recent source. However, AL2 exceedance of mercury was only present within the depth integrated sample with no contamination detected within the surface sample at BH108. This could indicate historic contamination at this location.

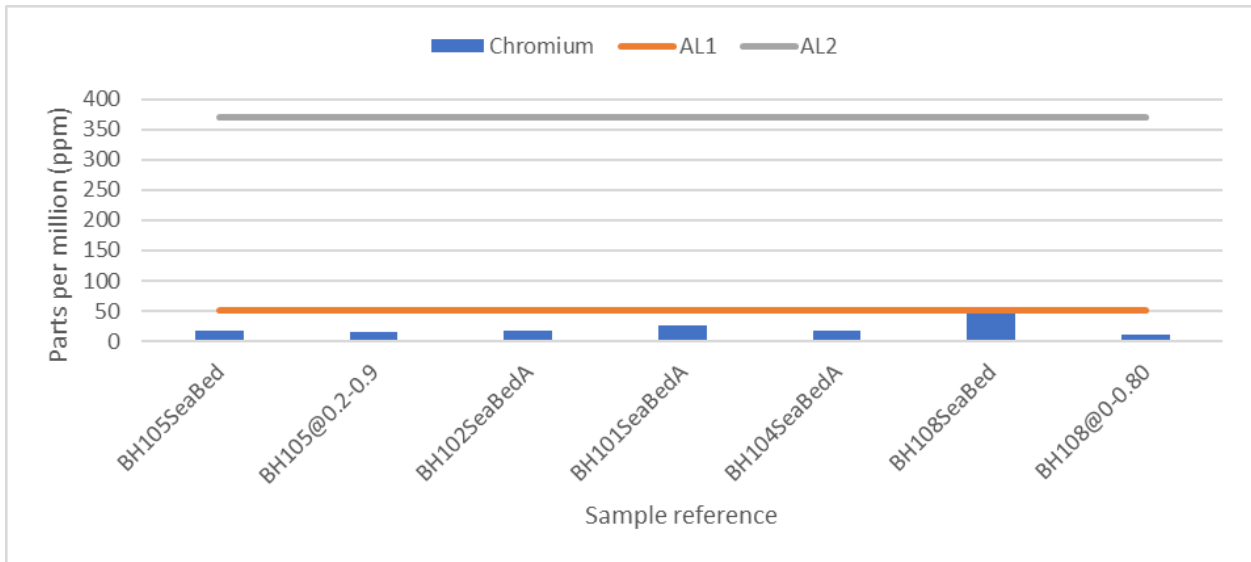
Figure 3 Chromium levels in samples in 2023

Figure 3 shows that the elevated chromium concentration is exactly 50 ppm, i.e. the AL1 for chromium with all remaining samples having very low concentrations well below AL1.
