Scotland - Northern Ireland (Scot-NI) 3 and 4 Replacement Cables

Technical Appendix E - Navigation Risk Assessment

P2302_R5150_Rev0

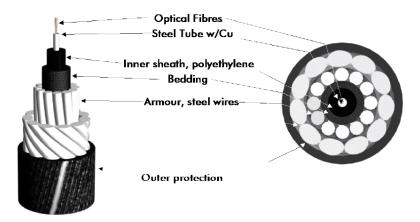
Figure 2-1 Example of double armour fibre optic cable

The cable types to be used for Scot-NI 3 and 4 are armoured fibre optic cables, which are a resilient cable type suitable for installation within the Irish Sea (Figure 2-1). The cable system will be an 'unrepeatered system' (a cable system with no power supply to the cable due to the short overall length). The cable itself is between 25mm (single armour) and up to 46mm (rock armour) in diameter, depending on the level of cable armouring required. The optical fibres are contained within a gel filled stainless steel tube. This is surrounded by a polyethylene insulation layer. The construction of this core provides protection against water penetration and hydrogen. The core is further protected by layers of steel wire and an outer polypropylene yarn.

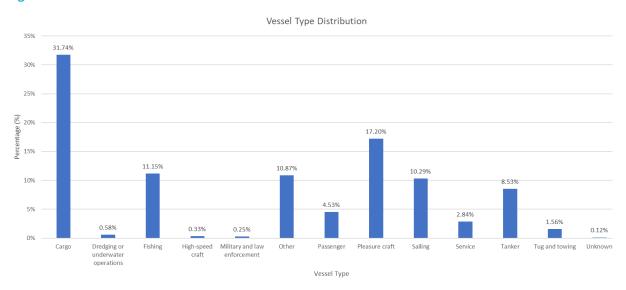
Figure 4-1 Vessel Distribution Across SCOT-NI-3 Route

A total vessel density of 31670 hours per month were recorded across the SCOT-NI-3 route in 2019. The percentages of the vessel categories are presented in **Figure 4-1.** Fishing vessels make up 11% of the data while Cargo vessels make 31%. The percentage of fishing vessels are a lot lower across the SCOT-NI-3 route than SCOT-NI-4.

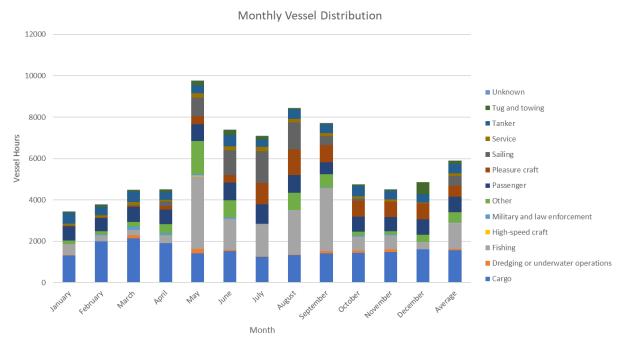
Figure 4-2 Seasonality Changes in Vessel Traffic Across SCOT-NI-3 Route

Seasonal distribution of the vessel traffic has been analysed in full and the busiest months are observed in from May to September. It should be noted that in August there is an abundance of 'Other' vessels while the previous month, July, has none. This may indicate an anomaly in the AIS data sourced publicly from EMODnet. No other anomalies have been observed in this data. **Figure 4-2** highlights the seasonal changes.

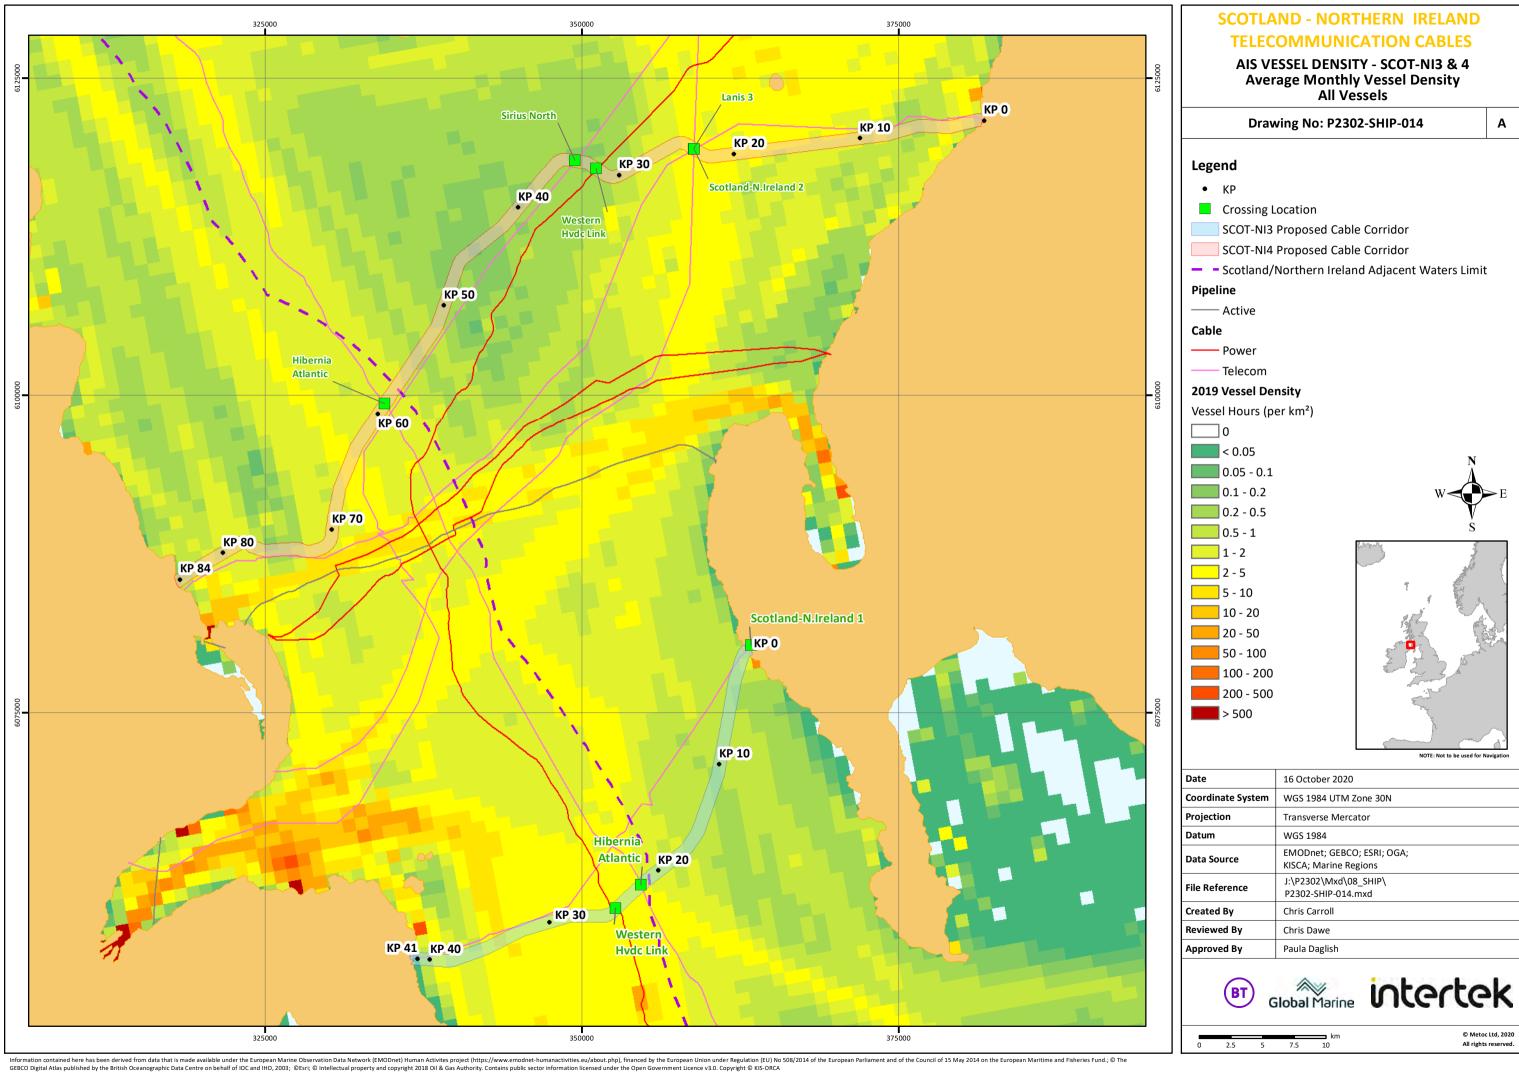
The SCOT-NI-3 Route crosses two undesignated shipping lanes which lead in and out of Belfast port at approximately KP20 to KP25 and KP30 to KP35.

Figure 4-3 (P2302-SHIP-014-A) highlights the shipping patterns (monthly) across the SOCT-NI-3 Route. Also annotated on the figure are the third-party crossing locations.

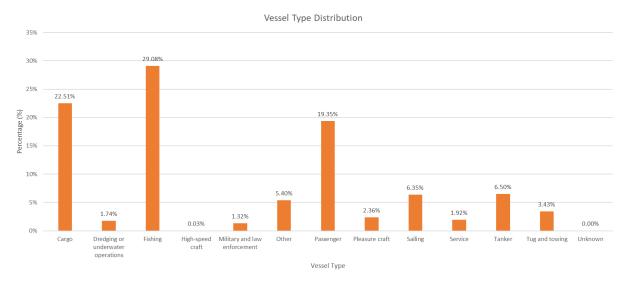
Figure 4-5 Vessel Distribution Across the SCO-NI-4 Route

A total vessel density of 42239 hours per month were recorded across the SCOT-NI 4 Route in 2019. The percentages of the vessel categories are presented in **Figure 4-5**. Cargo, Fishing and passenger vessels make up most of the dataset (22%, 29% & 19% respectively).

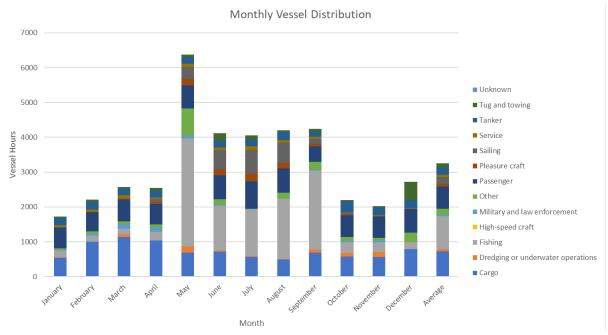
Figure 4-6 Seasonality Changes in Vessel Across the SCOT-NI-4 Route

Seasonal distribution of the vessel traffic has been analysed in full and the busiest period is between May and September with the busiest month being May with fishing unusually high during this month.

It should be noted that in August, the same anomaly of combining July's 'Other vessels' are present within the data. No other anomalies have been observed. **Figure 4-6** highlights the seasonal changes in. May to September appear to be the busiest which typically aligns with fairer weather needed for marine campaign works.

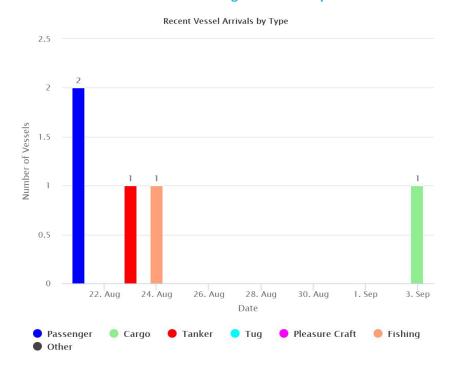
Figure 4-8 Vessel Arrivals between 22nd August and 3rd September 2020 at Larne Anchorage

One anchorage area associated with the Port of Larne is observed ~2.5km offshore and ~2.5km south of the SCOT-NI-4 Route and is designated for vessels waiting for berthing.

An indication of the anchorage usage can be found on the marine traffic website (ref 5) and highlighted in **Figure 4-8** below.

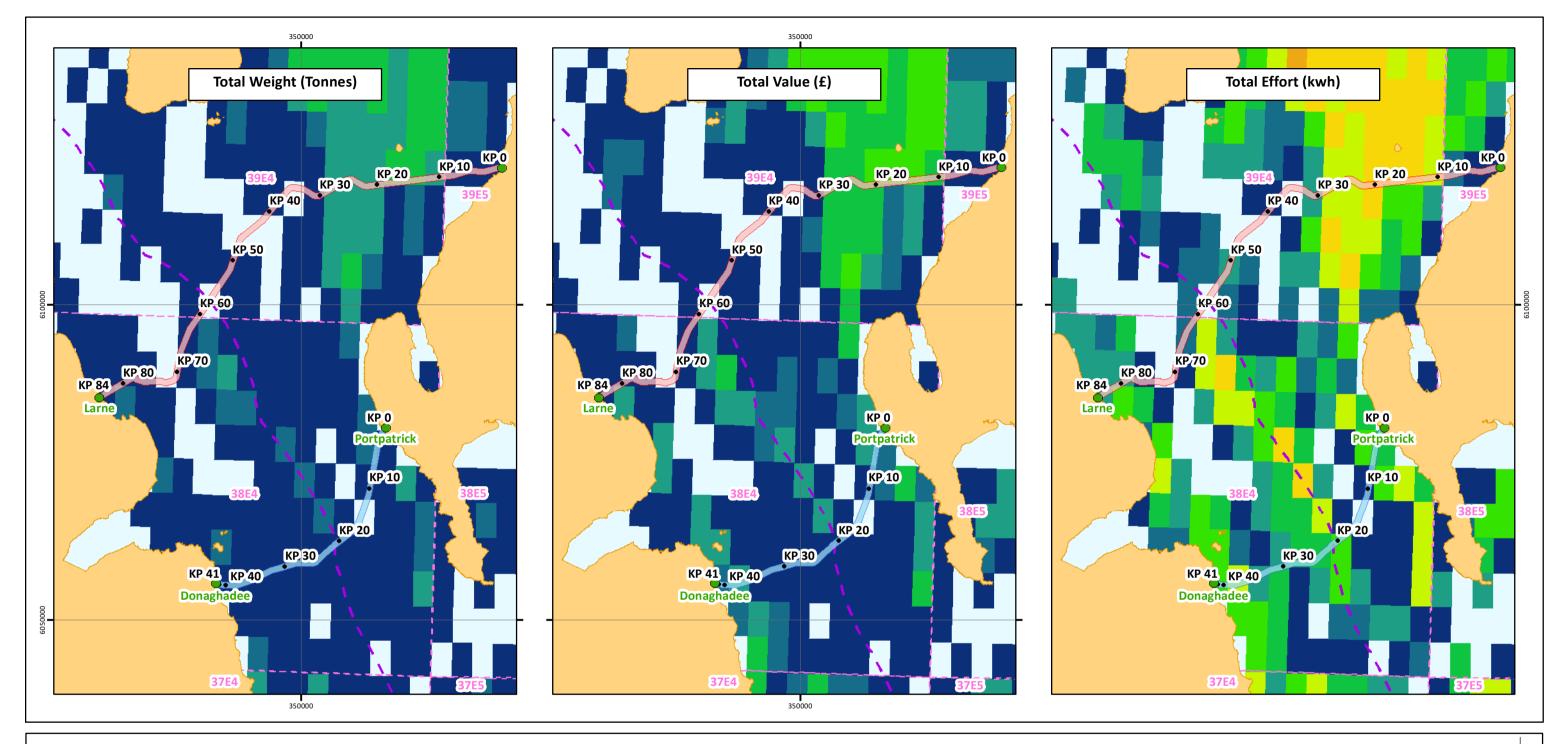
Drawing No: P2302-FISH-008 | A

Fishing intensity can be found in **Figure 4-10** (P2302-FISH-008-A) demonstrating that generally the total fishing effort is consistently present across both SCOT-NI Routes. By analysing the seasonality, it can be seen that fishing is more intense from May to September and more notably a significant increase in the month of May.

SCOTLAND - NORTHERN IRELAND TELECOMMUNICATION CABLES FISHING ACTIVITY - Fishing Activity for ≥ 15m UK Vessels 2017 by ICES Sub Rectangle

Appendix A.2. shows fishing intensity by season. The most distinct area where fishing is more intense is in the Firth of Clyde, between KP10 to KP30 across SCOT-NI-4, where there is a consistently fished area year-round, though towards the south of this area the intensity does vary by season. Both cables largely avoid this area, however Scot-NI 4 unavoidably enters it due to the location of its landfall at Girvan. Further south in the North Channel, there are other hotspots, though these are not consistently present across all seasons. The largest of these appears only in autumn. A smaller patch of activity appears towards the middle of the channel and is present throughout the year but varies in extent and intensity. Scot-NI 3 avoids this hotspot, passing south of it even at its largest extent during autumn (ref 9).

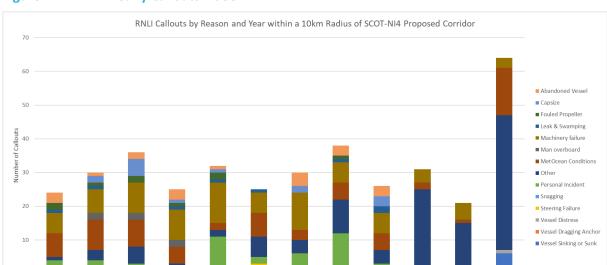
Figure 4-11 RNLI Yearly Callouts – SCOT-NI-3

With the exception of 'other', which as mentioned above is not relevant to this assessment, it can be seen that for both SCOT-NI Routes 'Machinery failure' account for a large portion of the dataset and make up 27% (11 per year) and 21% (7 per year) of the incidents across SCOT-NI-3 and SCOT-NI-4 respectively. Similarly, collisions only make up 0.1% of the data for SCOT-NI-3 (0.5 collisions per year) and no collisions were recorded across SCOT-NI-4.

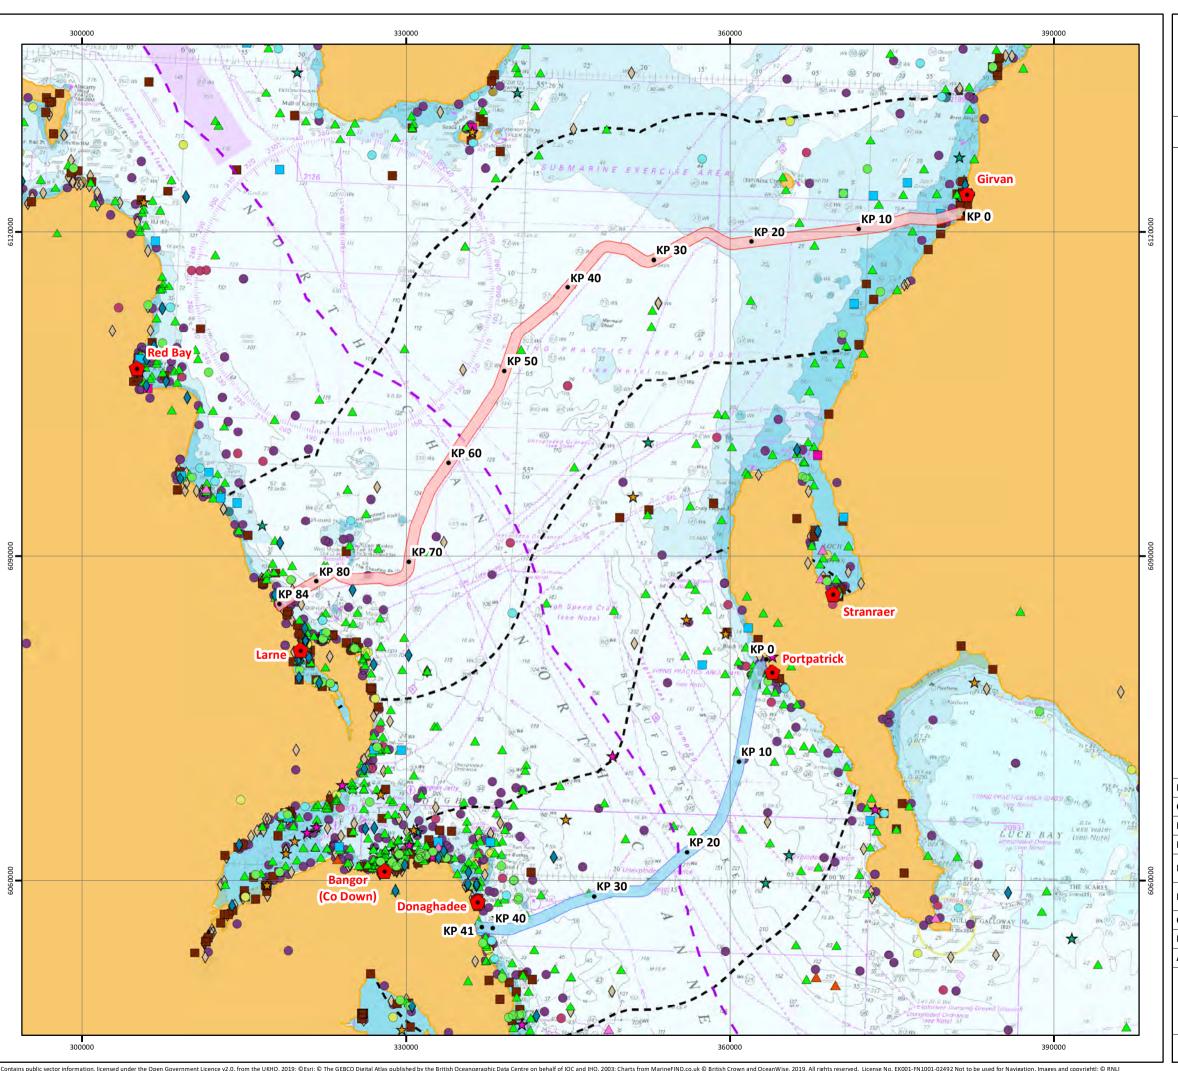
Figure 4-13 (P2302-RNLI-001) presents the locations of incidences recorded by the RNLI

ROYAL NATIONAL LIFEBOAT INSTITUTION Recorded Incidents between 2008 and 2019

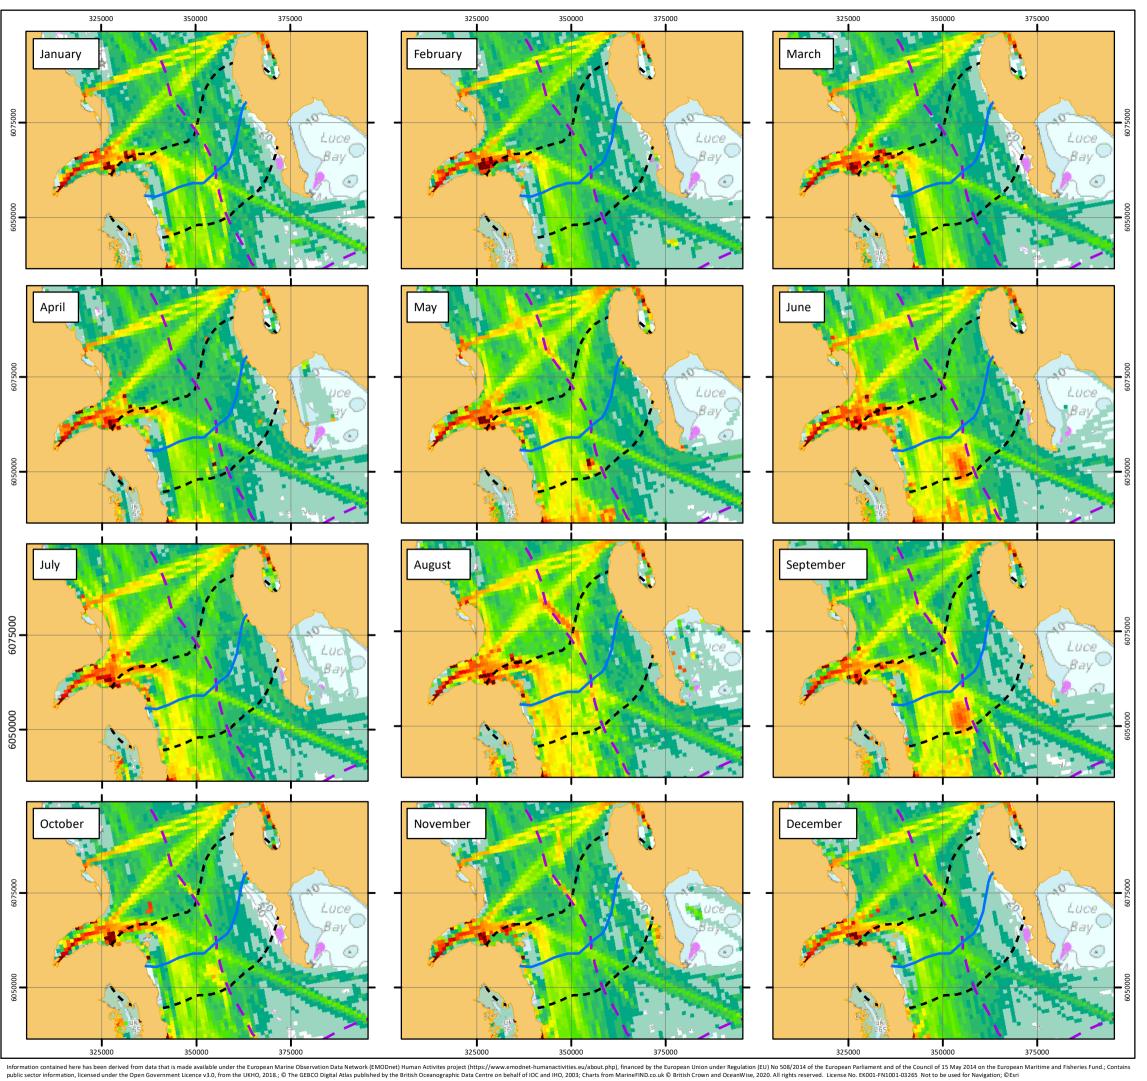
AIS VESSEL DENSITY - SCOT-NI3 Monthly Vessel Densities All Vessels

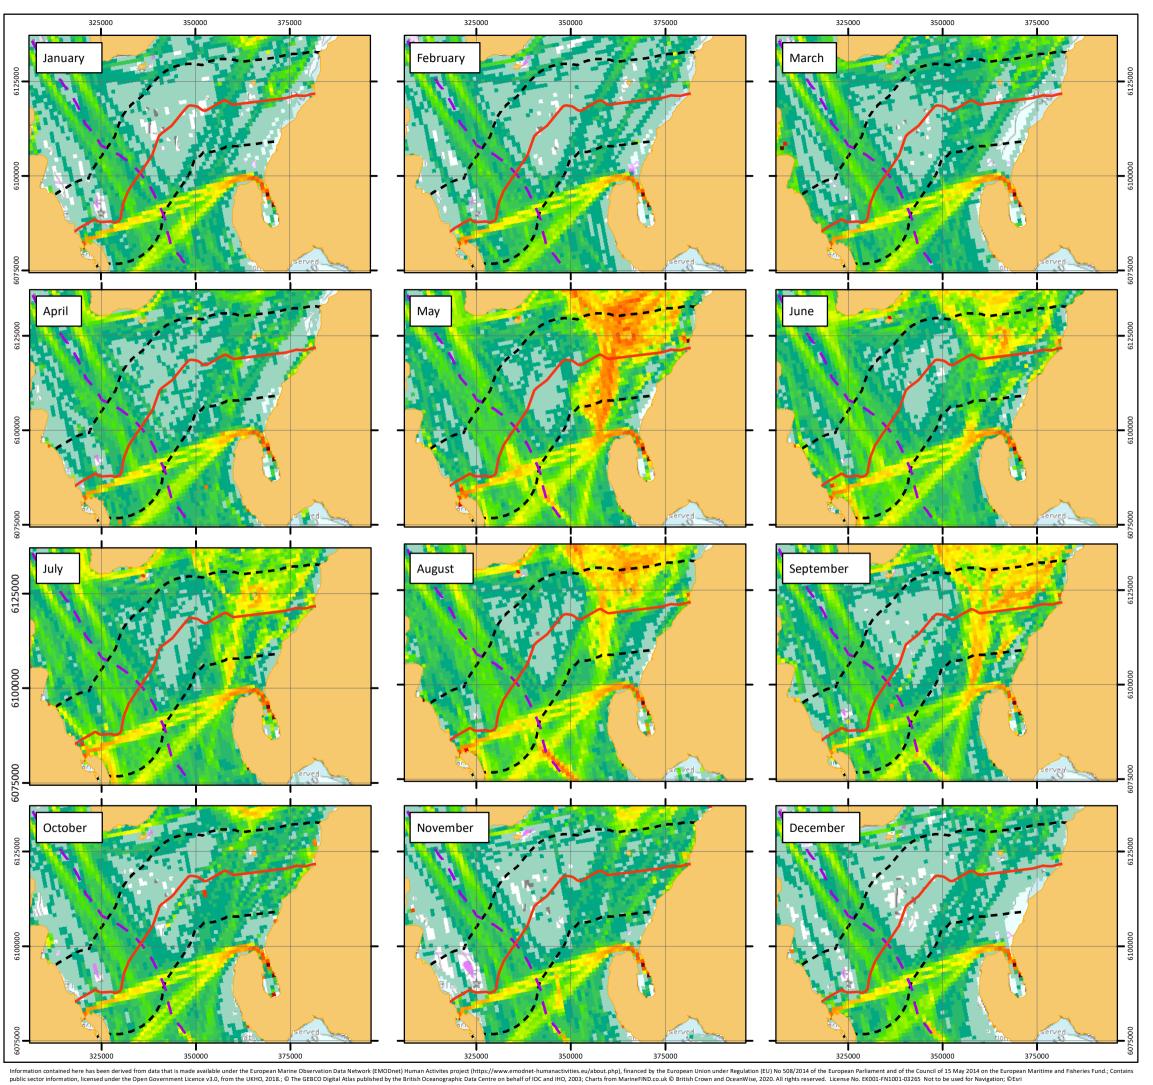
AIS VESSEL DENSITY - SCOT-NI4 Monthly Vessel Densities All Vessels

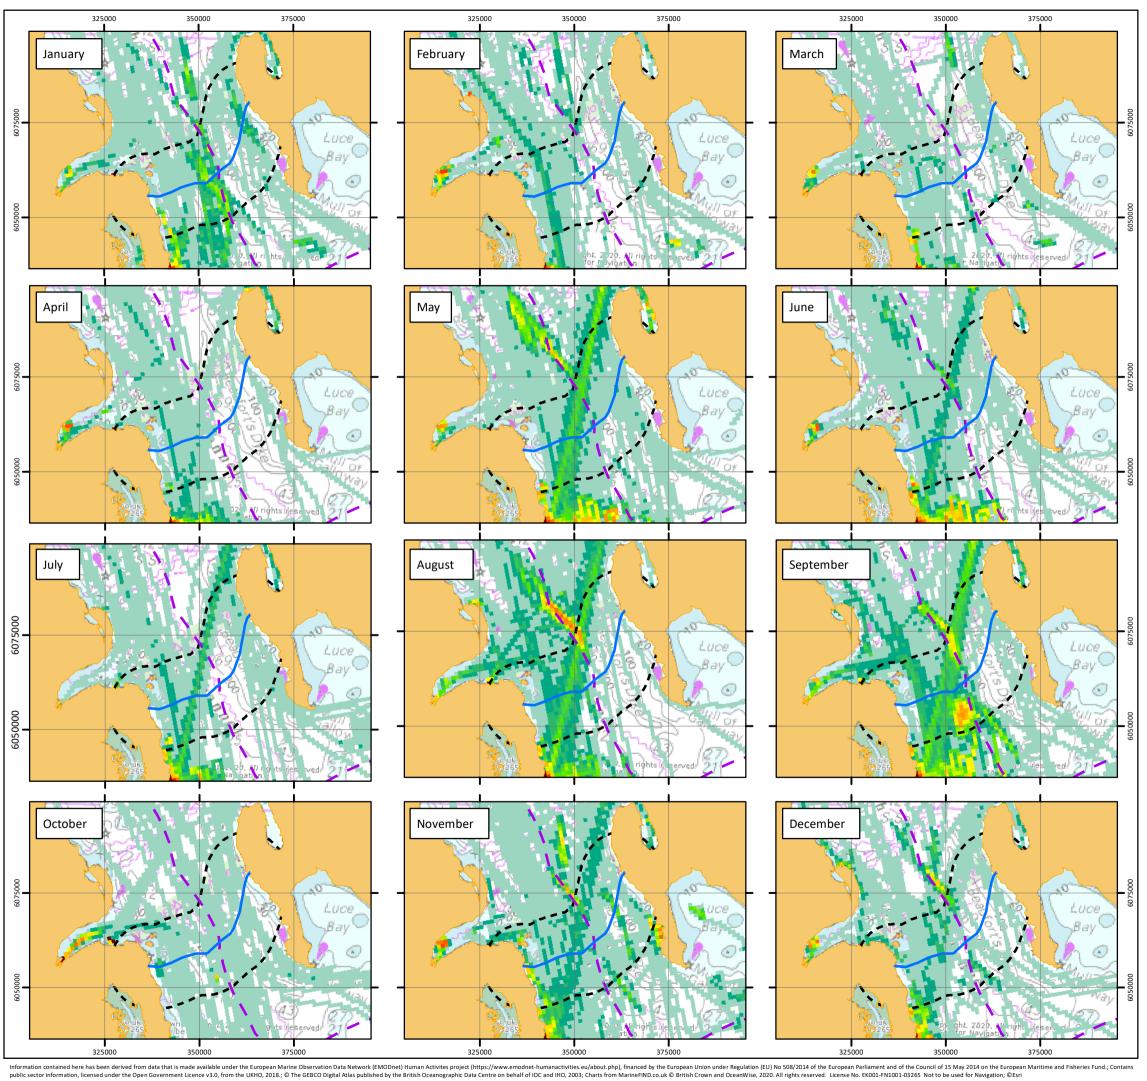
AIS VESSEL DENSITY - SCOT-NI3 Monthly Vessel Densities Fishing Vessels

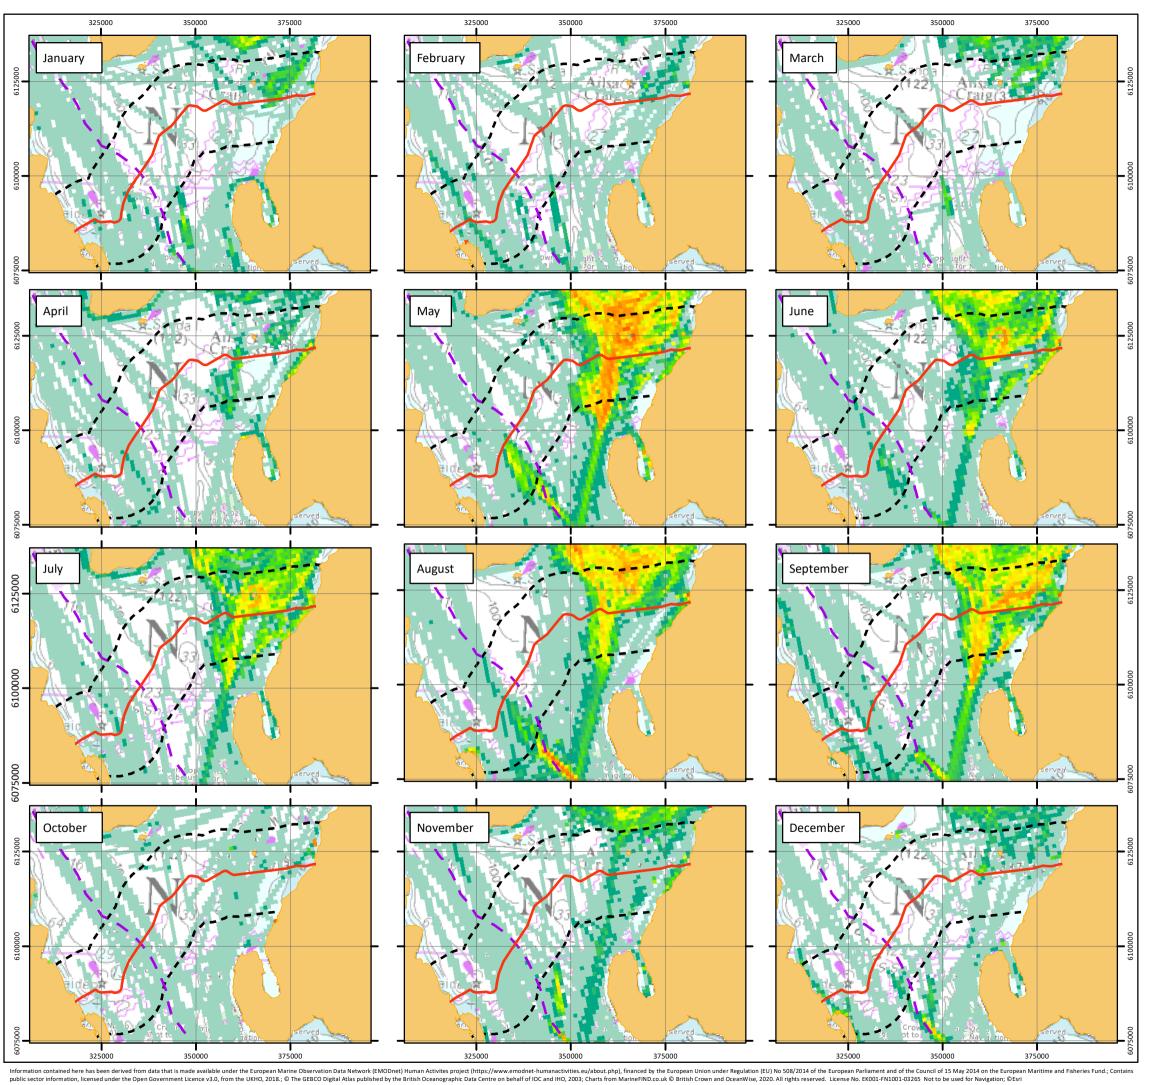
AIS VESSEL DENSITY - SCOT-NI4 Monthly Vessel Densities Fishing Vessels
