Nova Innovation Ltd

Shetland Tidal Array Bluemull Sound Cable Plan

Document number: EnFAIT-0234

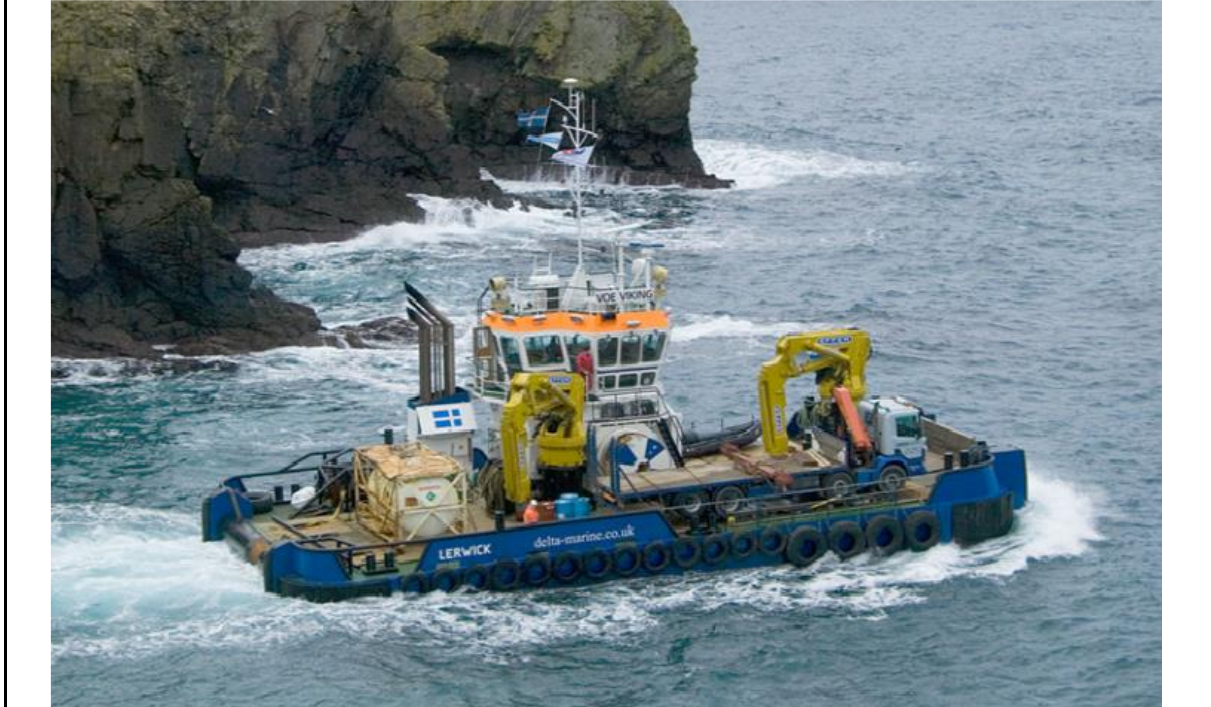
Figure 7.2 Representative cable installation vessel

The cables will be transported to site by road. A Multicat vessel similar to that shown in Figure 7.2 will be used to install the cables.

The actual vessel to be used has yet to be finalised but will be notified to the licensing authorities in advance of any work taking place.

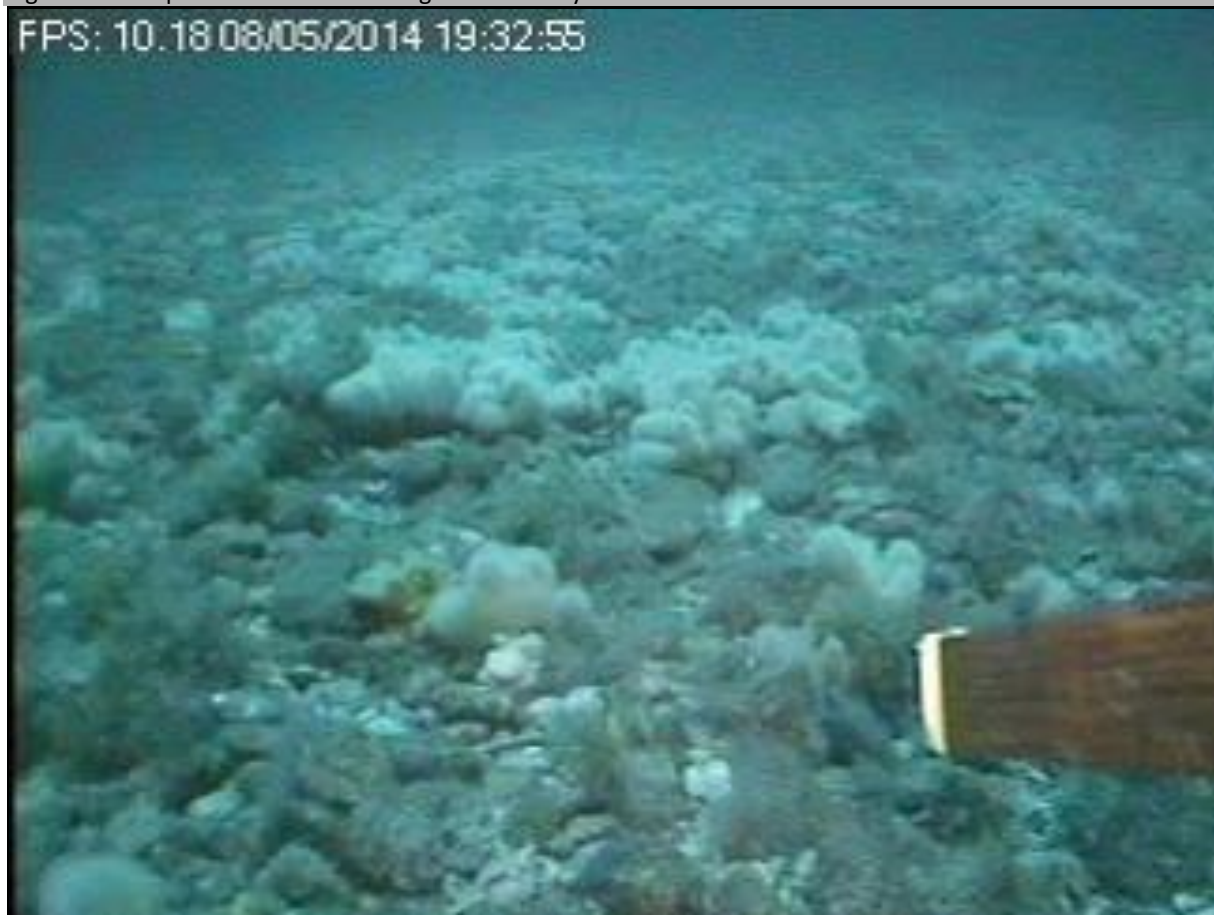
Figure 8.1 Still picture from ROV footage on the array site

The sea bottom at the site consists of relatively flat shattered rock and small boulders that forms a stable seabed. An additional detailed survey of the sea bed in the designated area will be carried before any works begin.

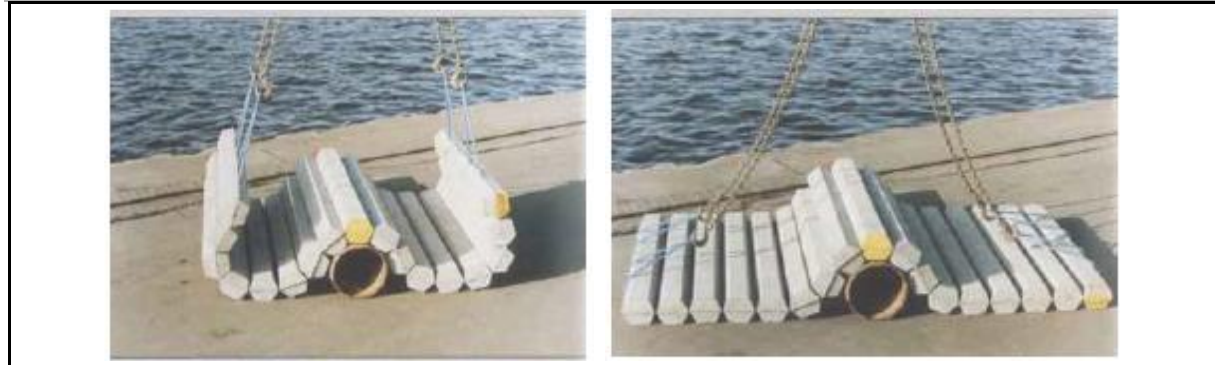
Figure 2.2 Concrete mattress being deployed over a pipe section

Concrete mattresses are commonly used to protect subsea cables and pipelines, particularly at their intersection, and as scour protection around subsea structures. They consist of a matrix of prefabricated concrete blocks connected by polypropylene rope. The installation of concrete mattresses typically requires diver intervention to assist with accurate placement (BERR 2008). It also involves significant surface operations and is not typically conducted in strong tidal streams. Concrete mattresses can each weigh up to 10 tonnes and a typical mattress would measure 5 m x 3 m x 300 mm thickness, though smaller and lighter mattresses are also available.

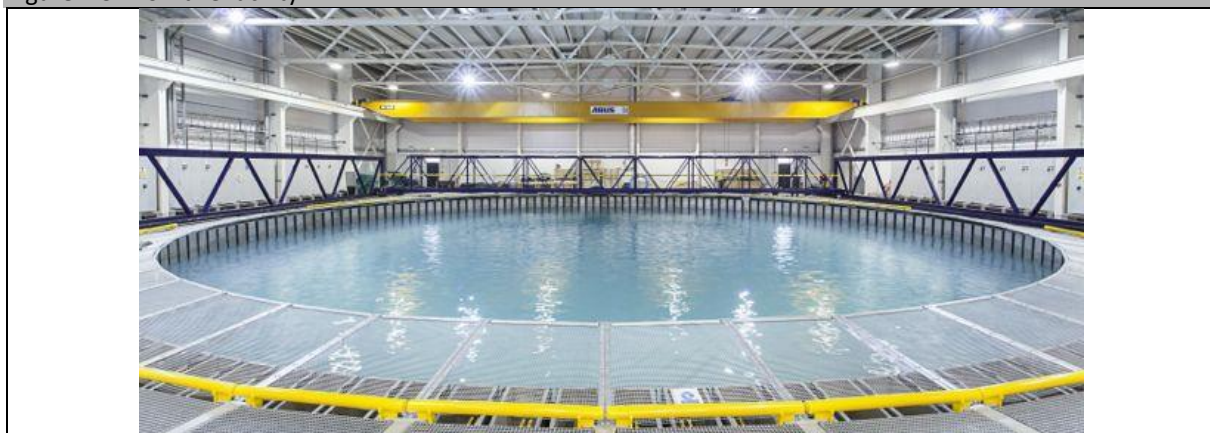
Figure 4.3: FloWave facility

In order to empirically test cable stability at conditions typically found at a tidal site Nova Innovation conducted a series of tests in the FloWave Test Tank at Edinburgh University. A variety of cables were laid on an analogue sea floor and their stability under different flow conditions was analysed.

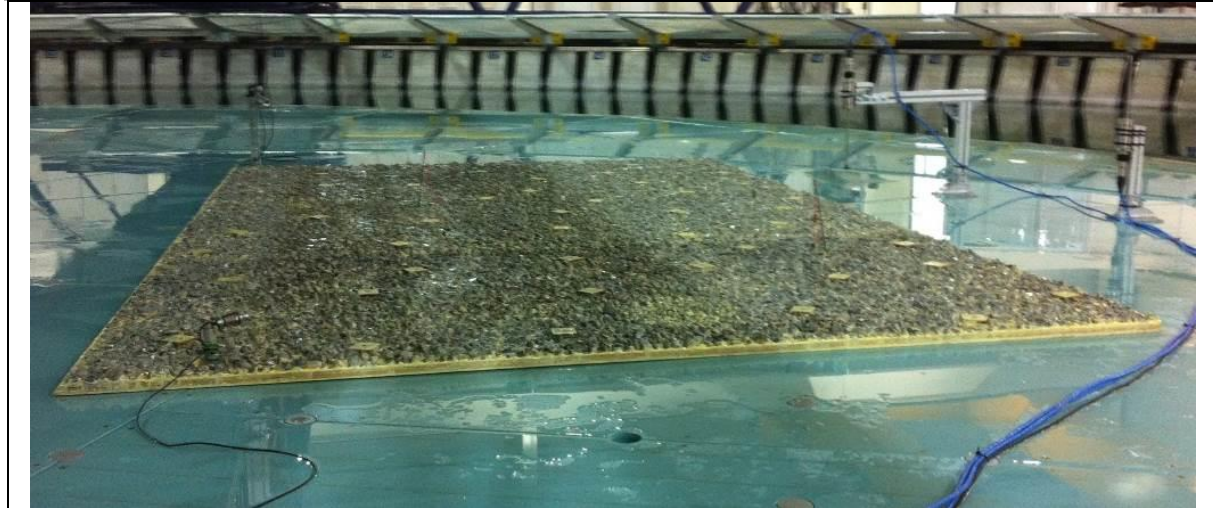
Figure 4.4: Seabed analogue secured to the FloWave submersible floor, subsea cameras and flow meters in place

. Figure 4.4 shows the three seabed sections assembled together and secured to the FloWave tank floor.

Empirical observations of the onset of cable instability were compared to predictions derived from DNV-RP-F109 and it was found that instability occurred at a flow rate approximately 20-40% higher than that predicted by naive application of the DNV formula. Measurements of the friction coefficient of cables to the analogue sea bed gave an indication as to why this might be the case: on a floor with roughness similar in scale to the diameter of the cable the cable has to slide upwards over a roughness feature (e.g. a boulder) in order to move laterally. This increases the effective friction coefficient of the surface, and can lead to the cable becoming “pinned” by a features on the seabed. Where a cable does experience local motion on a rough sea bed it is likely that it will move until it finds a stable location.

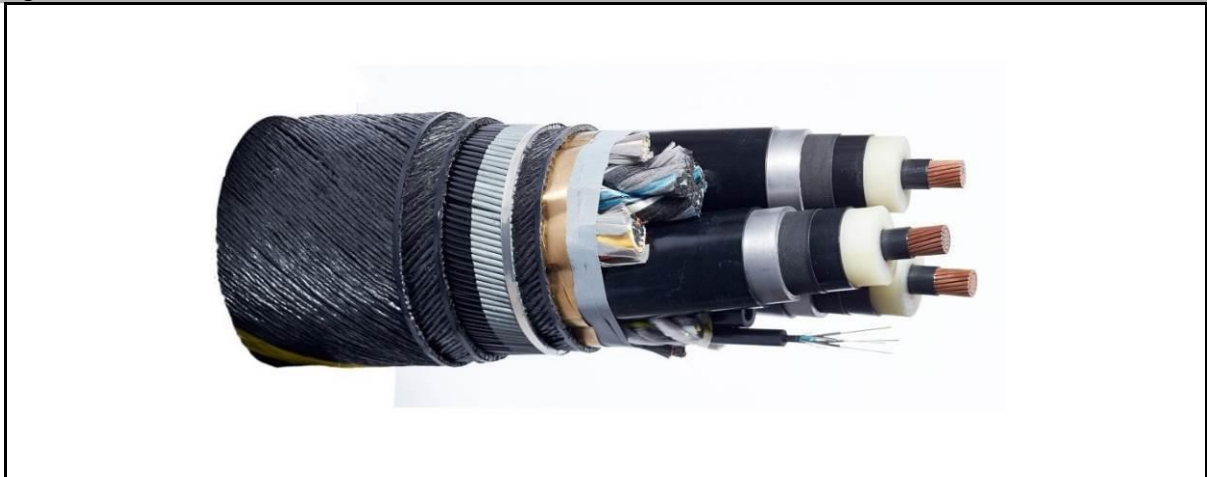
Figure 6.1: General sub-sea cable architecture

- 1) Single armour is more prone to damage over a 20 year life and provides less protection from abrasion than double armour.
- 2) Triple armour is prone to losing internal torque balance over time, is difficult to handle (stiff and heavy), and is more expensive to manufacture.
- 3) Variable armour layering (e.g. single layer in exposed area, double layer for the remainder) is often used in dynamic situations such as ROV or FPSO umbilical's, however it must be designed to length for the specific application. This means expensive bespoke manufacture rather than an off-reel 'cut and terminate' to length solution.

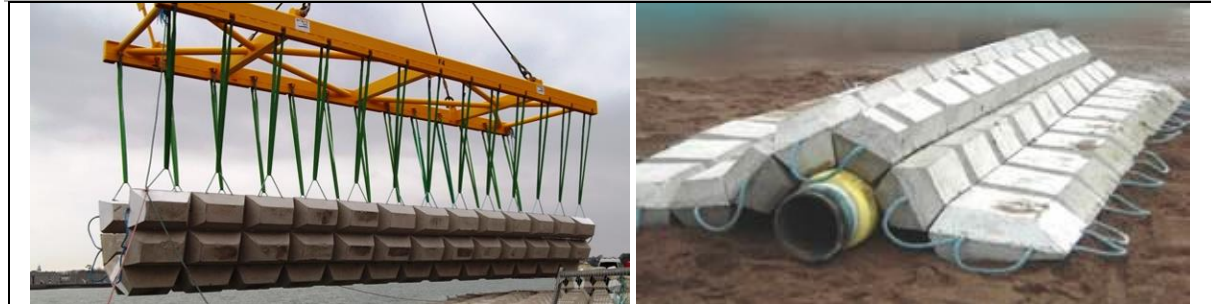
Figure 6.2: Concrete mattresses

Concrete mattresses are made up of flexible segments of concrete, typically held together by polypropylene ropes. They provide both cable protection and stabilisation and are available in a range of standard sizes or can be designed to meet specific requirements. A typical standard size is 6m x 3m x 0.15m with a submerged weight of roughly 2 tonnes. To deploy they are lowered over the cable using a lifting frame, then released automatically. Divers are typically used for accurate placement.

Two hours deployment time is typically required per mattress (largely preparation time), making the deployment cost per metre very high. Mattresses are typically used to provide protection and stability in targeted areas. Costs range from £400 per mattress upwards (excluding delivery), with additional costs for a lifting frame and divers for deployment. Deployment of such mattresses in fierce tidal streams has very seldom been practiced and would incur very significant deployment vessel and operational risks.

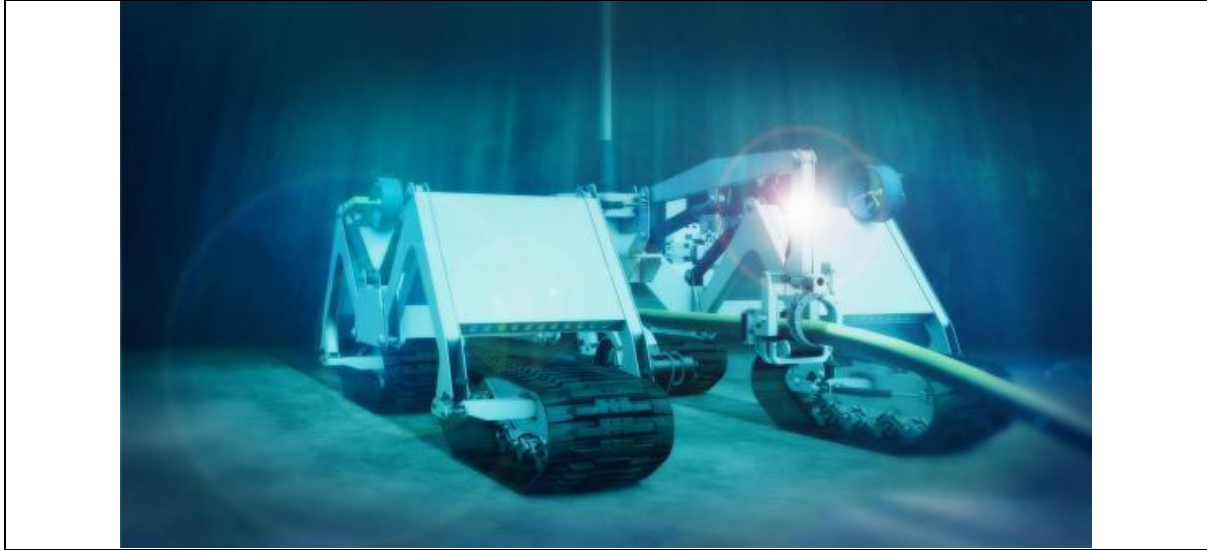
Figure 6.3: Cable trenching plough

This technique is appropriate for sites consisting of sand or clay. However, it is not suitable for tidal sites like the Bluemull Sound which largely consists of hard rock.

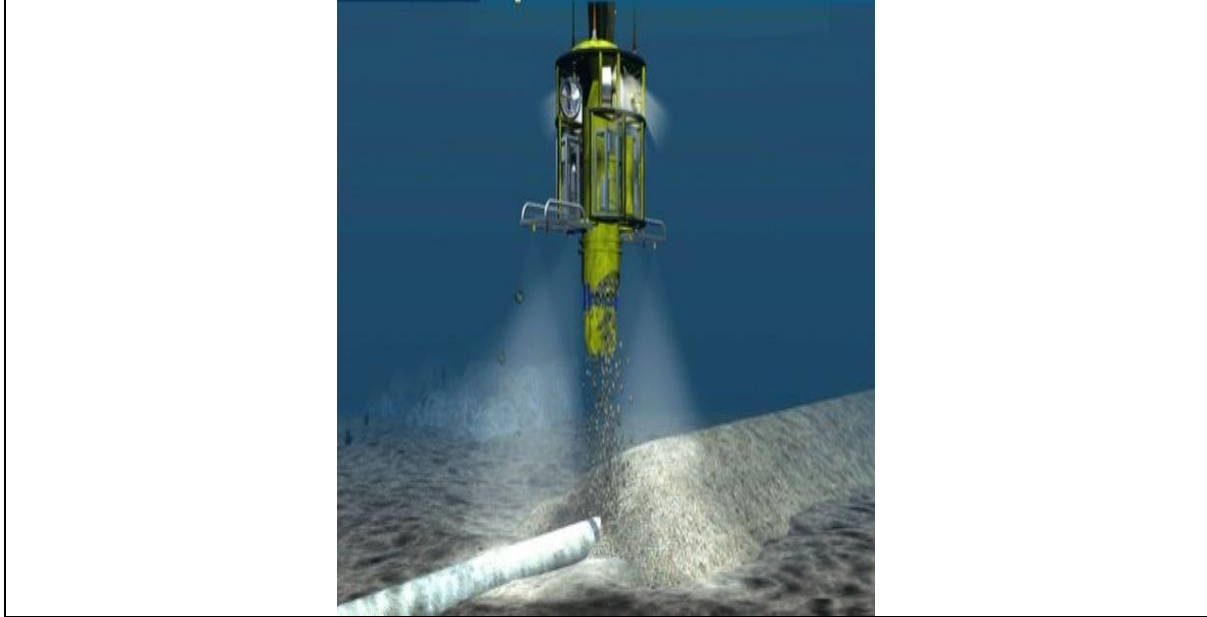
Figure 6.4: Rock dumping via a fall pipe

However, the fact that the Bluemull Sound is largely swept clean of boulders makes clear that berm stability would be an issue, risking cable integrity and ongoing significant annual maintenance costs. Rock dumping remains a snagging risk for fishermen and anchors.

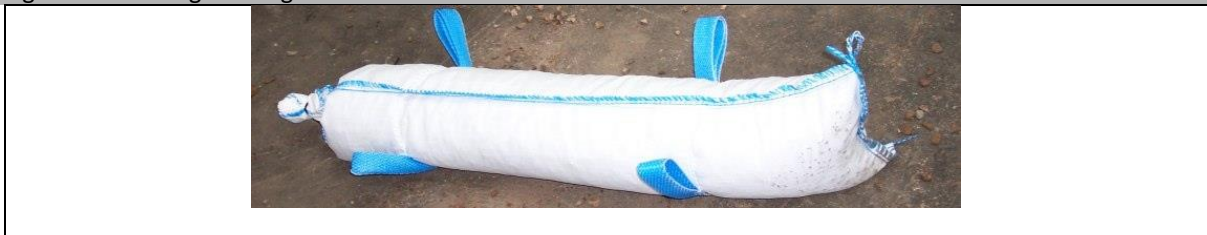
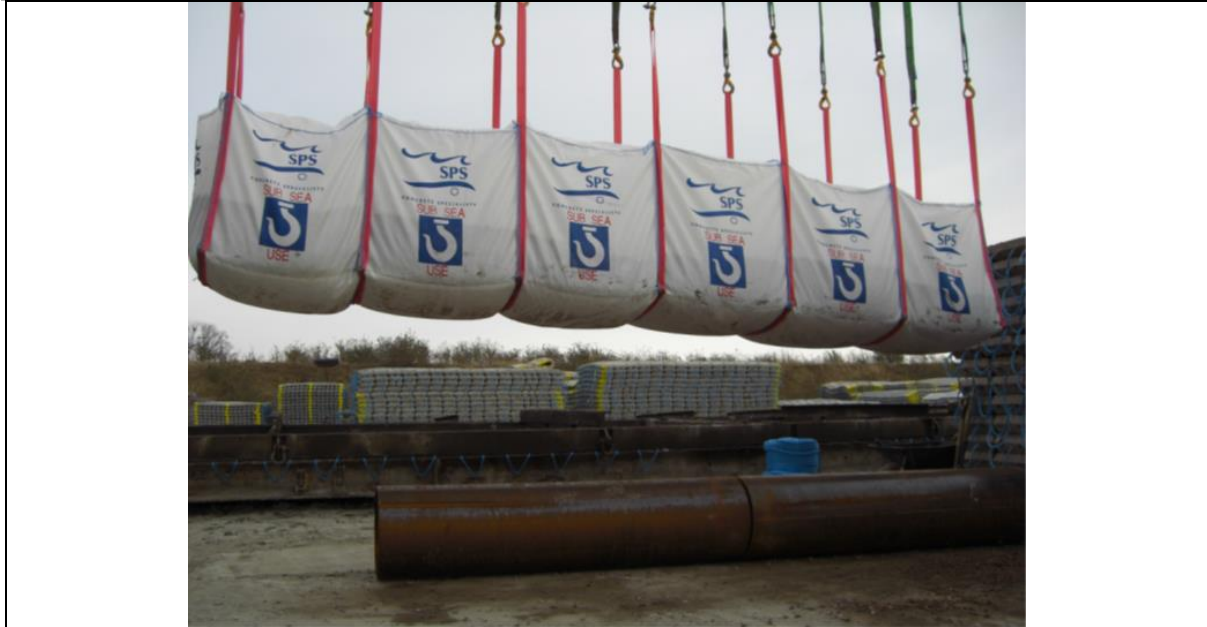
This type of protection could potentially be used to protect the cable; however, as with the analysis for concrete mattresses in Section 0, the bag would need to be carefully designed to ensure this solution would provide any more hydrodynamic stability than a bare cable). In addition, as with concrete mattresses (a) it is not this stabilisation method would not have any positive impact on navigational safety and (b) it would be extremely expensive to use this solution to protect the entire length of cable.
