R100 Orkney Isles Telecommunication Cables

Technical Appendix E - Navigation Risk Assessment

P2308_R5391_Rev3 App E | October 2021

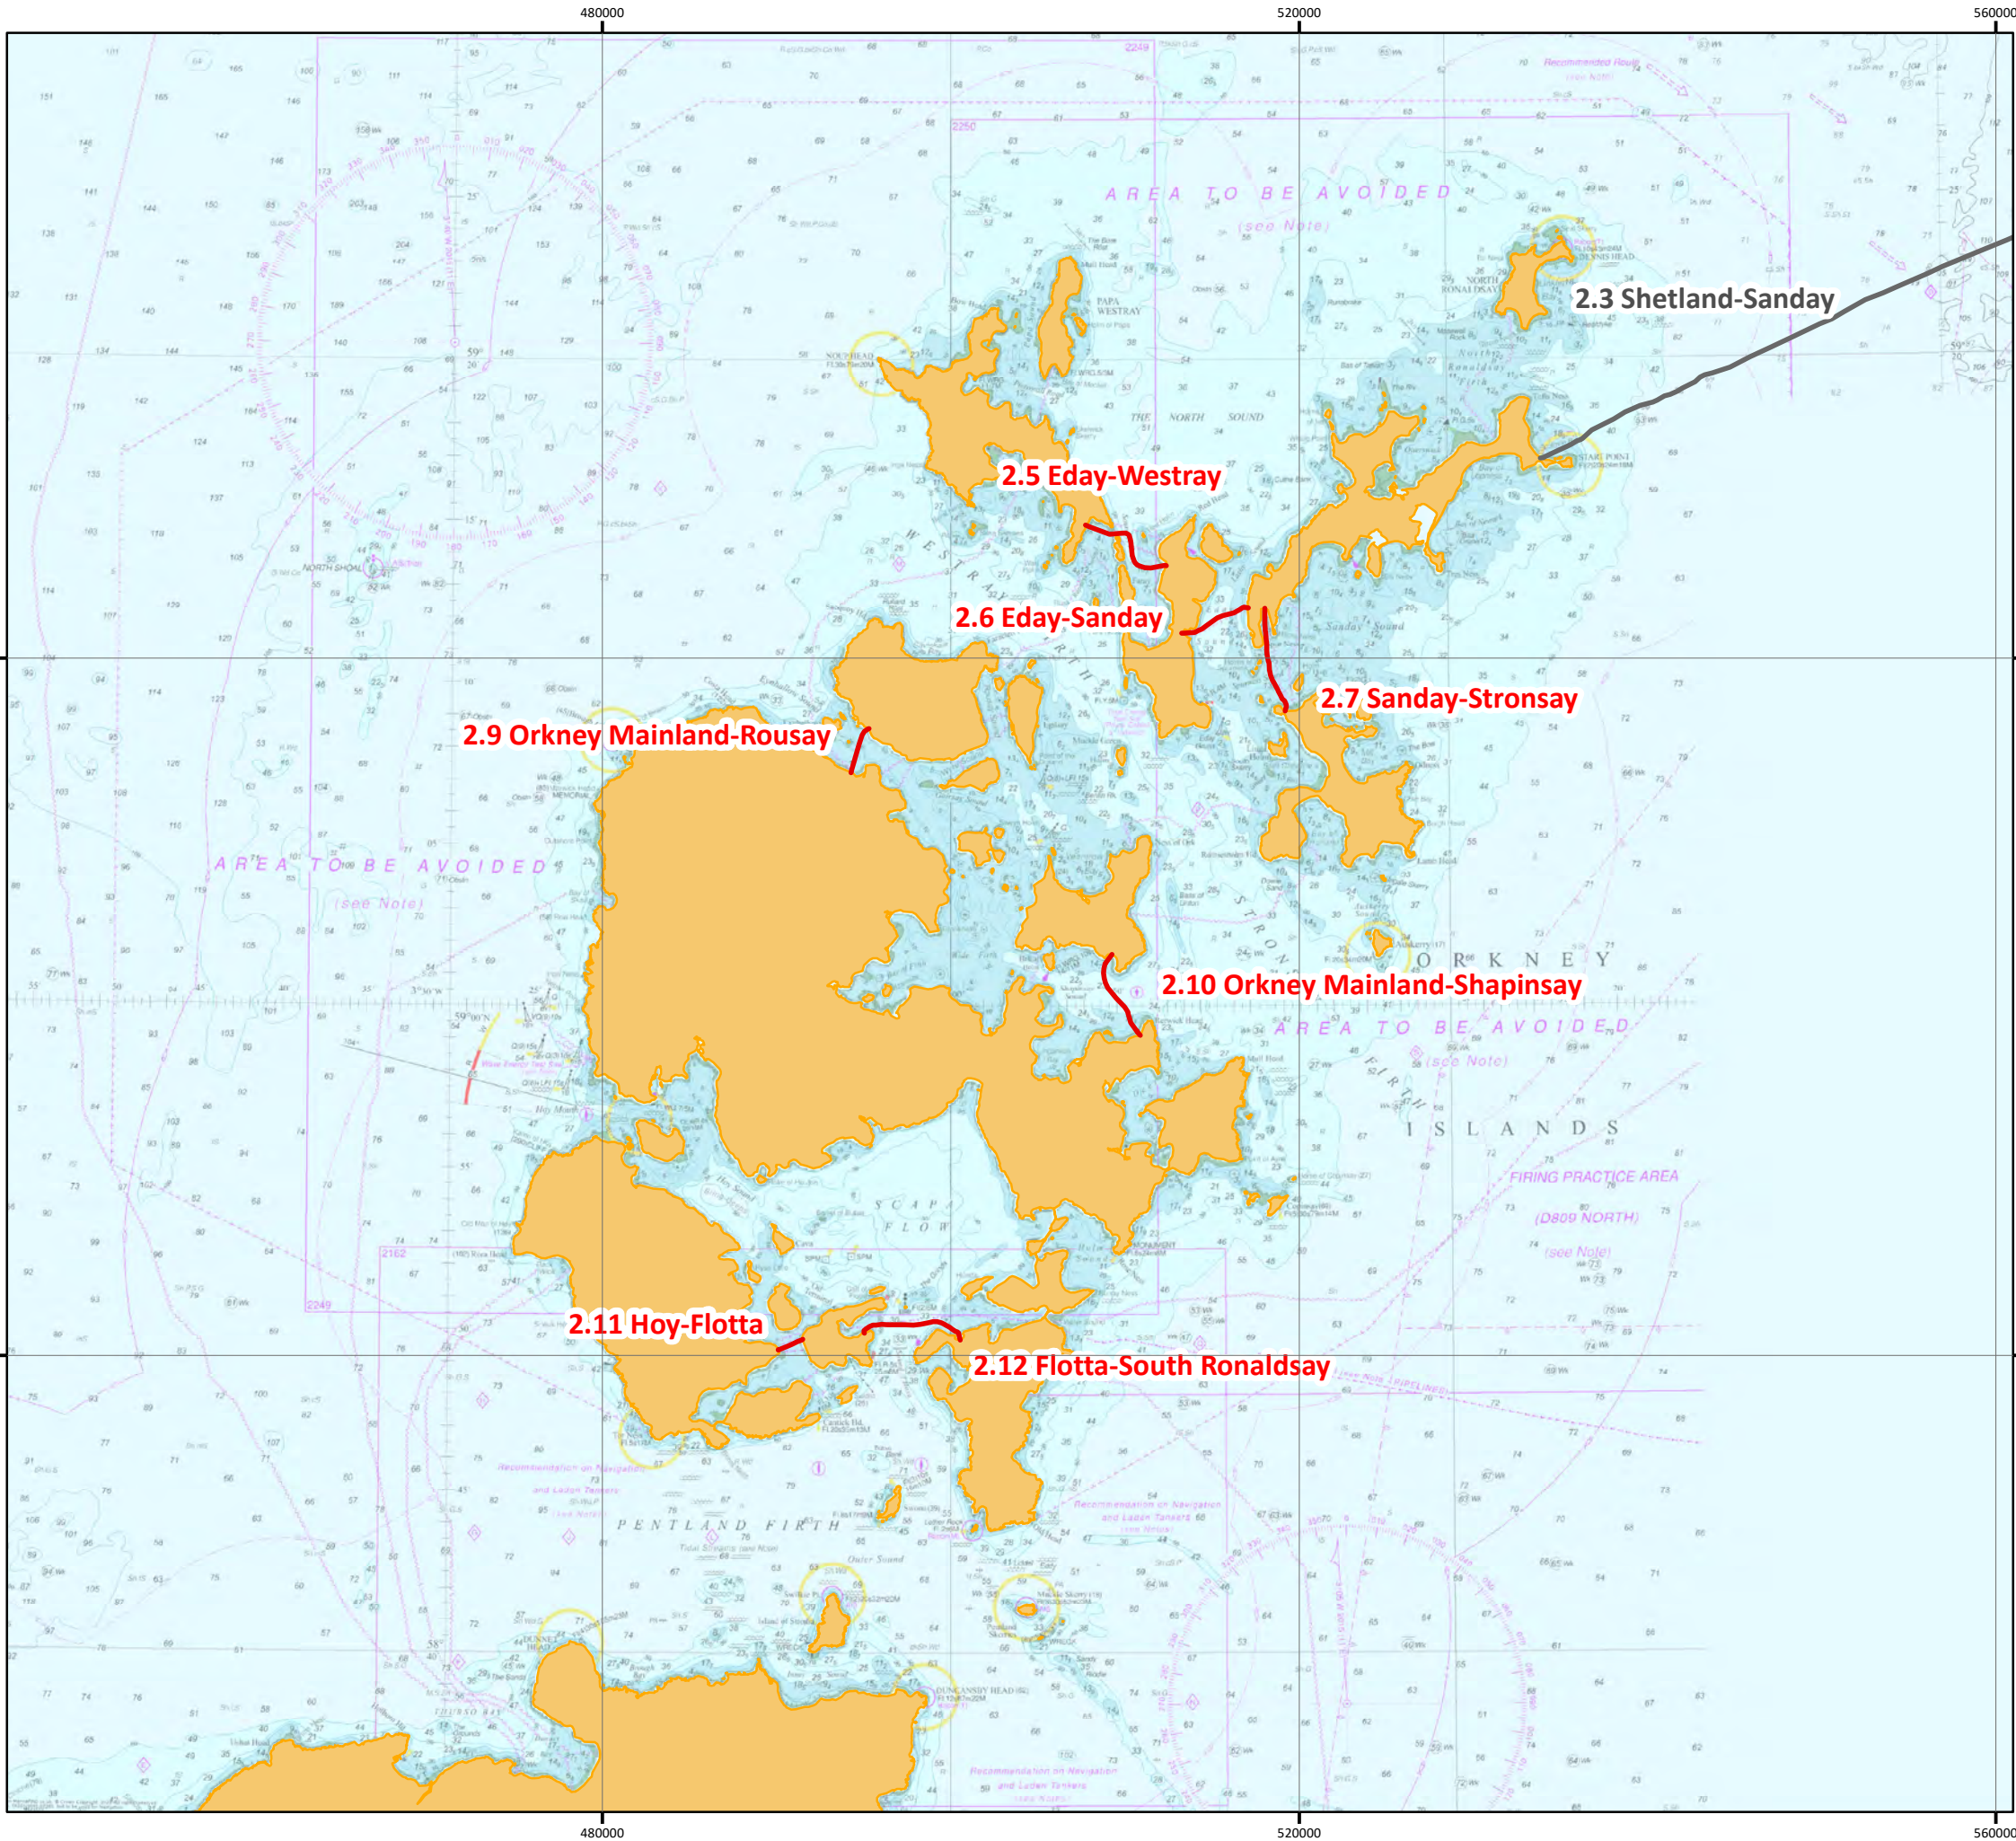
There are seven cable corridors connecting various islands in Orkney highlighted in **Figure 1-1** (P2308-LOC-001_OR) (*Note that Cable Corridor 2.3 Shetland-Sanday is not included in this assessment and is assessed in Shetland NRA ref P2308_R5367*). Details of cable corridor landing points and positions are described in **Table 1-1**.

LOCATION OVERVIEW
Cable Route Centre Lines - Orkney

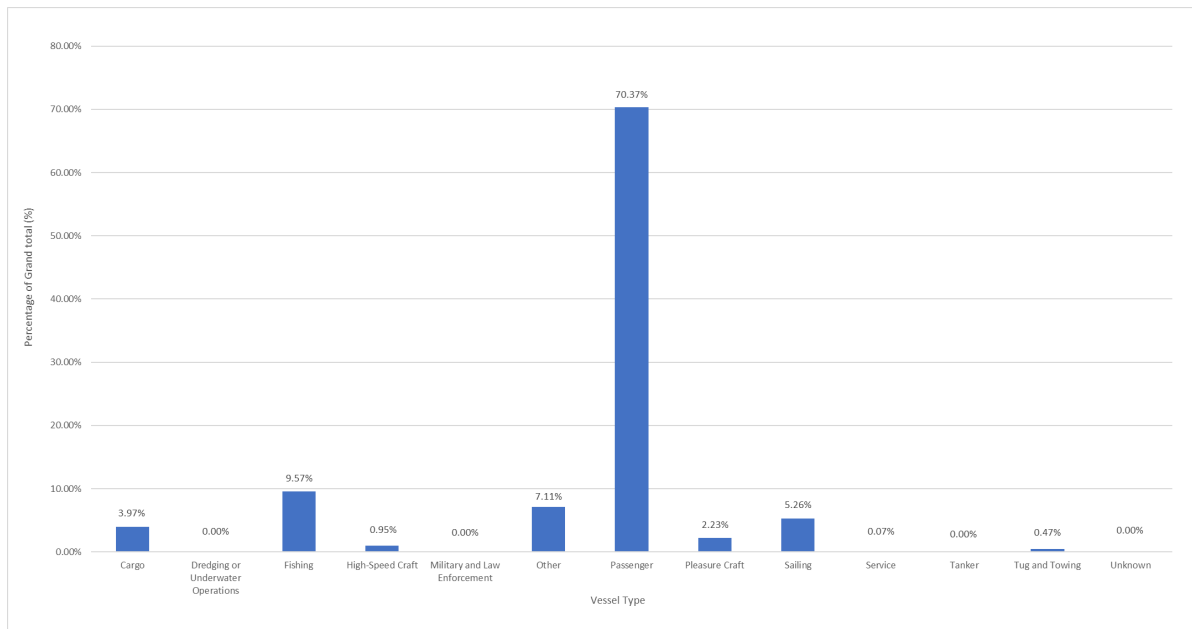
Figure 3-3 Vessel Distribution Across the 2.5 Eday – Westray Study Area

A total vessel density of 1352 hours per month were recorded across the study area in 2019. The percentages of the vessel categories are presented in **Figure 3-3**. Passenger vessels make up nearly all of the data (70%).

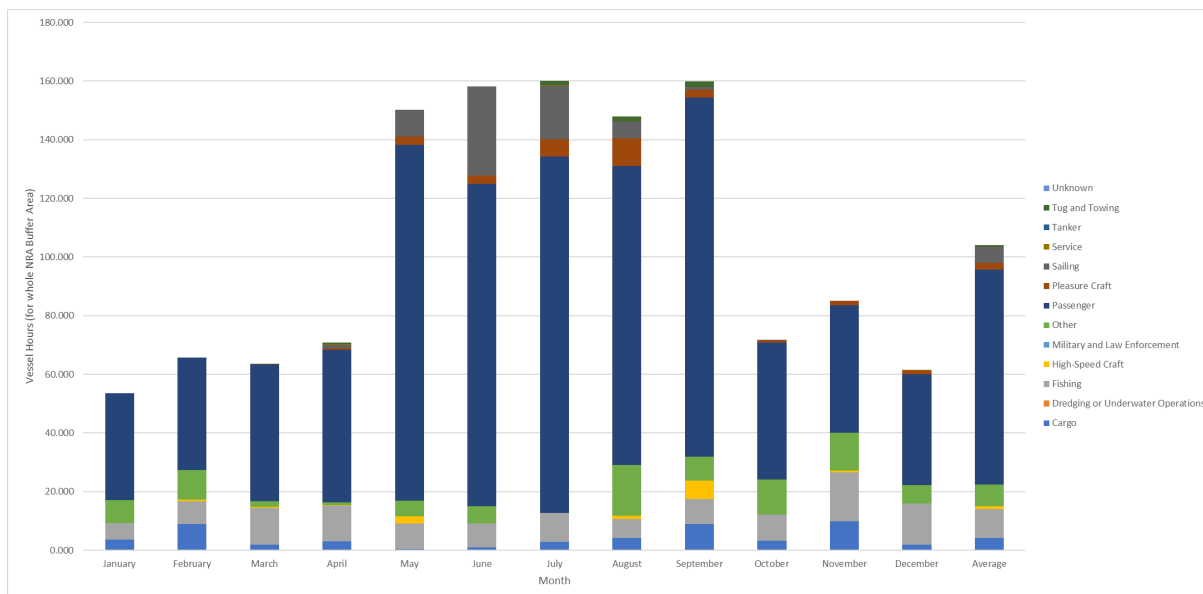
Figure 3-4 Seasonality Changes in Vessel Traffic Across the 2.5 Eday-Westray Study Area

Seasonal distribution of the vessel traffic has been analysed in across the study area and the busiest months are observed to between May and September. **Figure 3-4** highlights the seasonal changes.

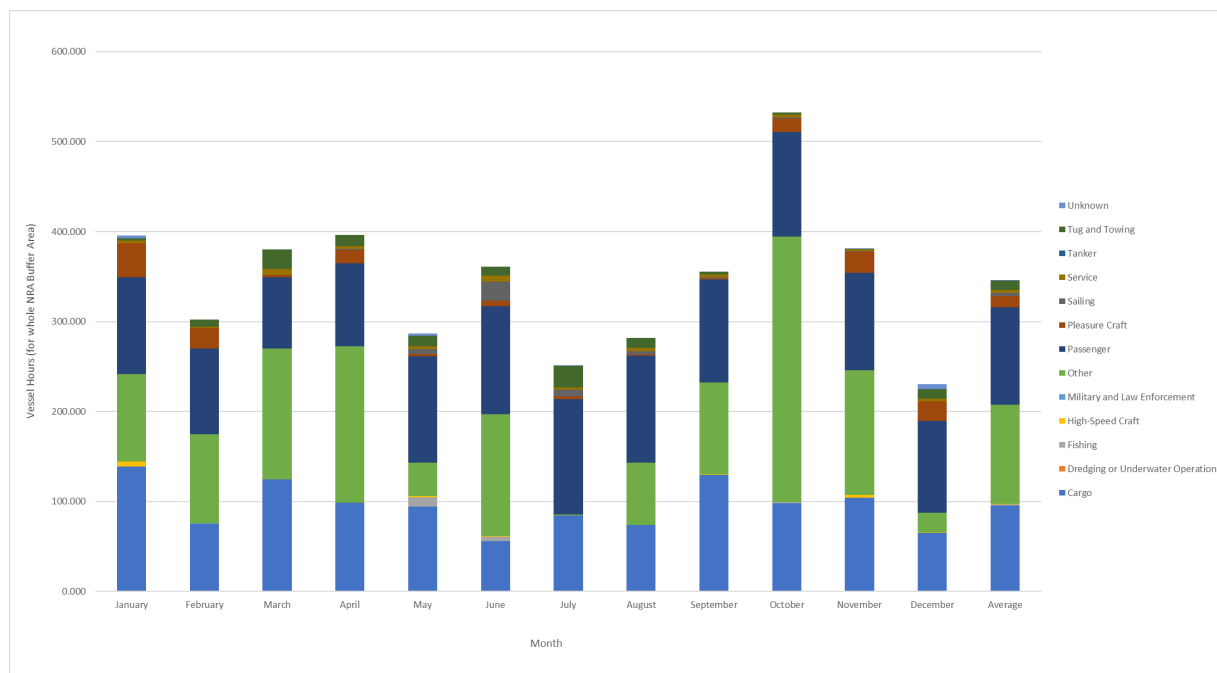
Figure 3-8 Seasonality Changes in Vessel Traffic Across the 2.6 Eday – Sanday Study Area

Seasonal distribution of the vessel traffic has been analysed in across the cable corridor and the busiest month is observed to be October. **Figure 3-8** highlights the seasonal changes.

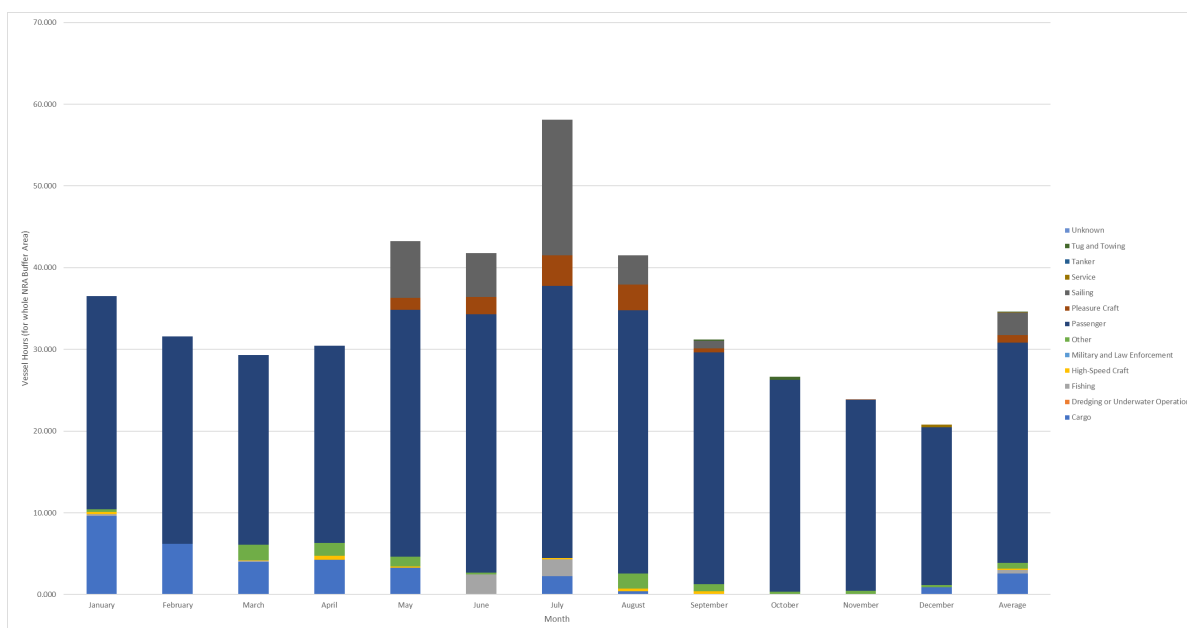
Figure 3-12 Seasonality Changes in Vessel Traffic Across the 2.7 Sanday Stronsay Study Area

Seasonal distribution of the vessel traffic has been analysed in across the cable corridor and the busiest months are observed between July and August. **Figure 3-12** highlights the seasonal changes.

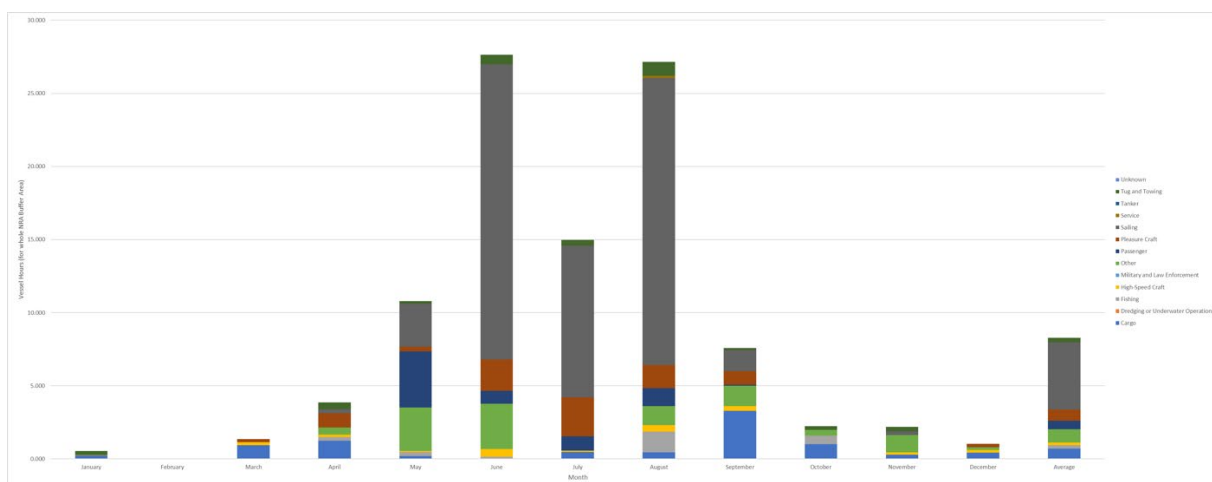
Figure 3-16 Seasonality Changes in Vessel Traffic Across the 2.9 Orkney Mainland – Rousay Study Area

Seasonal distribution of the vessel traffic has been analysed in across the cable corridor and the busiest months are observed between July and August. **Figure 3-16** highlights the seasonal changes.

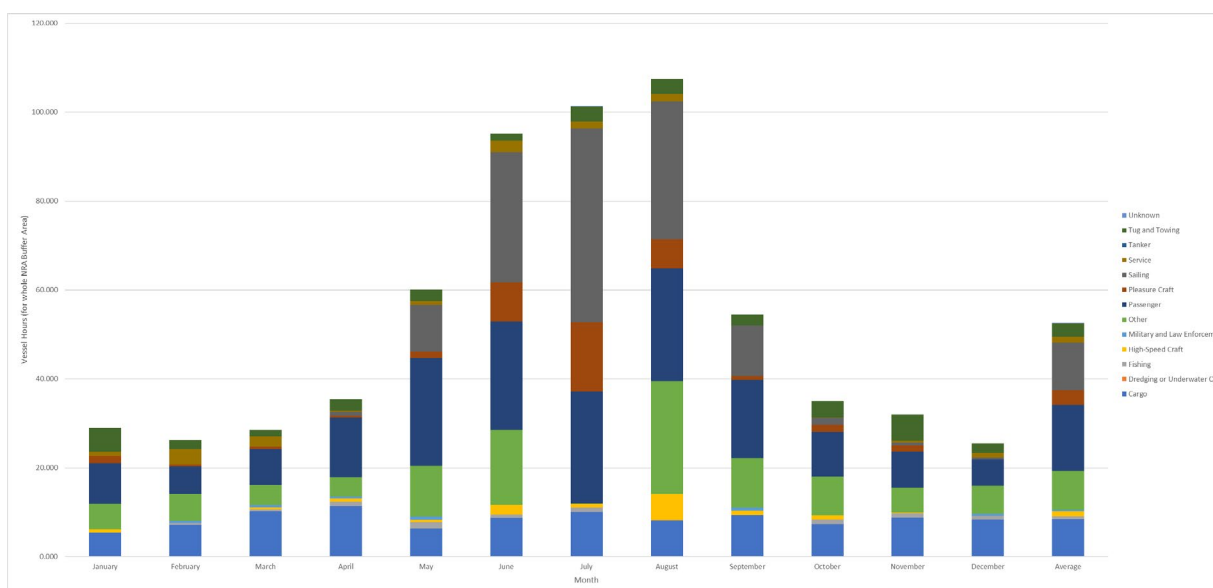
Figure 3-19 Seasonality Changes in Vessel Traffic Across the 2.10 Orkney Mainland - Shapinsay Study Area

Seasonal distribution of the vessel traffic has been analysed in across the cable corridor and the busiest months are observed between July and August. **Figure 3-19** highlights the seasonal changes noting an increase in sailing vessels between these months.

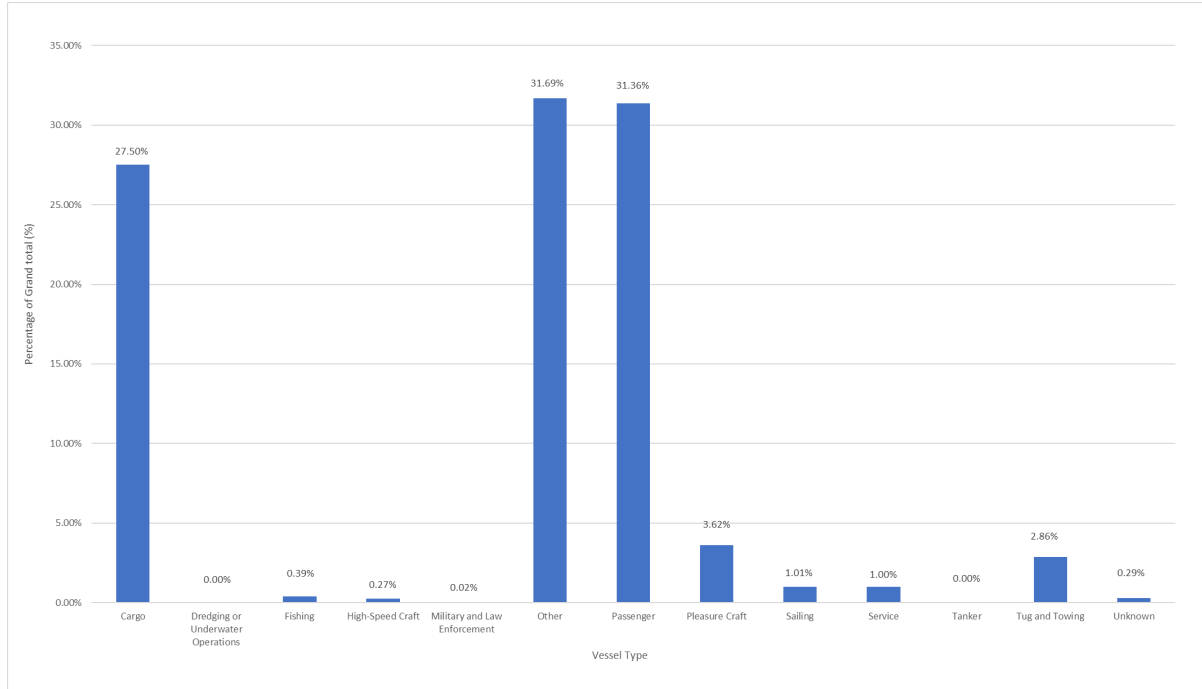
Figure 3-22 Vessel Distribution Across the 2.11 Hoy – Flotta Corridor

A total vessel density of 4500 hours per month were recorded across the cable corridor in 2019. The percentages of the vessel categories are presented in **Figure 3-22**. Cargo, Other and Passenger vessels all make up around 30% of the data.

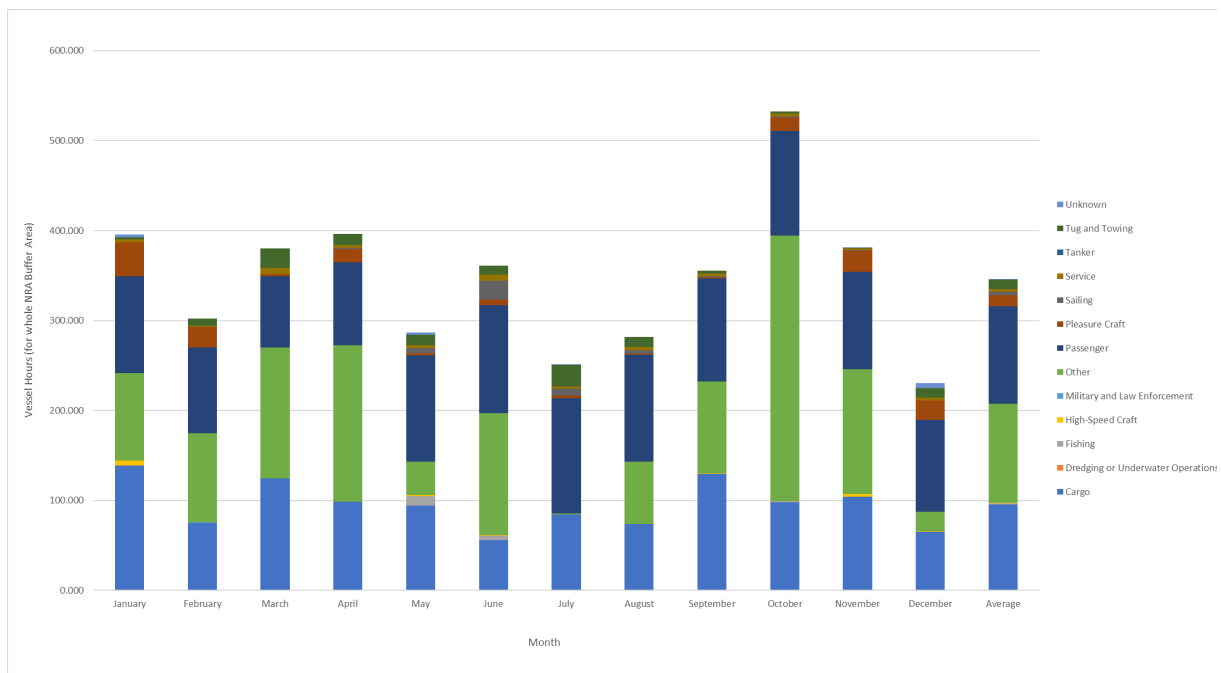
Figure 3-23 Seasonality Changes in Vessel Traffic Across the 2.5 Hoy - Flotta Corridor

Seasonal distribution of the vessel traffic has been analysed in across the study area and the busiest month is observed to be October, although they are largely similar throughout the year. **Figure 3-23** highlights the seasonal changes.

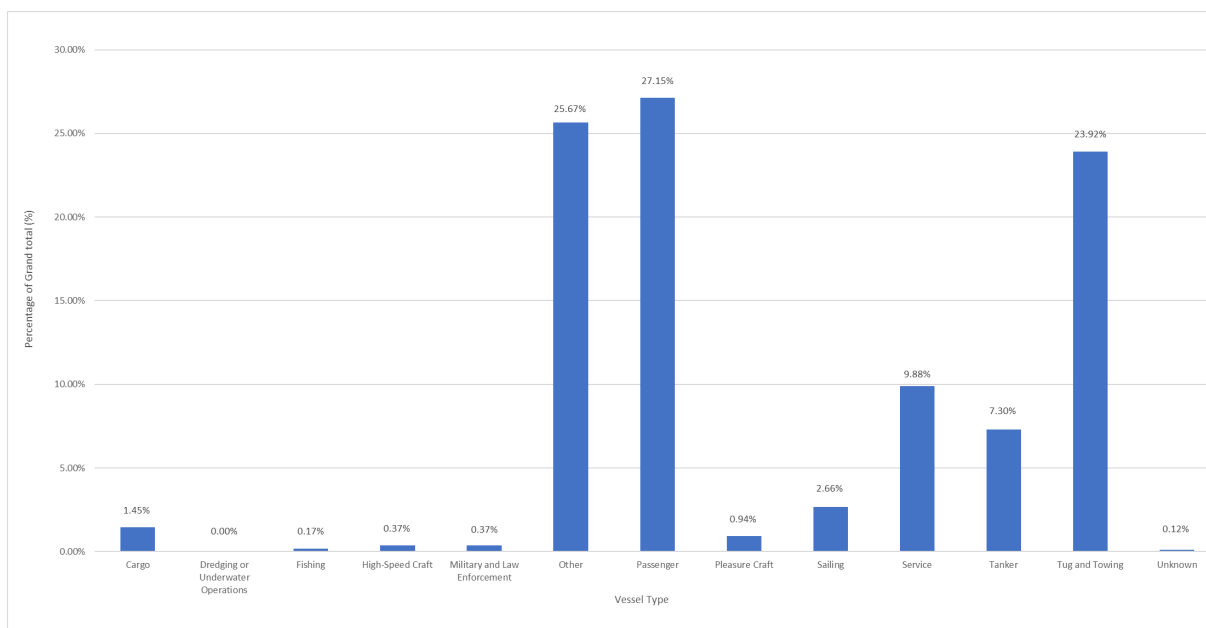
Figure 3-27 Vessel Distribution Across the 2.12 Flotta – South Ronaldsay Study Area

A total vessel density of 1421 hours per month were recorded across the study area in 2019. The percentages of the vessel categories are presented in **Figure 3-27**. The vessels that make up the majority of the data are passenger 27%, Other 25%, and Tug & Towing making up 23%.

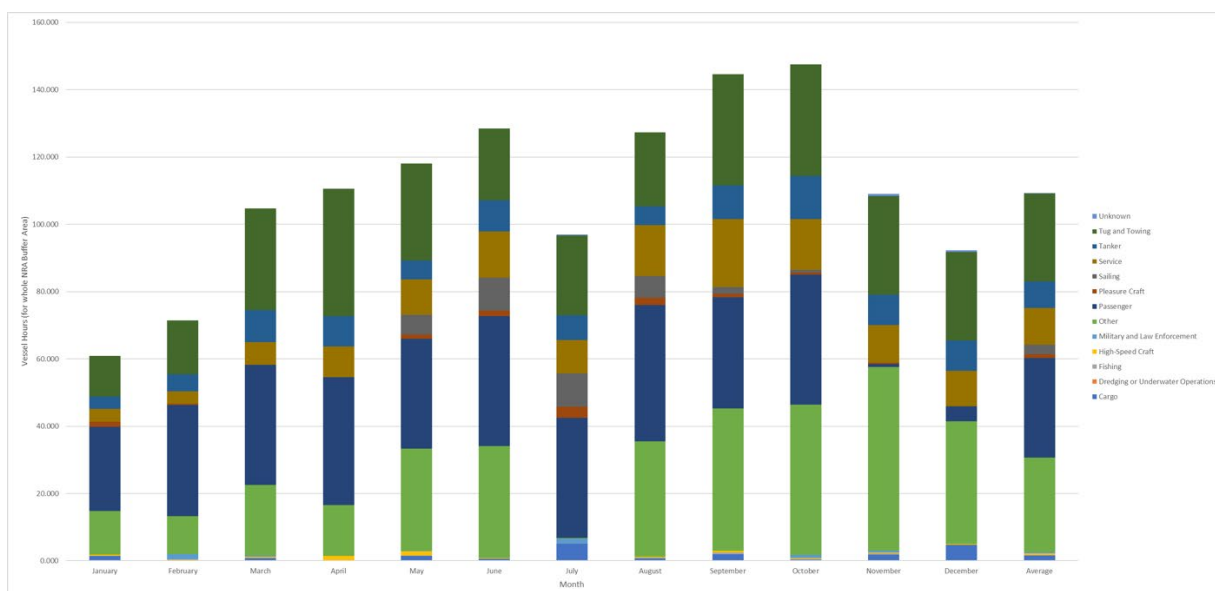
Figure 3-28 Seasonality Changes in Vessel Traffic Across the 2.12 Flotta – South Ronaldsay Study Area

Seasonal distribution of the vessel traffic has been analysed in across the study area. There isn't much variation between the months with the least busy observed in January and February. **Figure 3-28** highlights the seasonal changes.

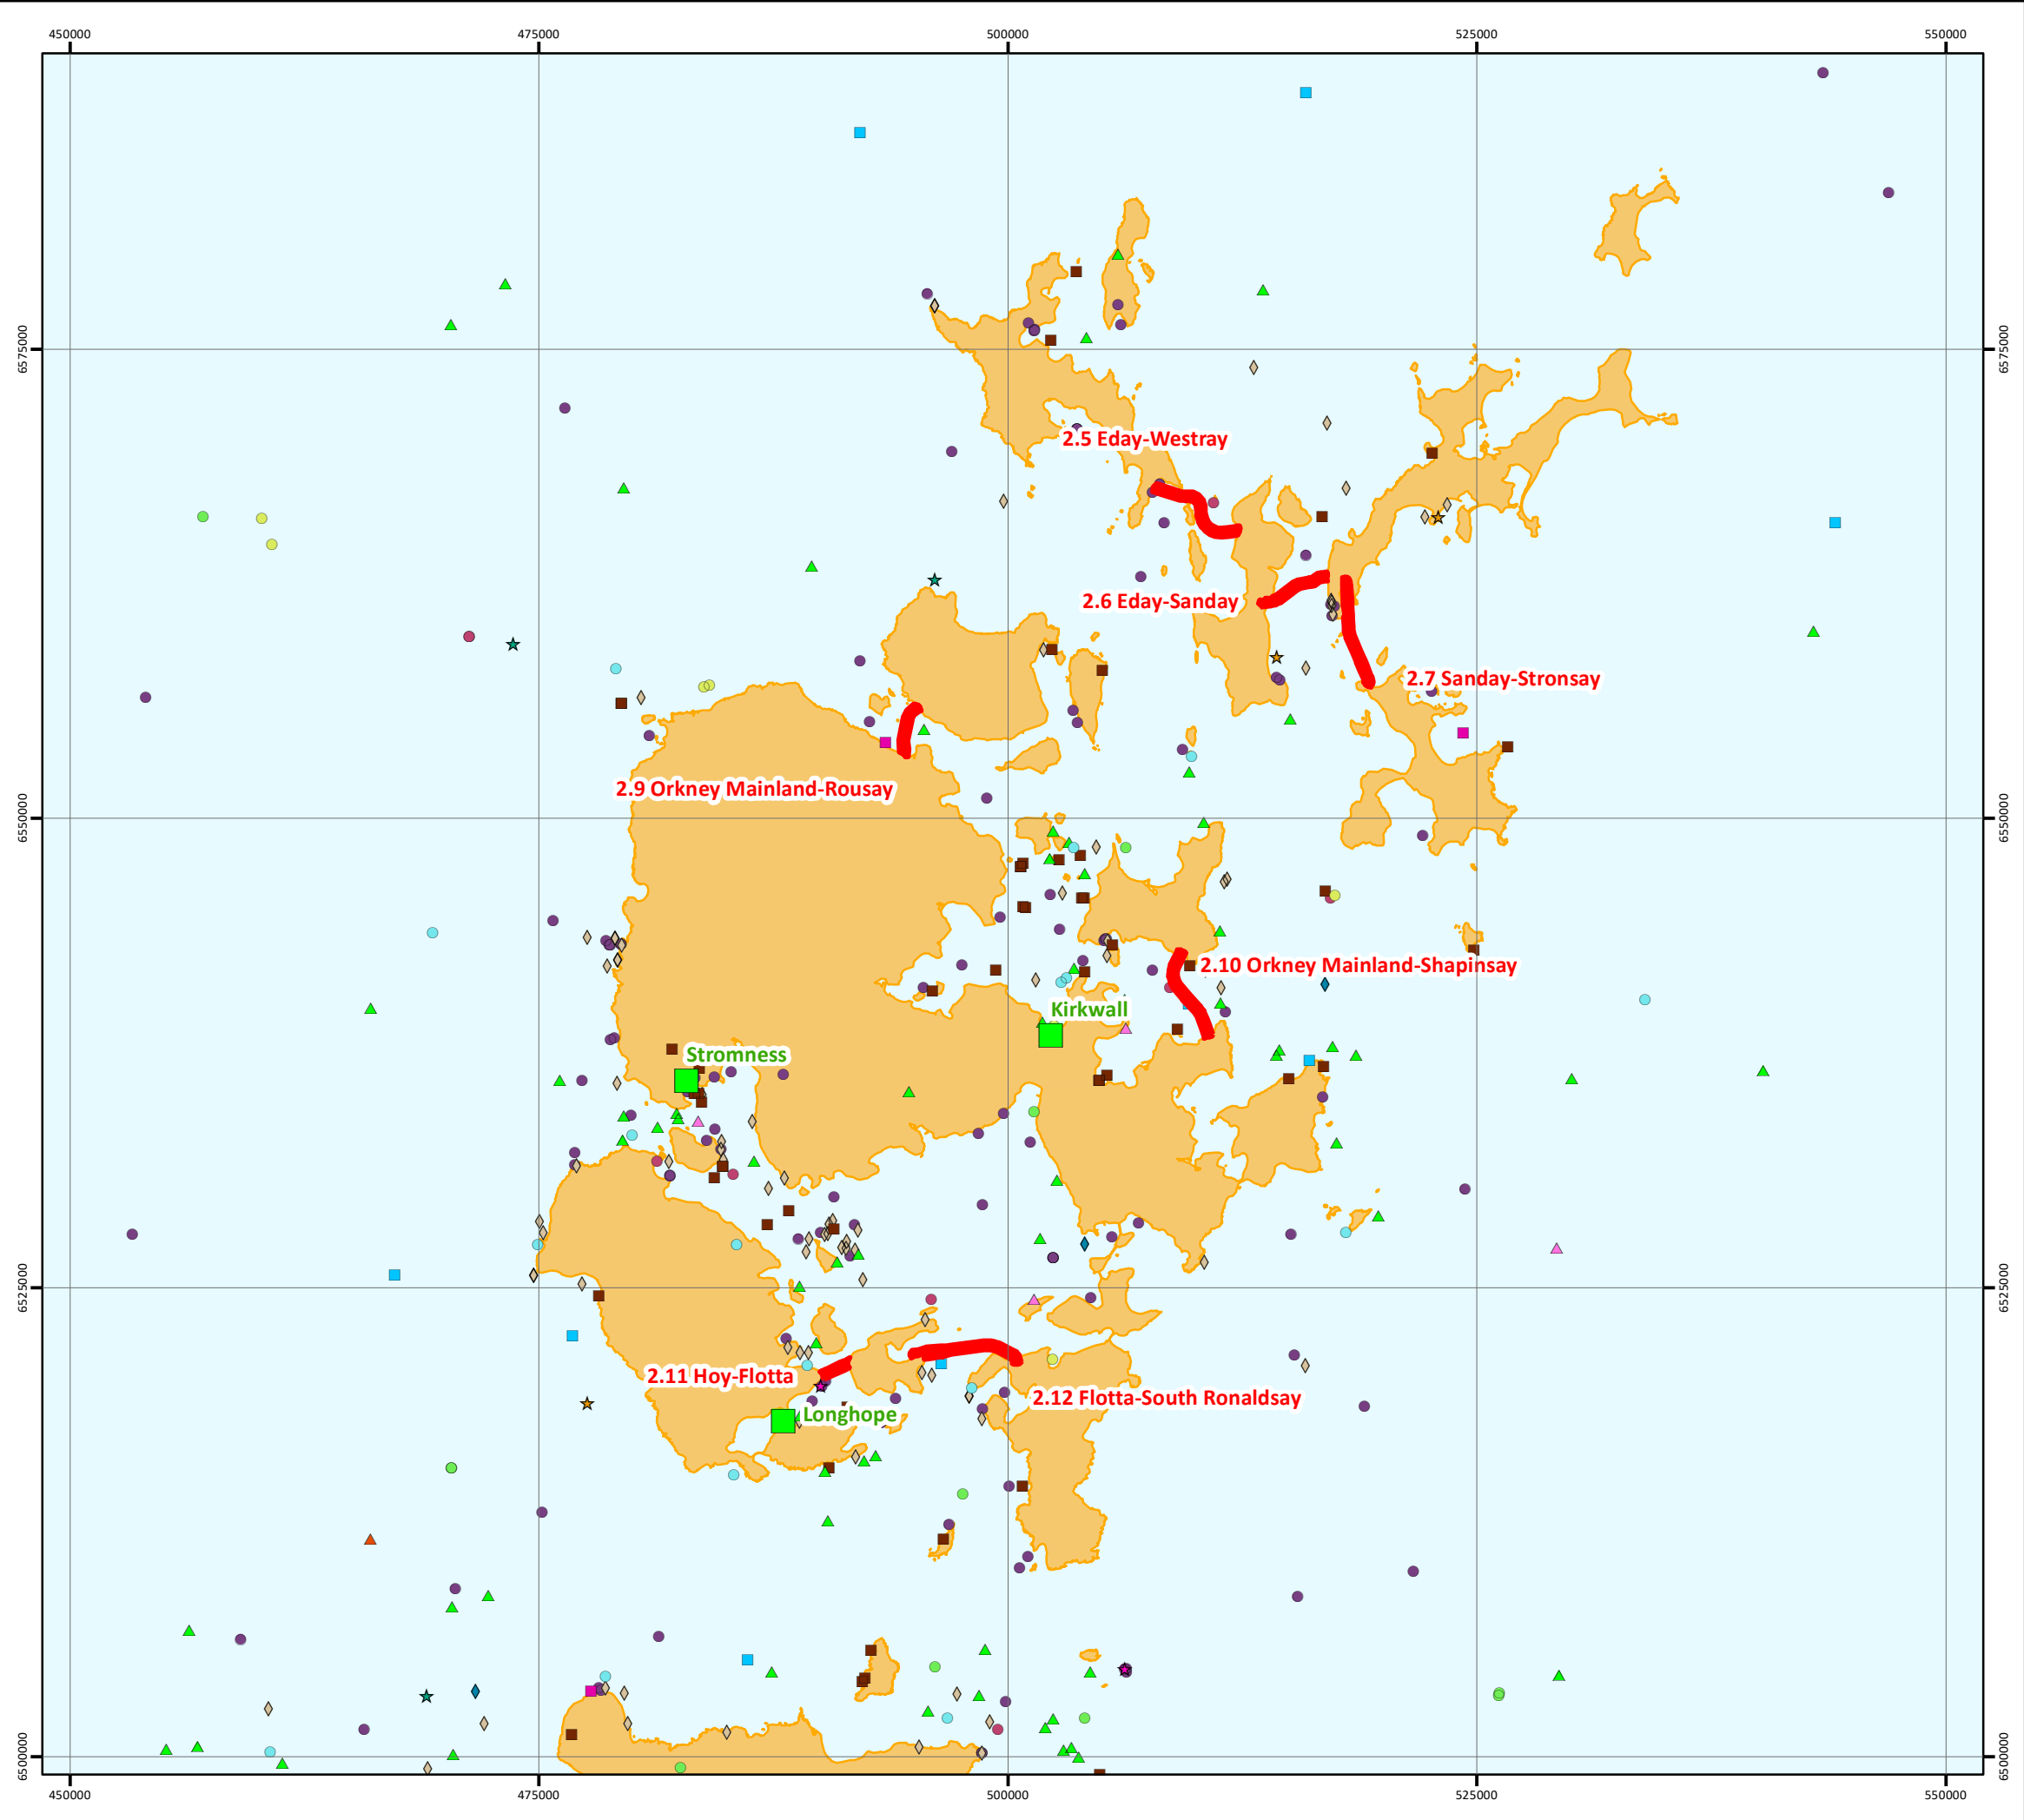
Figure 3-40 (P2308-RNLI-001_OR) presents the locations of incidences recorded by the RNLI.

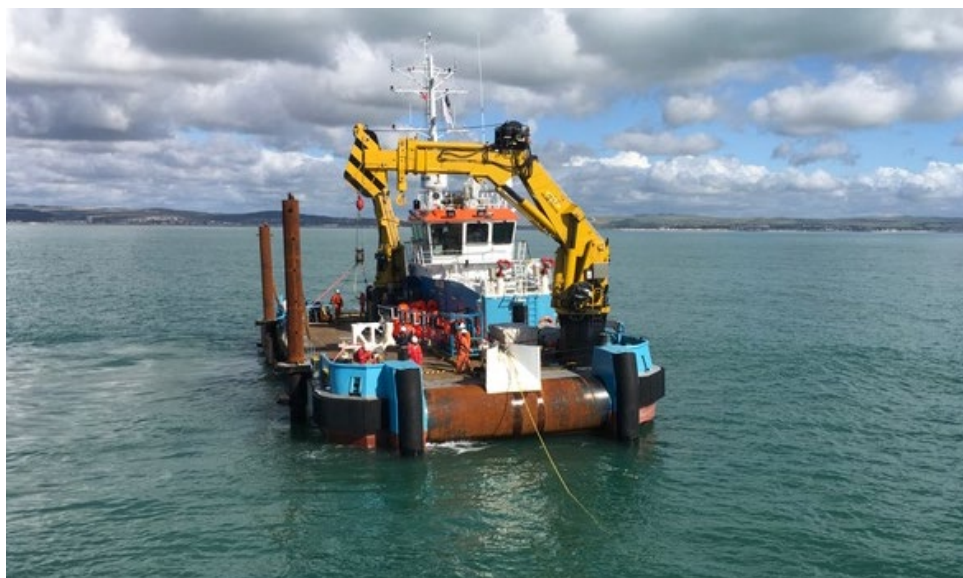
Figure 2-5 Typical multicat

A multicat (Figure 2.5) can be mobilised to support either cable installation or cable burial operations in shallow water areas where the main lay vessel cannot access. The vessel would be mobilised with a small deck spread to support cable storage and installation equipment as cable engine and cable chute, along with a burial tool and support equipment.

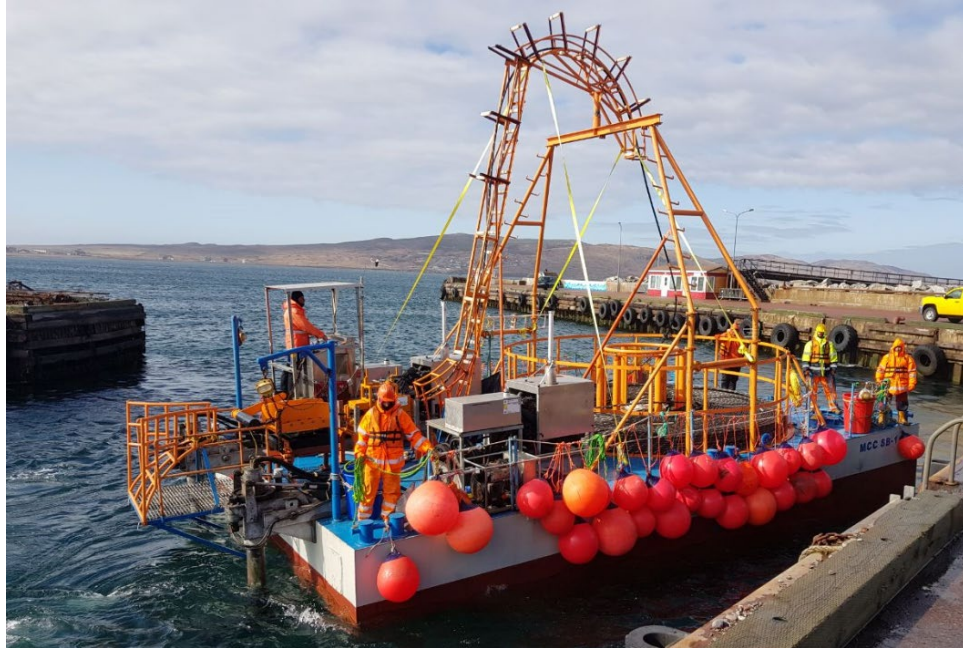
Figure 2-6 Barge

A self-propelled barge can be mobilised to support either cable installation or cable burial operations in shallow water areas where the main lay vessels or multicats cannot access (Figure 2.6). The vessel would be mobilised with a small deck spread to support cable storage and installation equipment as cable engine and cable chute, along with a burial tool and support equipment. Anchor/clump weights will be deployed from a support vessel or from the barge in advance of the works.

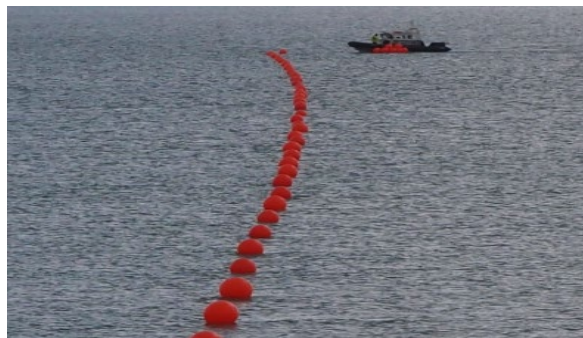
Figure 2-7 Typical shallow water vessel

For all shore end and shallow water operations, multiple small inshore vessels (such as RIBs) will be used to support the cable pull in, the lowering of the cable onto the seabed and any burial of the cable in waters depths less than 15m (Figure 2.7).

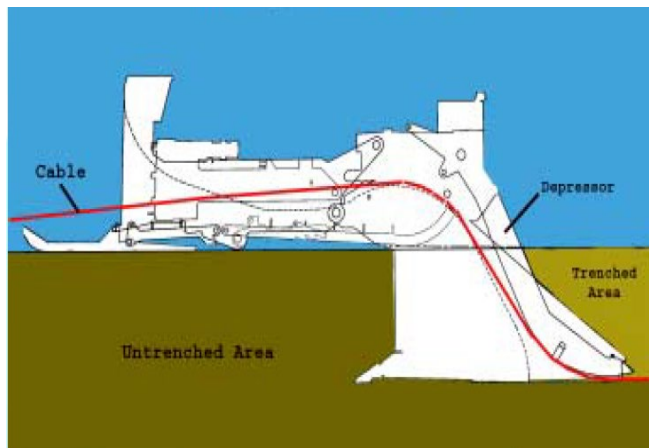
Figure 2-9 Plough schematic

The MLV will lay away from the first shore end and bury the cable via the plough as described in Section 2.5.2.2 below. There will be certain sections (such as in areas of hard ground and at crossings (if any)) where the cable will be laid on the surface of the seabed and will not be ploughed (Section 2.5.3).

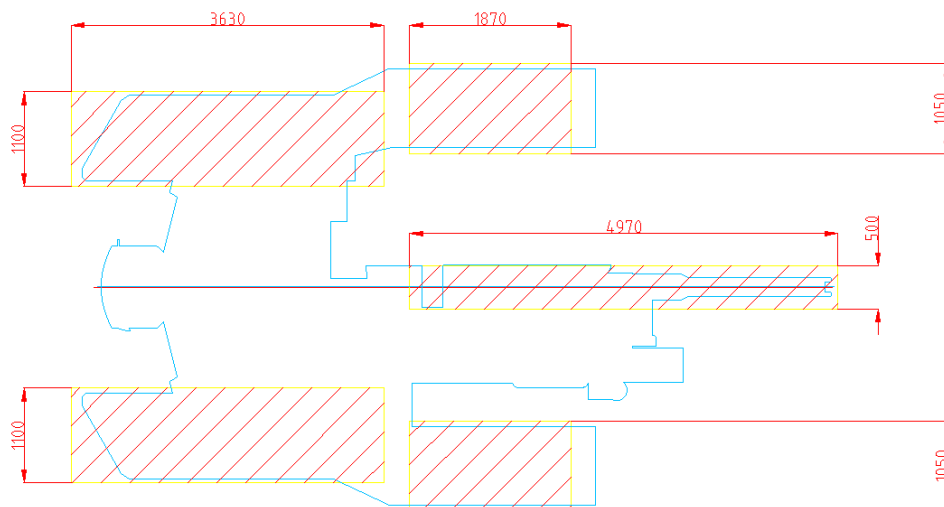
Figure 2-10 Plough footprint

The skids have an approximate footprint of 7m² per skid and the share footprint is approximately 2.45m². The plough share width is approximately 0.5m. The dimensions of the plough in contact with the seabed is outlined in Figure 2-10 and demonstrated by the hatched areas. The plough dimensions are indicative of the size of equipment to be used. Burial by plough will be carried out at a minimum rate 600m/ hour.

Note: measurements are in millimetres (mm)

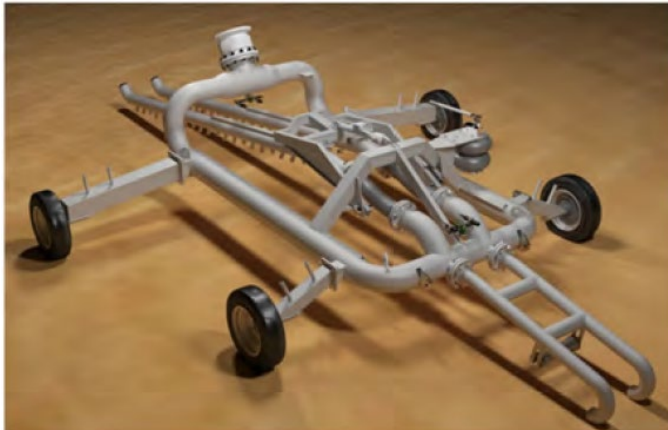
Figure 2-14 Typical diver assisted jet burial tool

An ancillary support vessel will set up close to the landfall and the burial tool will be deployed to the beach where the cable will be loaded into the tool. Having run up the water pump, the jet legs will then be lowered to the required PLB depth as it is slowly commencing burial. This operation will continue until the burial tool approaches the plough down position, when it will be recovered to the ancillary support vessel, and divers will post-lay bury the final section of cable using surface fed burial lances. PLB of the inshore section could also take place from the plough down position towards the beach.
