SITE PHOTOGRAPHS

05/07/2023

ERECT A SEAWALL AND RECLAIM LAND

Atlantis Lodges, (land near), Finstown, Orkney, KW17 2EH

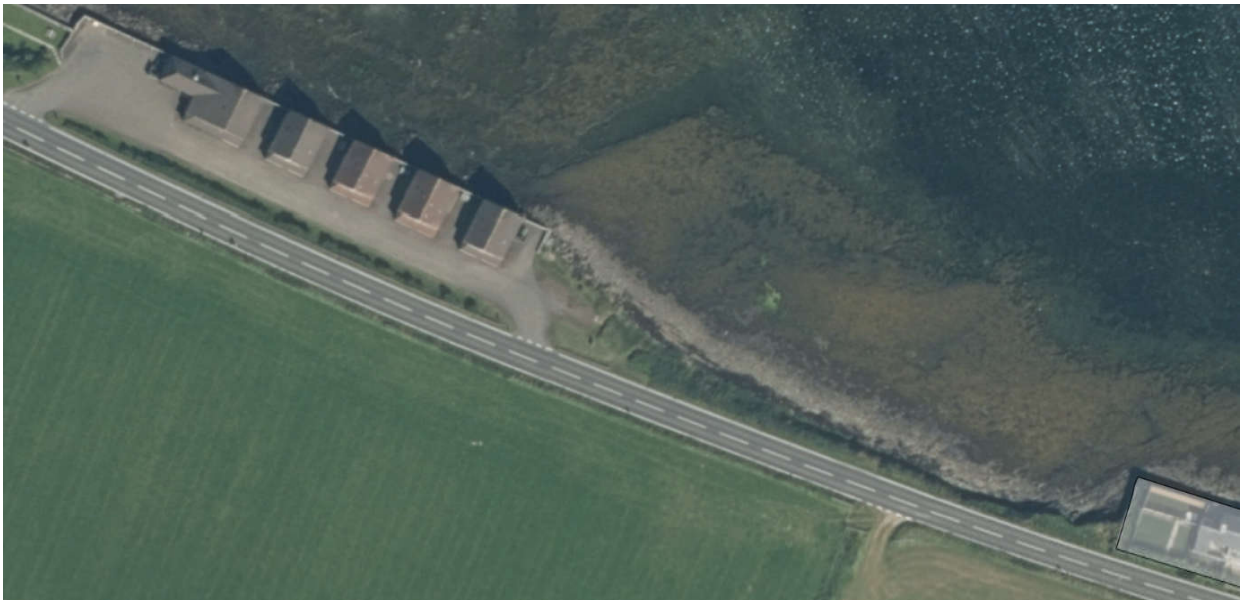
Aerial view of the site, pre development, the five Atlantis Lodges on the left, note the accretion of material to the east of the existing seawall and the shadow indicating the natural cliff line.

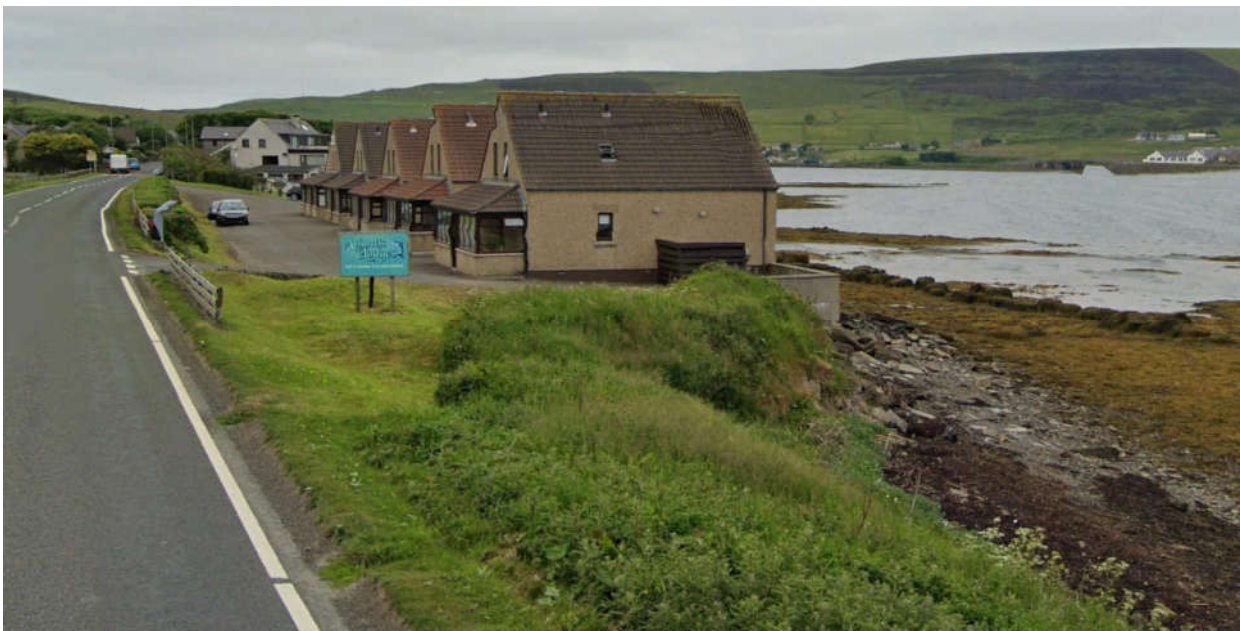
Pre development view of the site from the south east. A965 public roadway on the left. Road drainage 'offlets' in the foreground leading to a wide swale like verge.

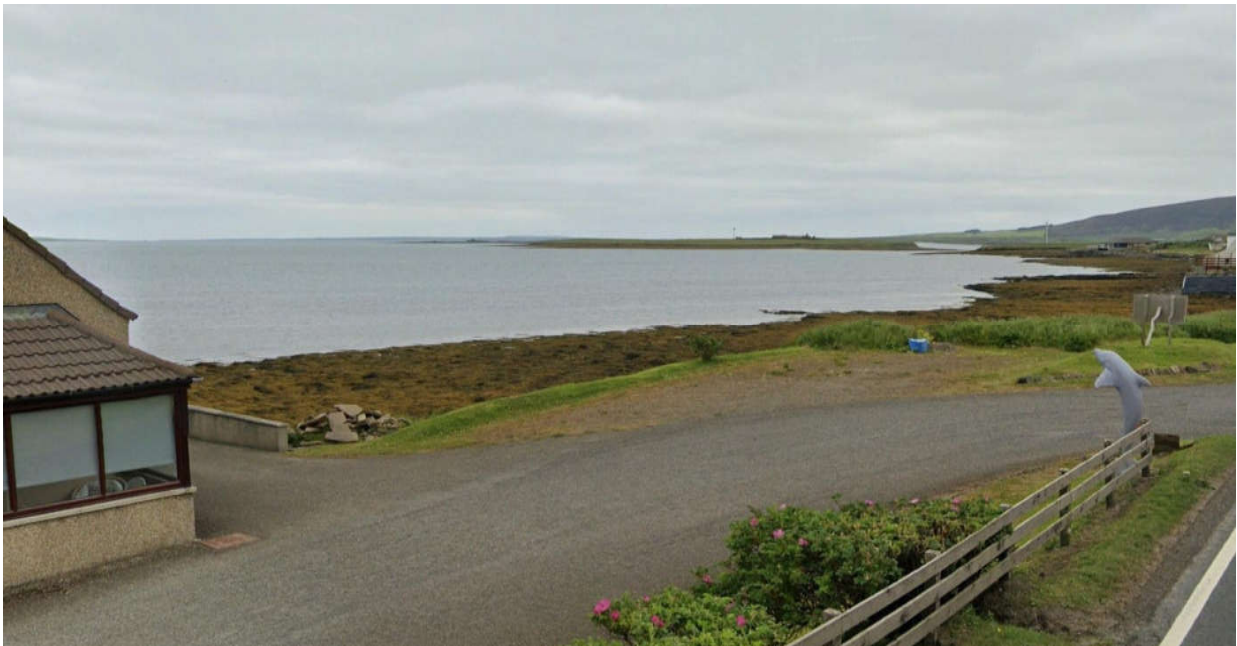
Pre development view of the site from the west. A965 roadway edge marking on the right.

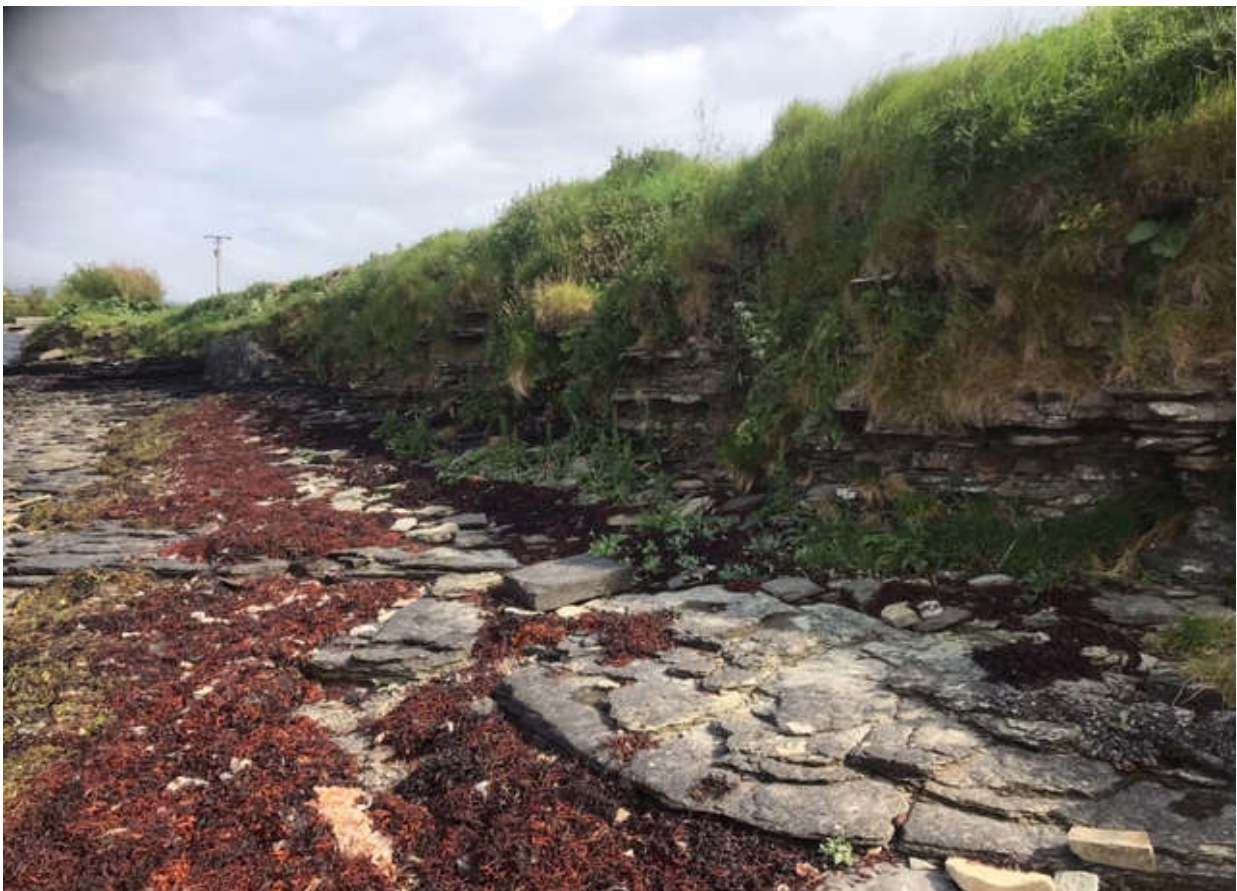
Natural shore profile immediately to the east of the proposed termination of the terraced stonework against the vertical bedrock cliff. Note the exposed bedrock backshore and near horizontal bedding
