BRIDGE DETAILED & HCE EXAMINATION REPORT

ELR: WCM2	Contract Mileage: 102 m 0088 yds 4.00 ch			Struc. Ref 031/082A	
Examination Type:	Additional Assess HCE	NR ID:	11016334	Exam Date:	14-Feb-2012
Area:	Scotland West	BRS:	0	OS Ref:	NS58716475
Structure Name:	NEW CLYDE BRIDGE	Type:	BU	Exam ID	305231
Route:	Gretna - Glasgow Central (via Beattock)	Complete Examination:		N/A

OS Ref: NS58716475 BRS: Name: NEW CLYDE BRIDGE

The remit was to examine structural elements affected by HCE code MJA in accordance with document HCE – Codes v1.5.

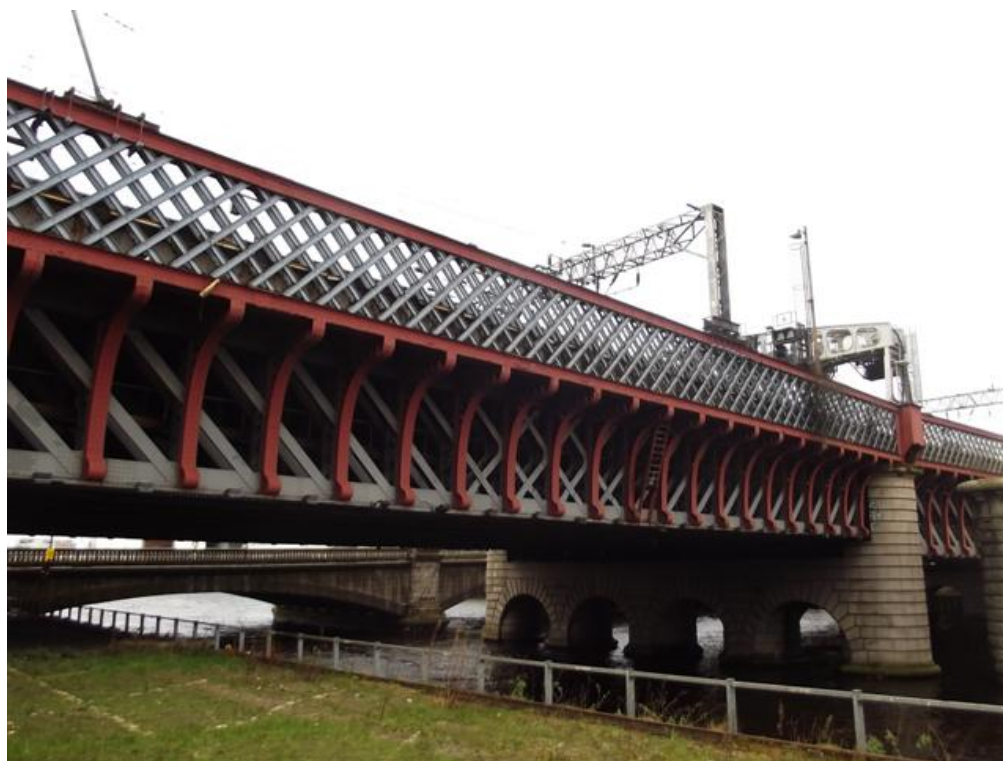
Photograph 1 – Typical elevation (14/02/2012).

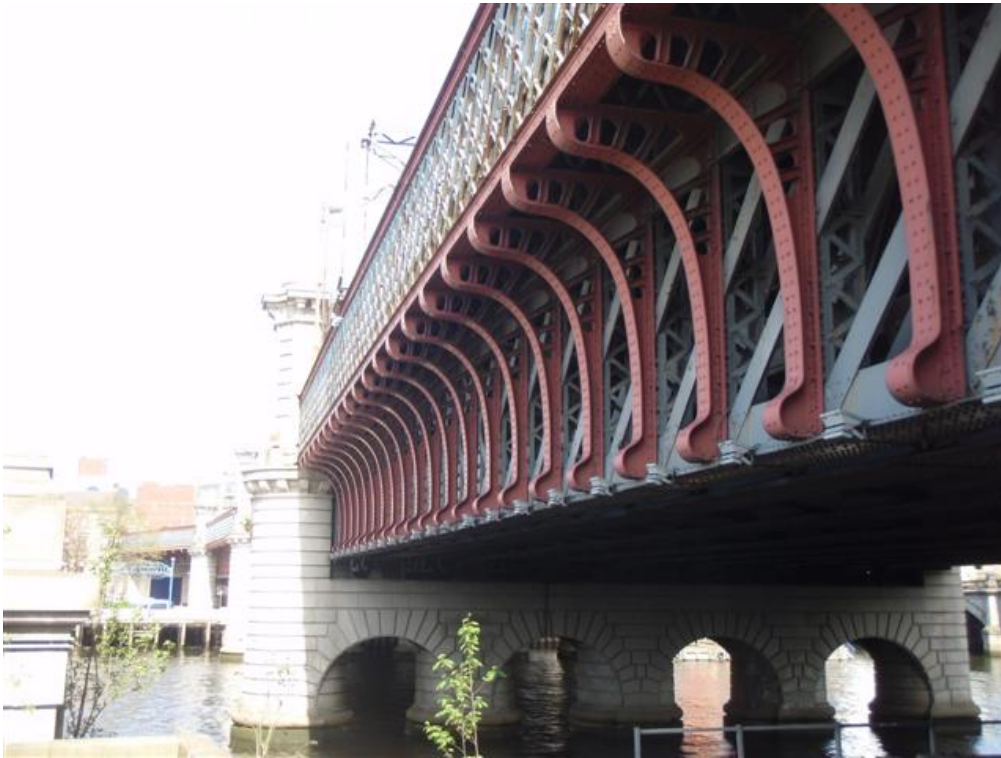
P1 - Downside elevation from LM - 17/04/11

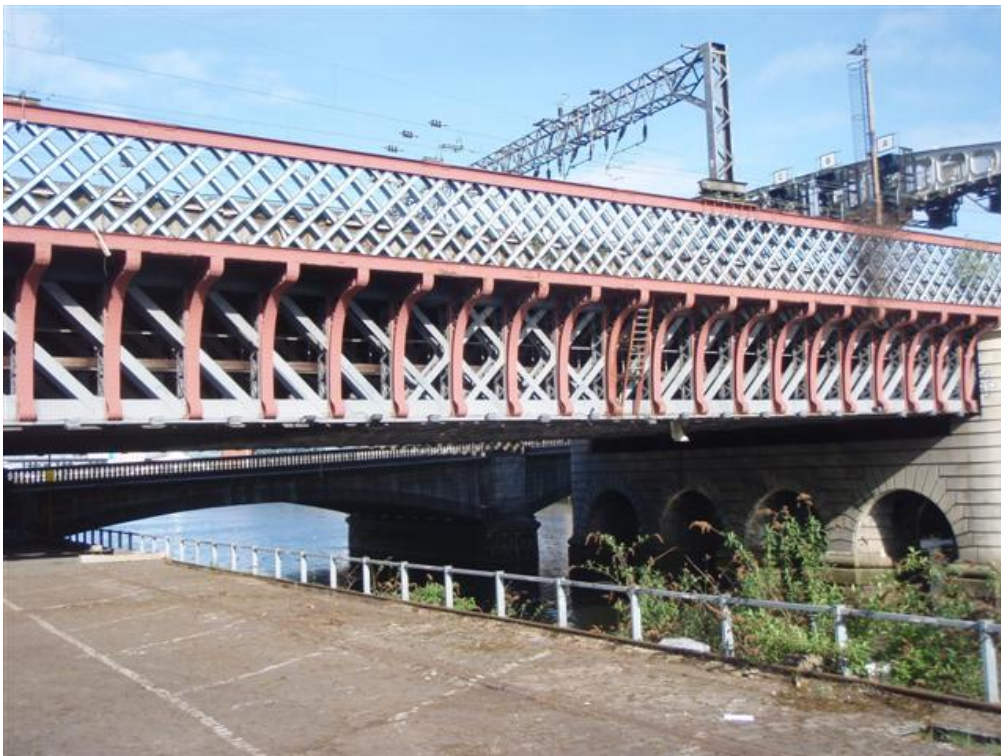
P2 - Upside elevation from LM - 17/04/11

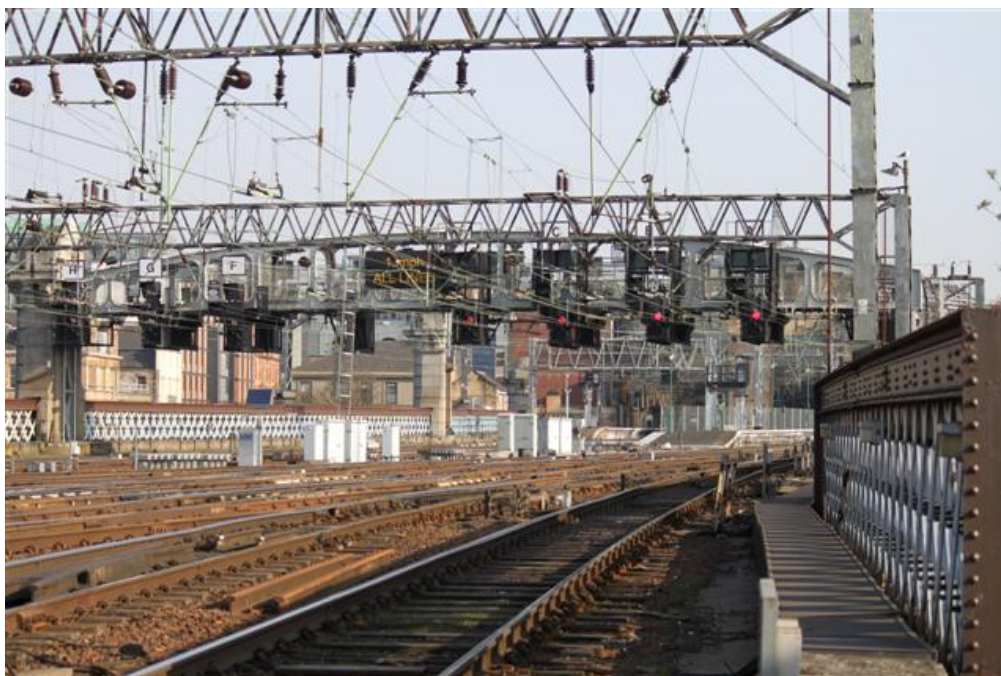
P3 - Top from LM side - 17/04/11

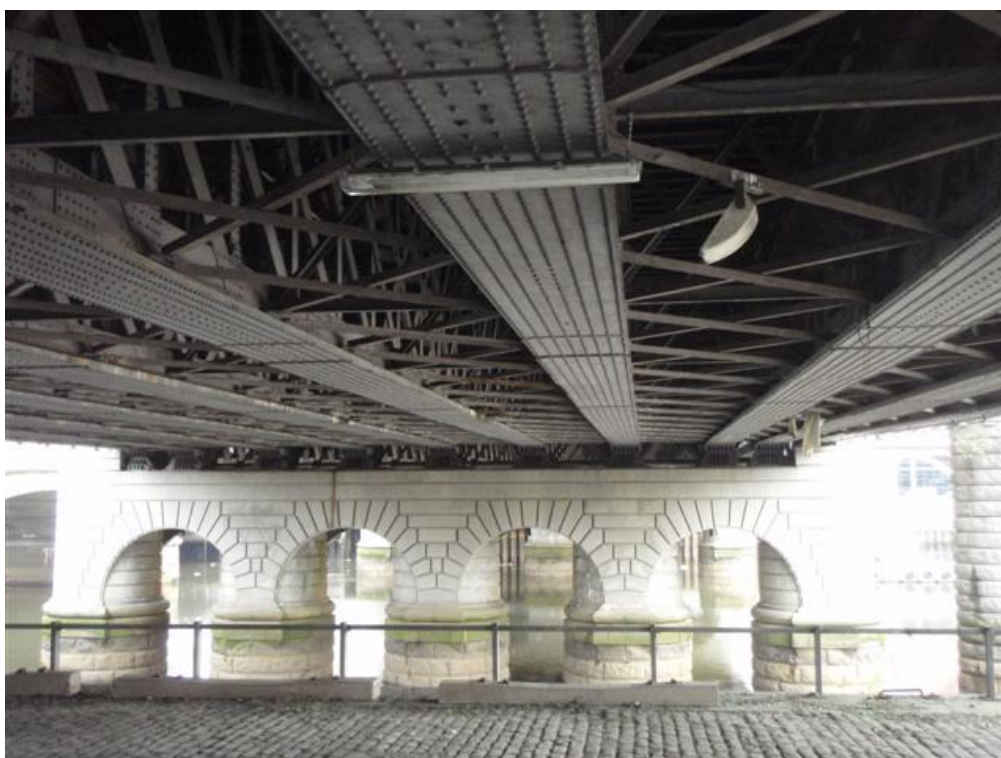
P4 - Underside from LM side - 17/04/11

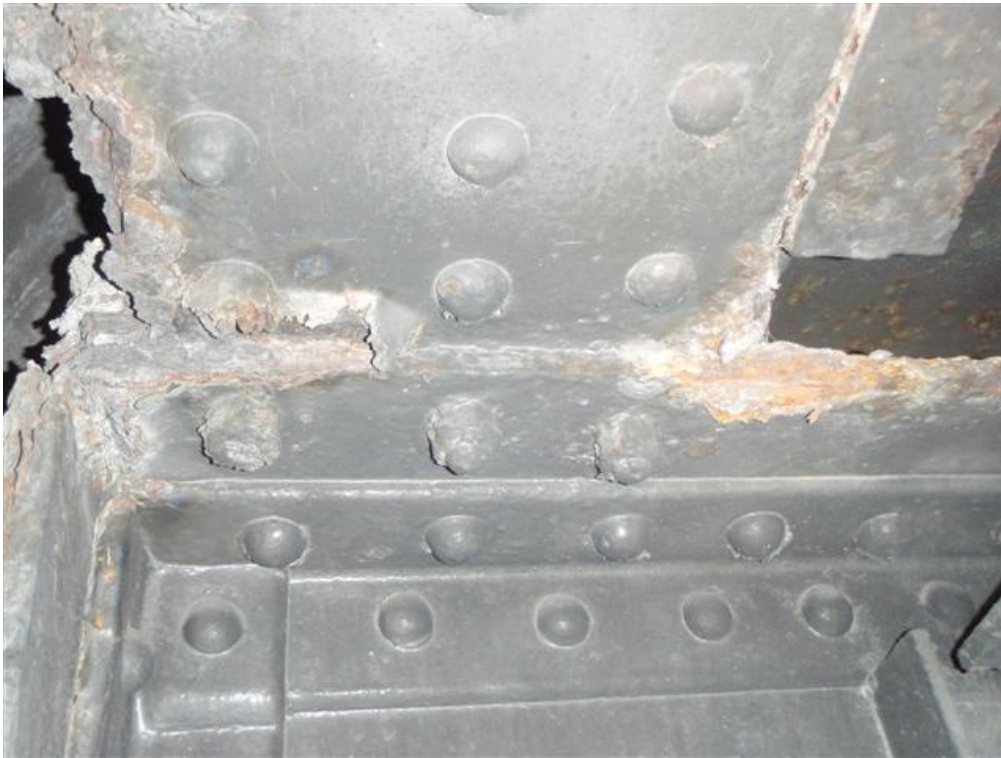
P5 - MGE1-TB upside-Thin/lamin at LM - 20/04/11

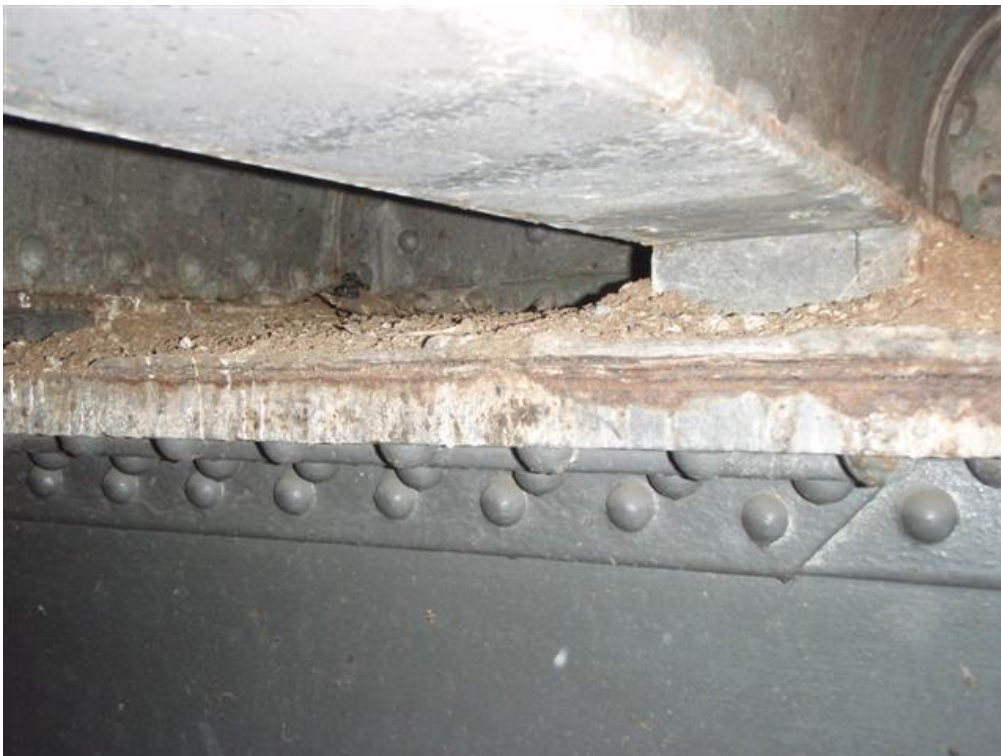
P6 - MGE1-TB upside-Thin/lamin at VP5 - 20/04/11

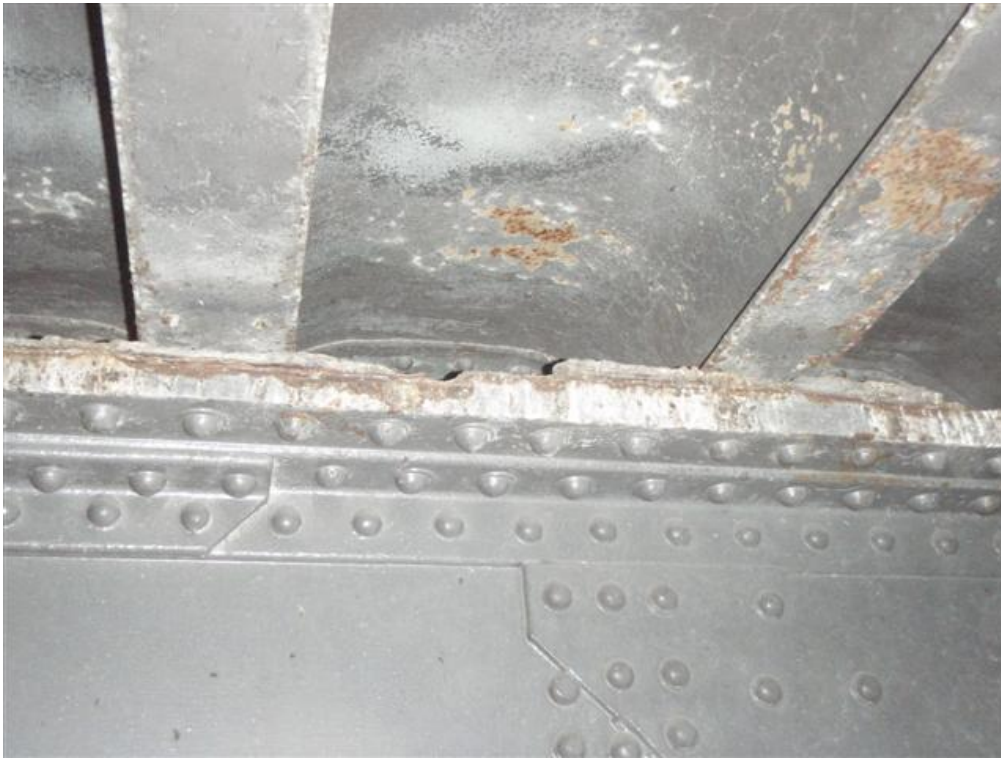
P7 - MGE1-TB upside-Thin/lamin at VP5 - 20/04/11

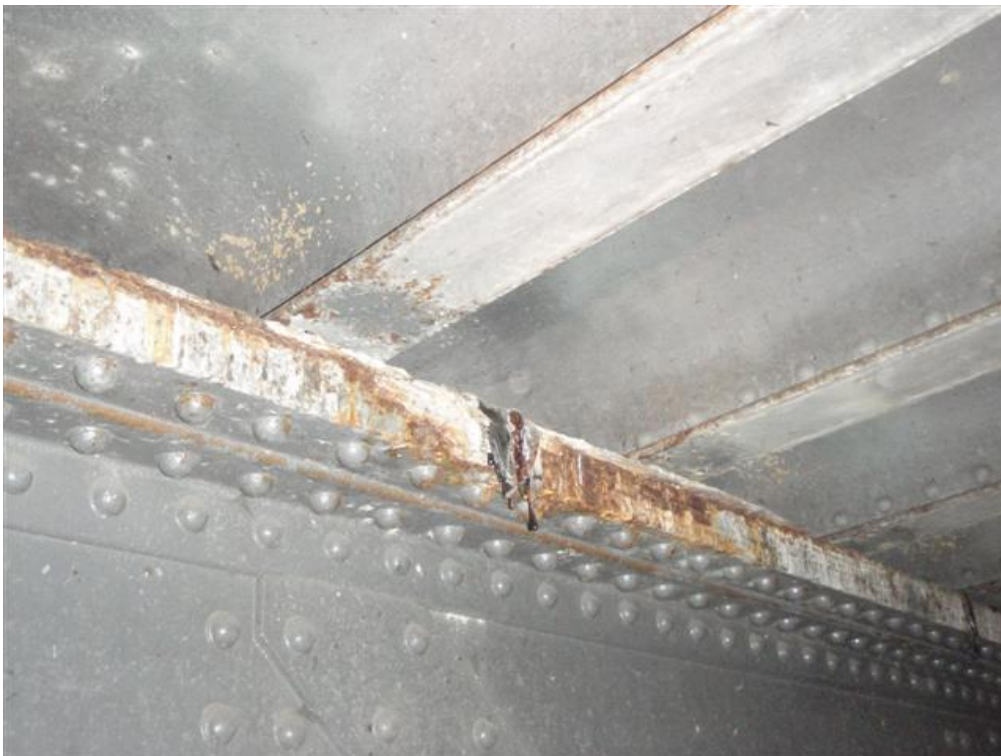
P8 - MGE1-TB upside-Thin/lamin at VP10 - 20/04/11

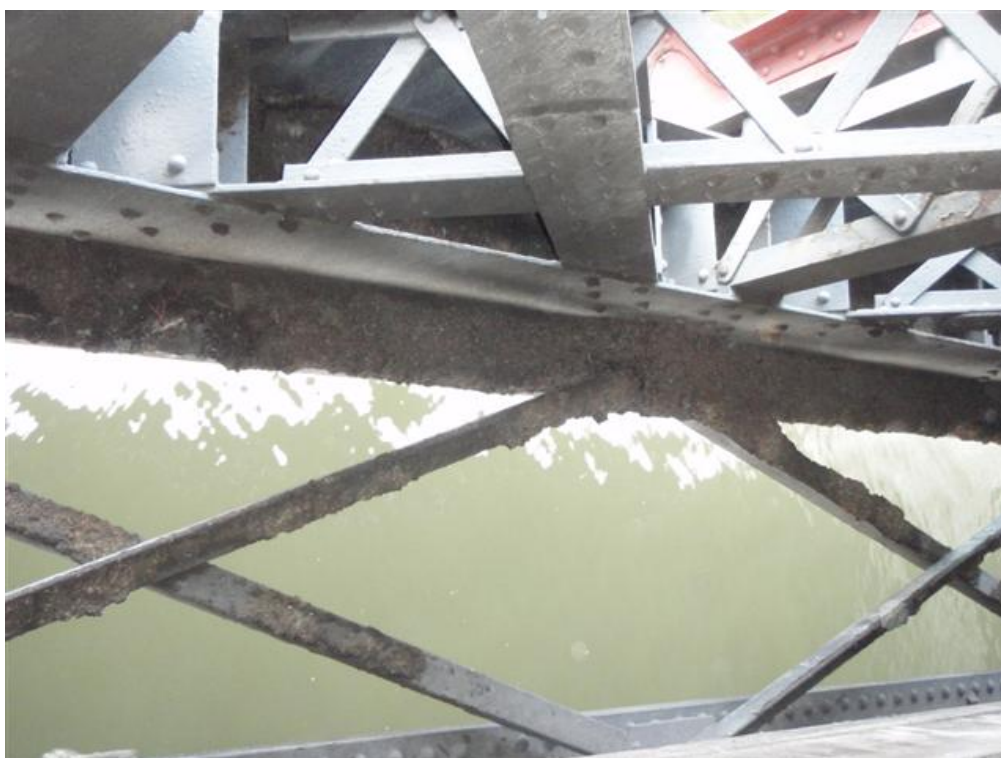
Bottom Boom - Generally BB shows areas of minor LOP and corrosion, Max 1mm, covers <5%.
Internal trough and top face of bottom flange at upside has heavy covering of bird dirt, 100mm deep, more so from mid span to HM end, Photo No. 10.
Debris is lying in internal trough to isolated areas.

P10 - MGE1-BB upside-Heavy covering of bird dirt - 20/04/11

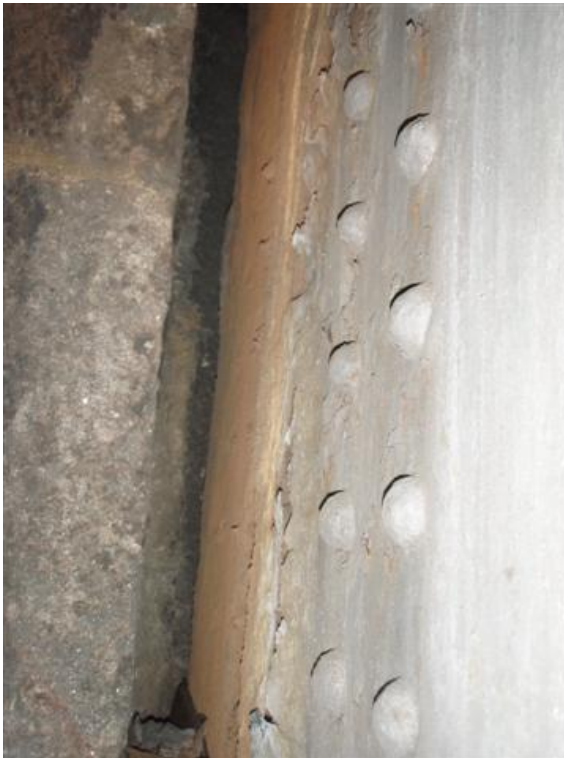
End Plates - LM - EP shows widespread areas of LOP with moderate corrosion and lamination from downside edge, 600mm wide x full height x 10mm Max deep. Rivets are pin head at same location. Fault due to seepage from adjacent box gutter, Photo No. 12 shows top and Photo No. 13 shows bottom.

P13 - MGE1-EP-Thin/lamination at downside bottom - 20/04/11

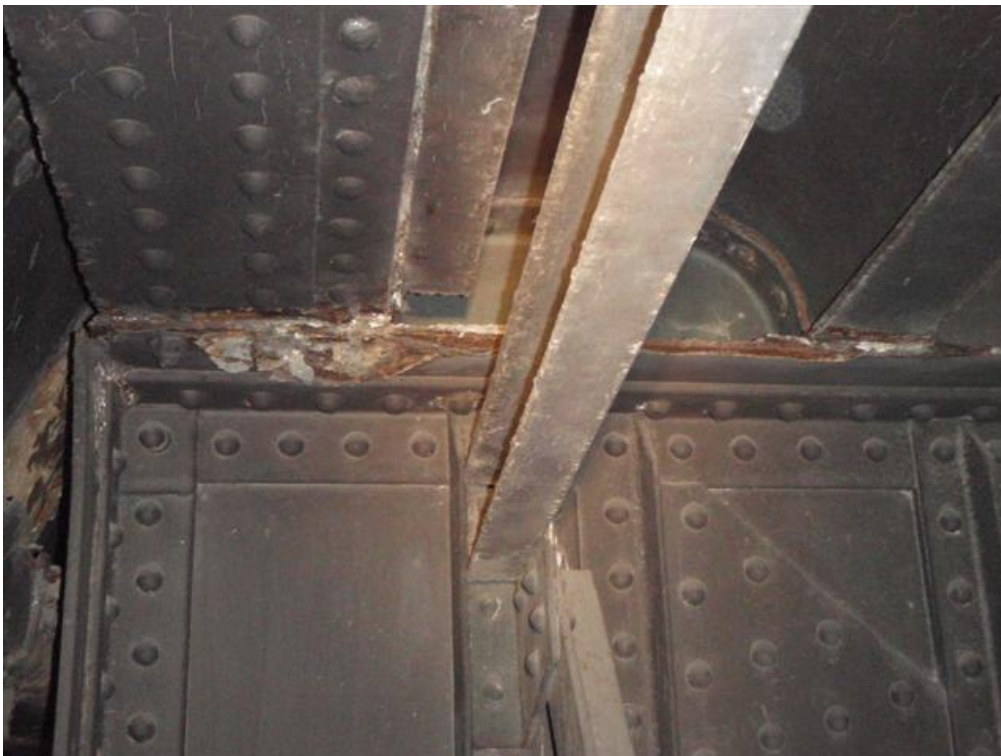
P14 - MG11-TB upside-Thin/lamin at LM - 20/04/11

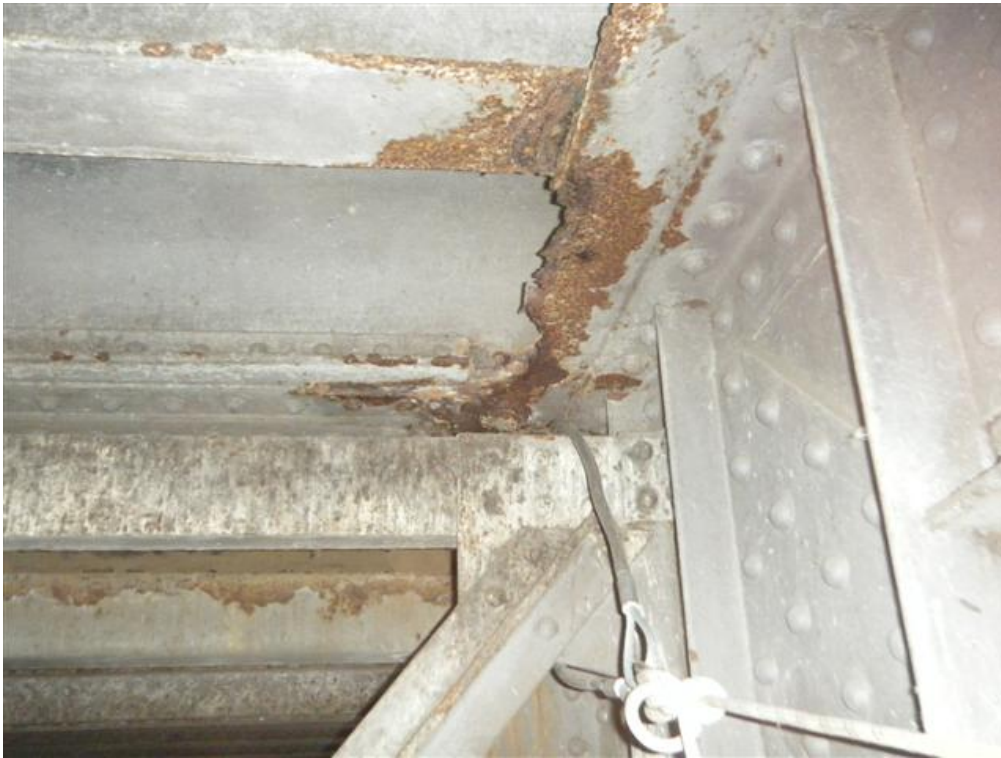
Area of severe corrosion and thinning to K/E with notching at high mileage downside 600mm from end plate , 1.1m x 50mm, Photo No. 15.

3no bolt connections to deck at same location also show severe corrosion.

P15 - MGI2 - Top flange at HM downside end - LOS & KE - 20/04/11

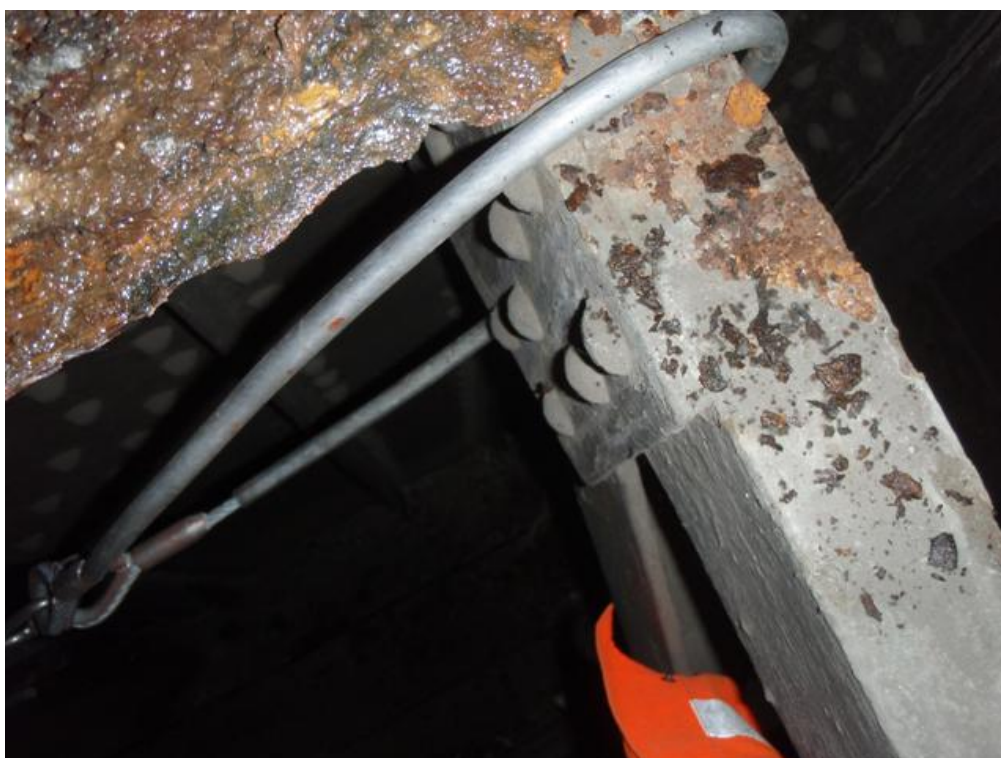
TB upside flange toe at LM end shows thinning to KE for 400mm, Max 12mm, Photo No. 19. Same area show minor LOS, area total 200mm x 30mm Max, Photo No. 20 and 21.

P20 - MG14-TB upside-LOS at LM - 19/04/11

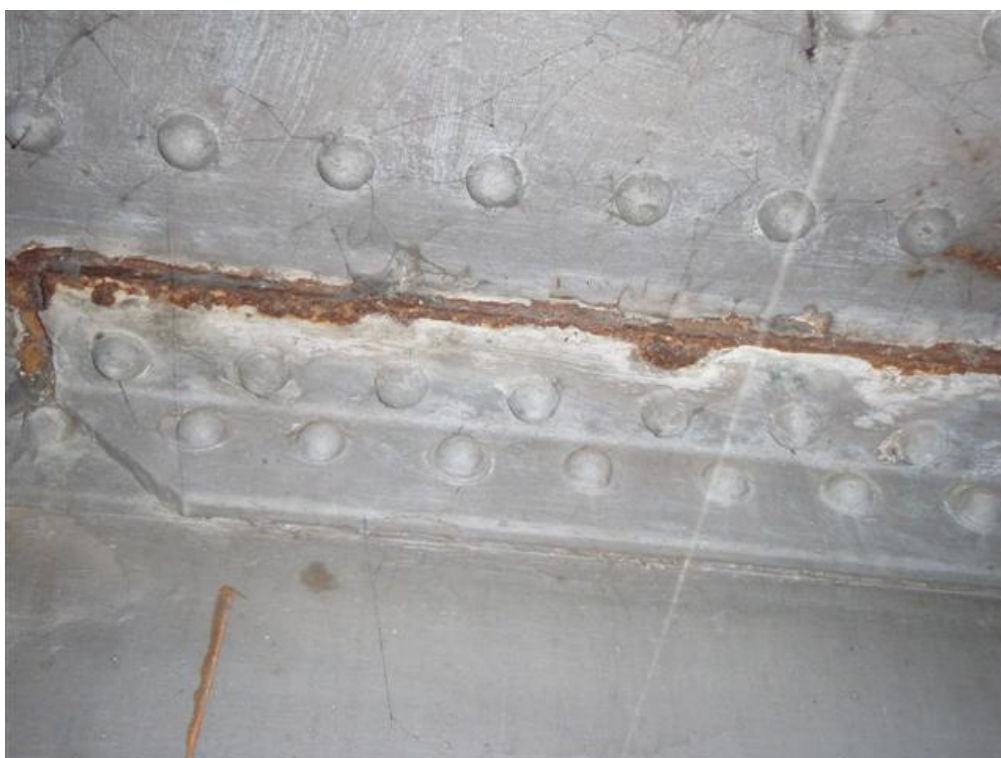
P22 - MG14-TB-Typical RJ to stiffener plates - 19/04/11

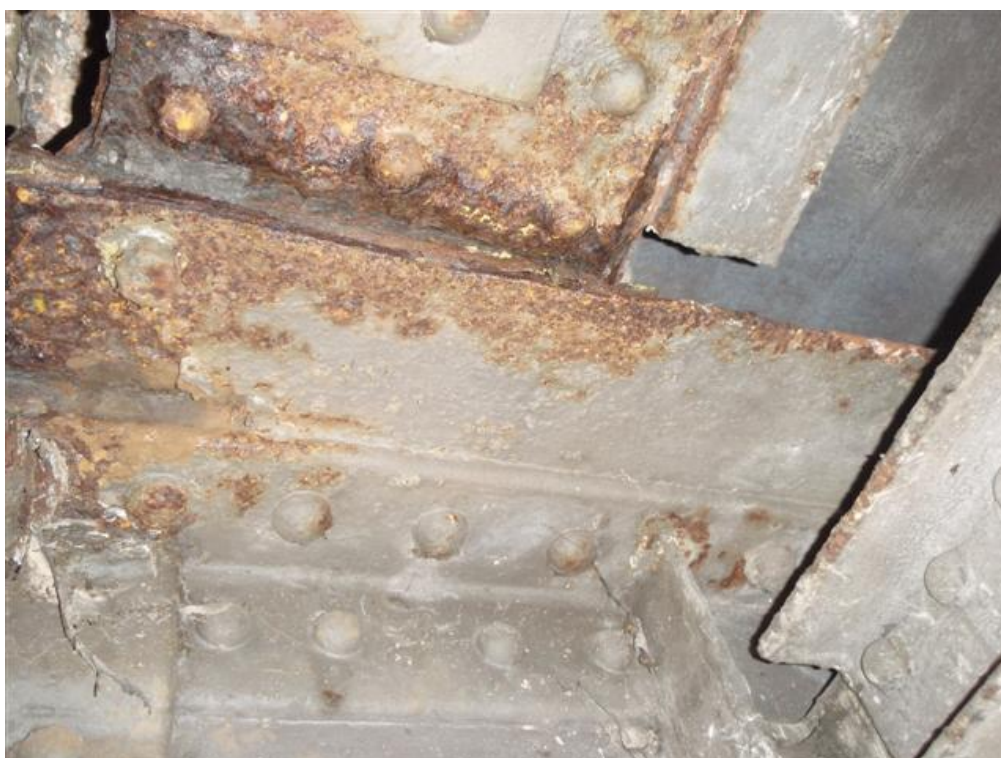
P26 - MG15-TB downside-Thin/lamin at HM - 21/04/11

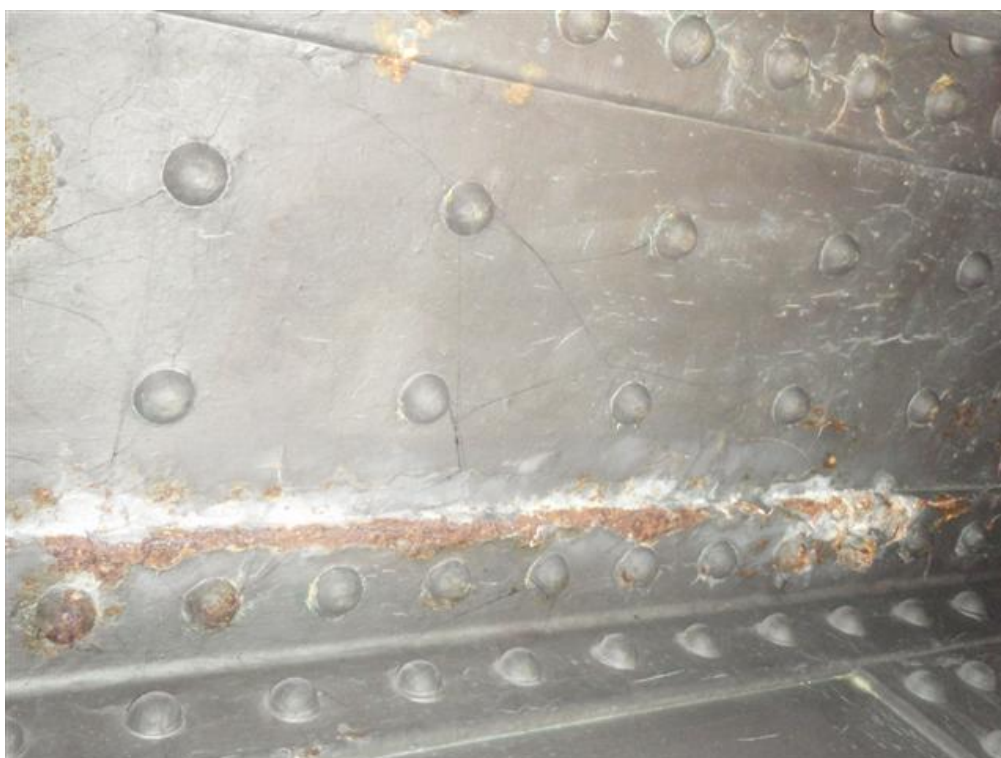
P28 - MG15-TB-Typical RJ to stiffener plates - 18/04/11

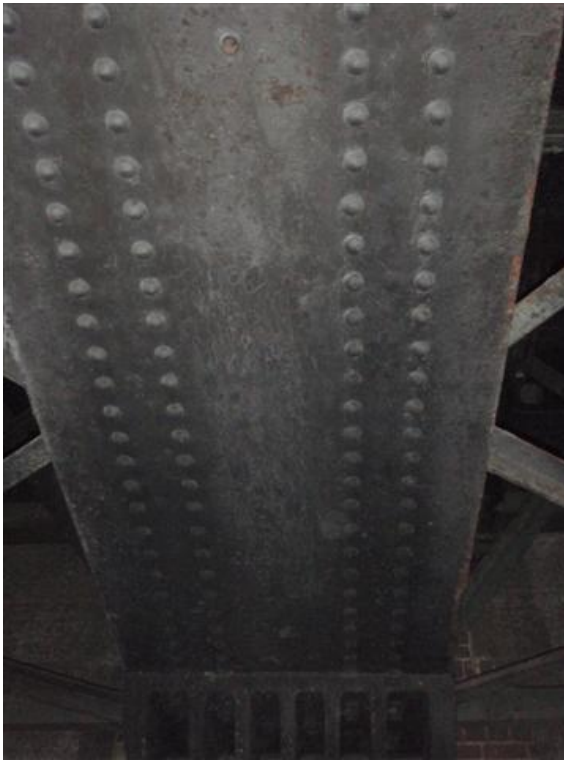
P29 - MGI5-BB-Soot covered bottom flange at LM - 21/04/11

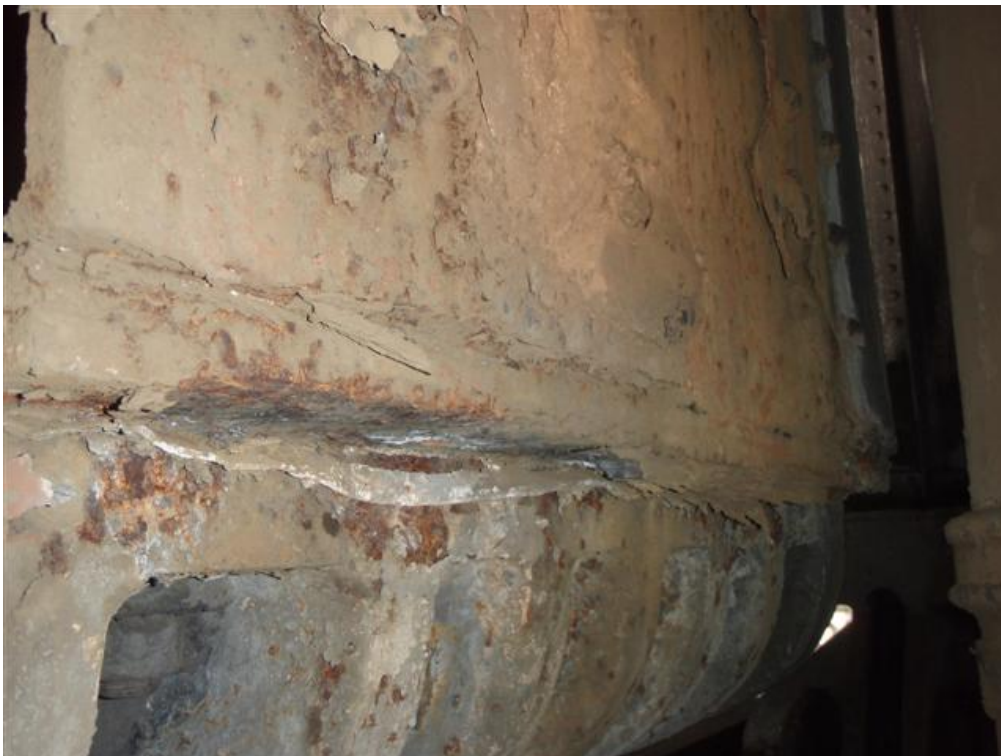
P30 - MGE2-BB-Lamin & thin to bot flange at HM end - 24/04/11

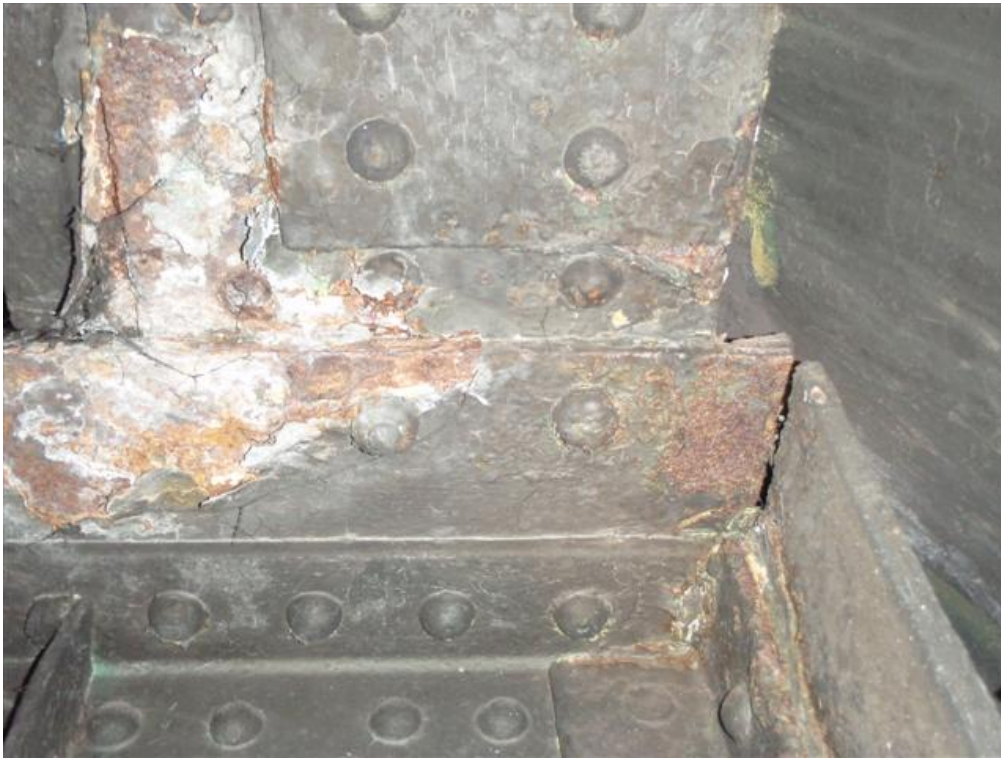
P37 - MGI6-TB downside-Thin/lamin at LM - 17/04/11

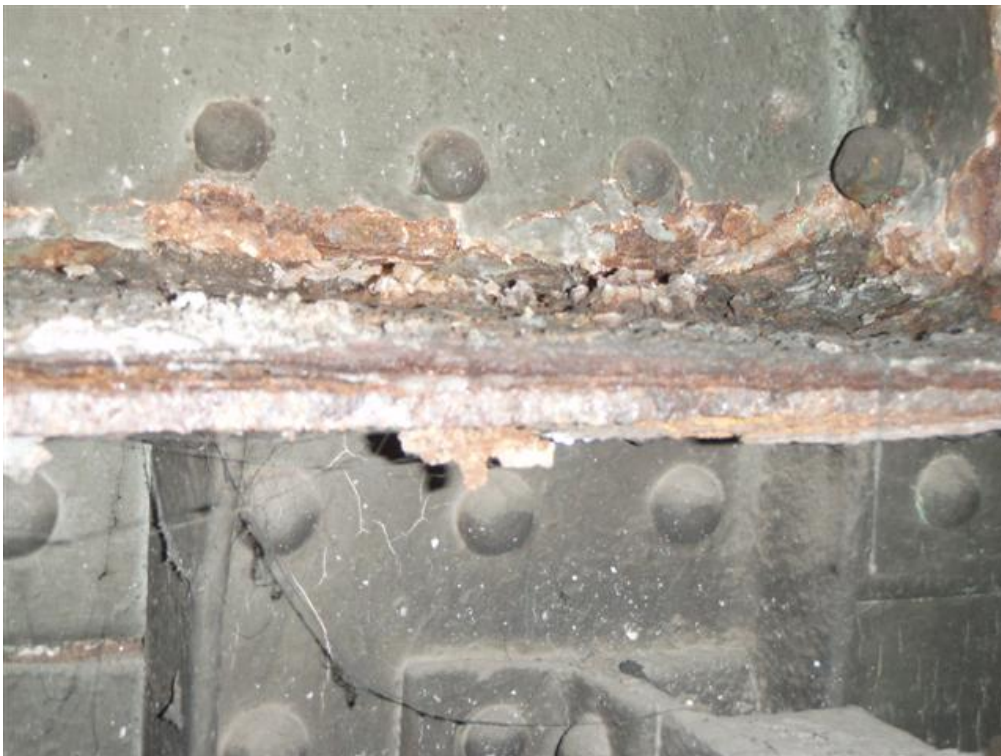
P38 - MGI6-TB downside-Thin/lamin at LM - 17/04/11

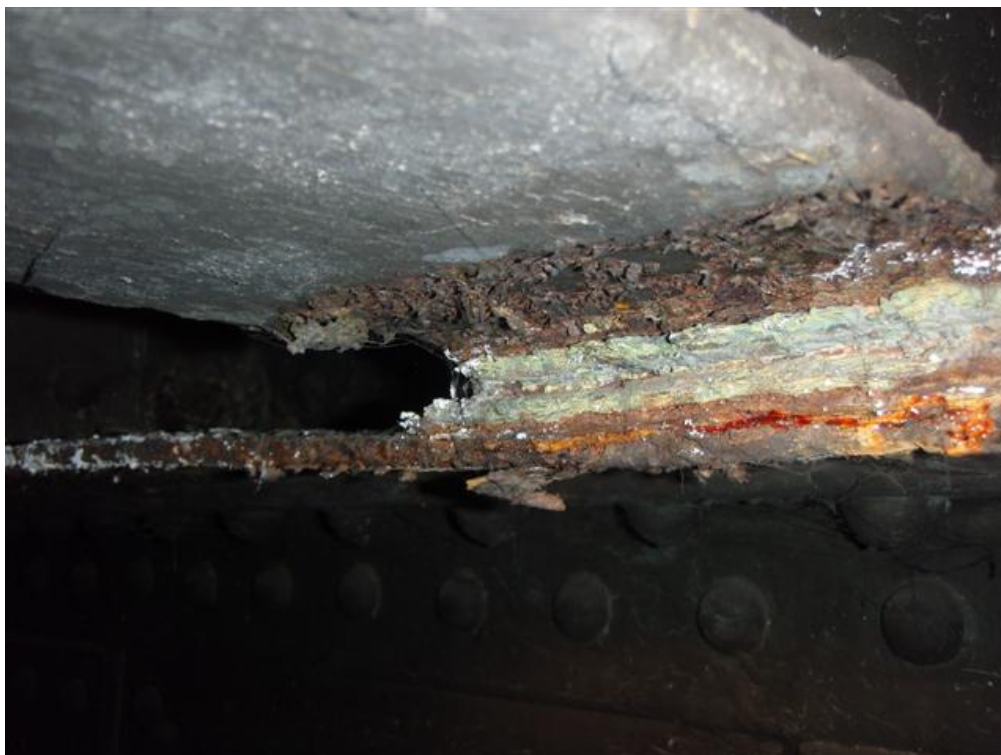
P40 - MGI6-TB downside-RJ&lamin at joins to trough deck - 17/04/11

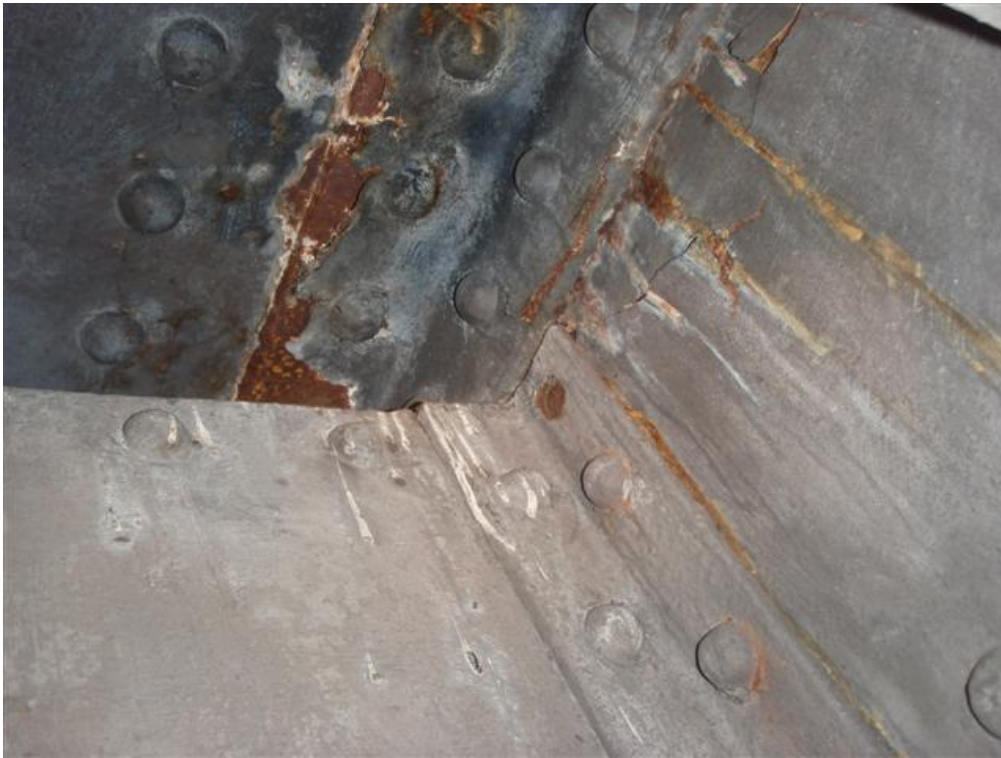
P41 - MGI6-TB-Tie plate-Sheared rivet at LM upside - 19/04/11

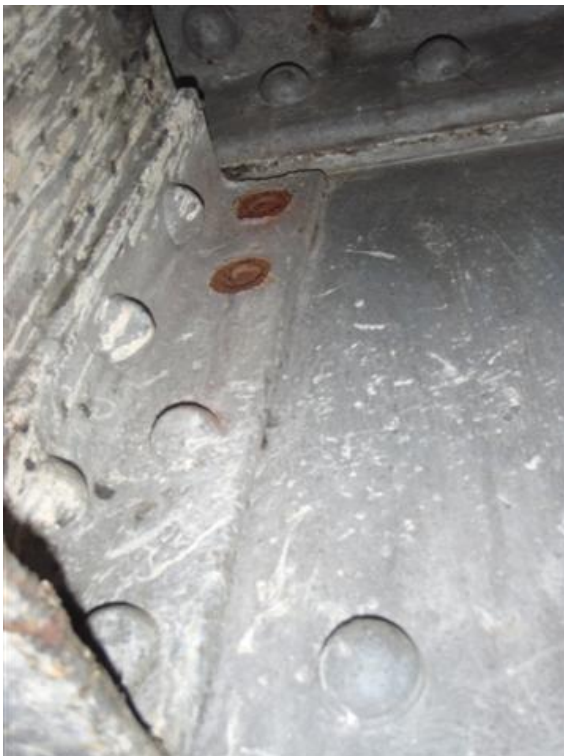
P42 - MGI6-TB-Tie plate-Sheared rivets at HM downside - 19/04/11

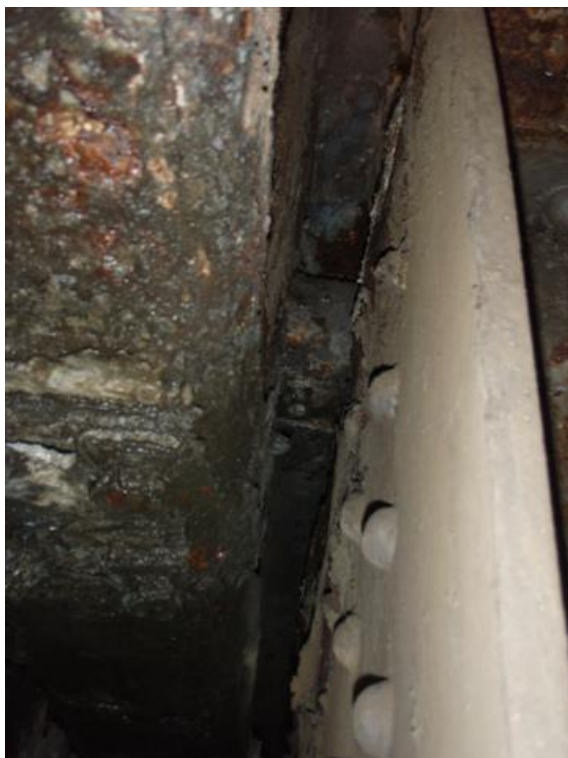
P44 - MG16-HM EP-Thin/lamination at top - 19/04/11

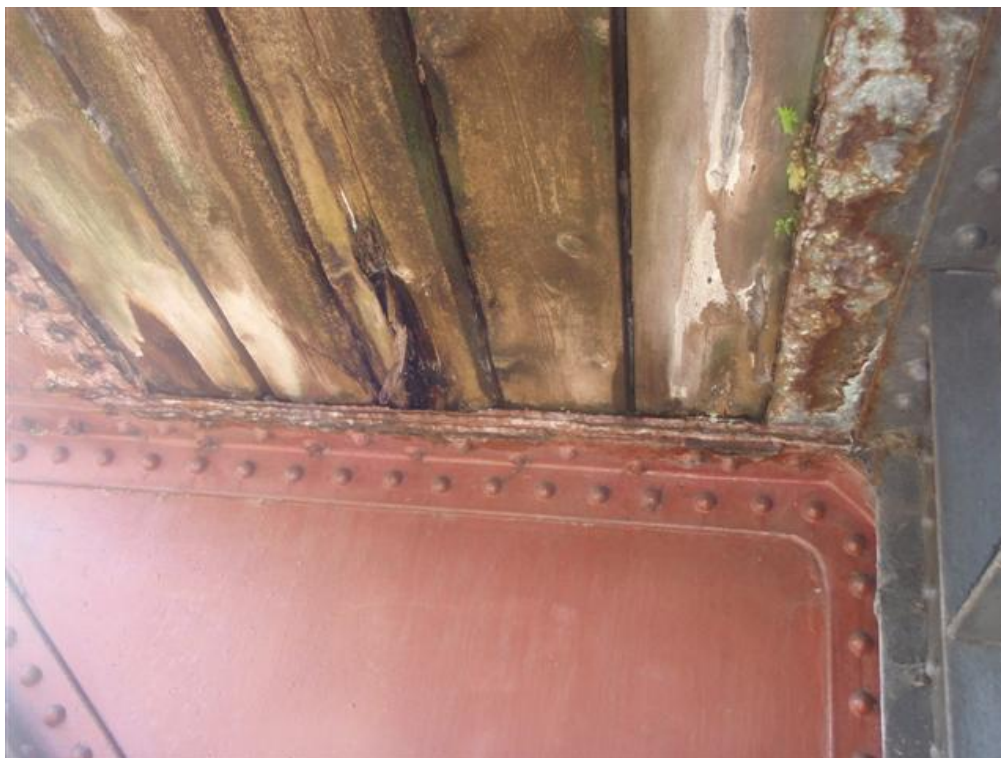
P46 - MGE2-TB upside-Typical lamin at LM- 17/04/11

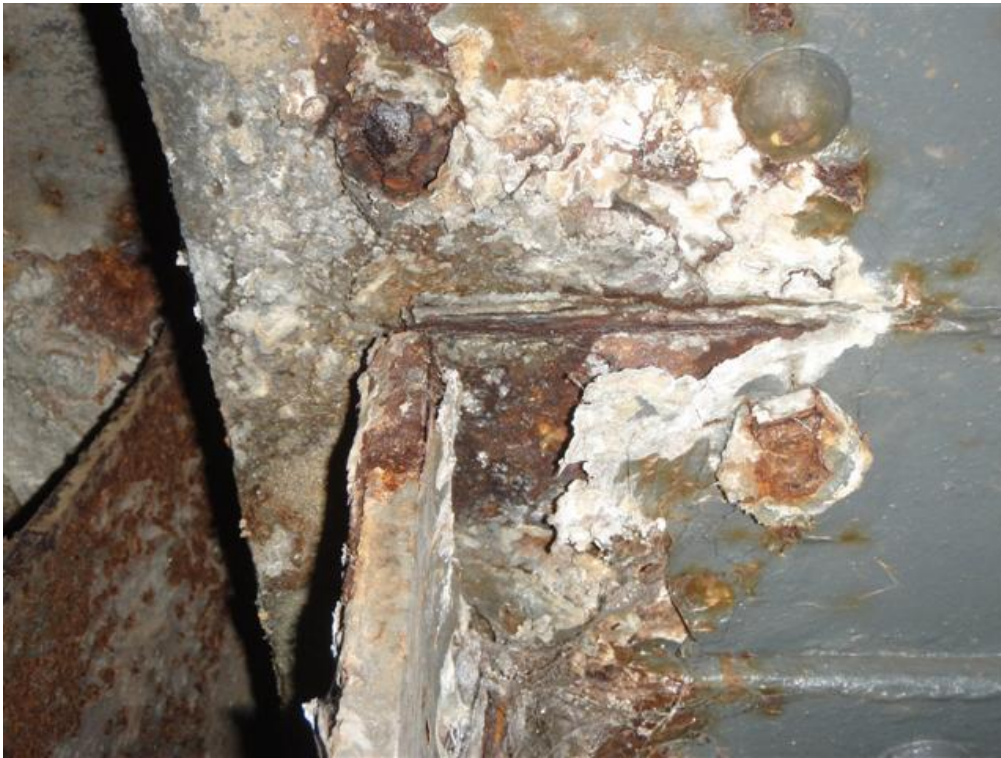
P47 - MGE2-TB downside-Thin/lamin at HM - 18/04/11

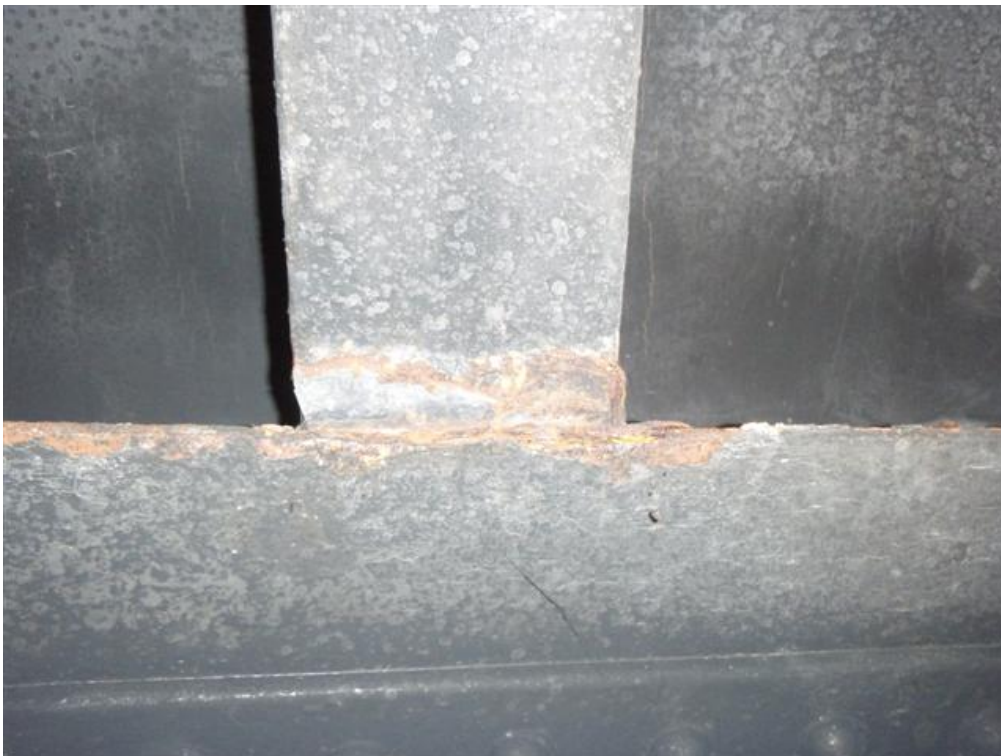
P48 - MGE2-TB downside-RJ&lamin at joins to trough deck - 17/04/11

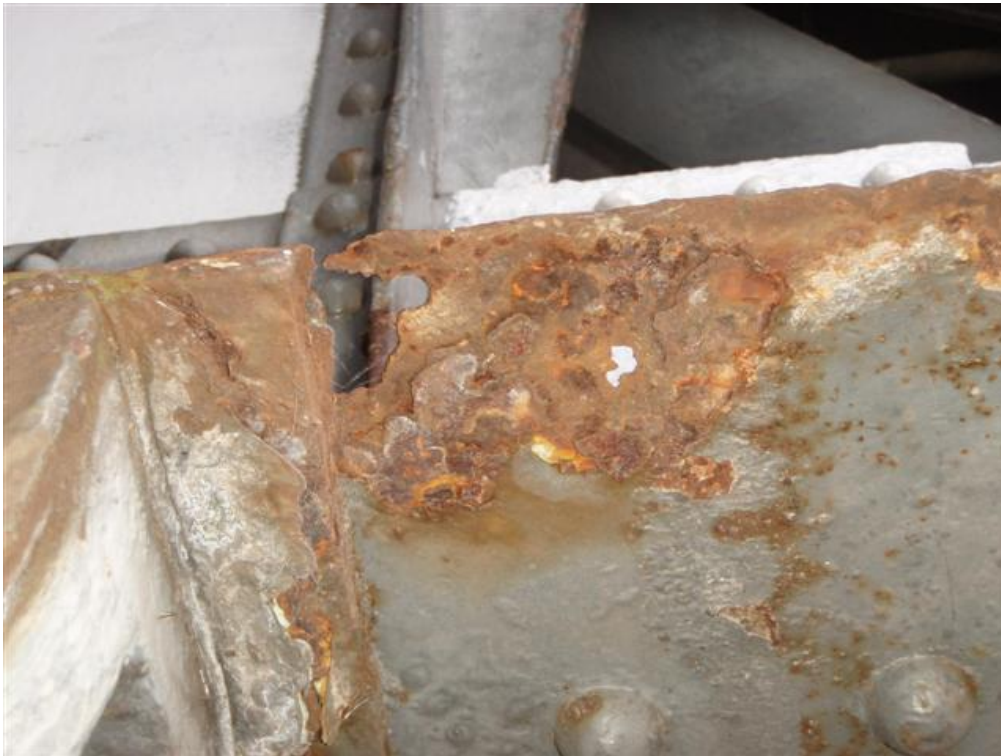
P51 - MGE2-BB-LOS at LM upside flange toe - 17/04/11

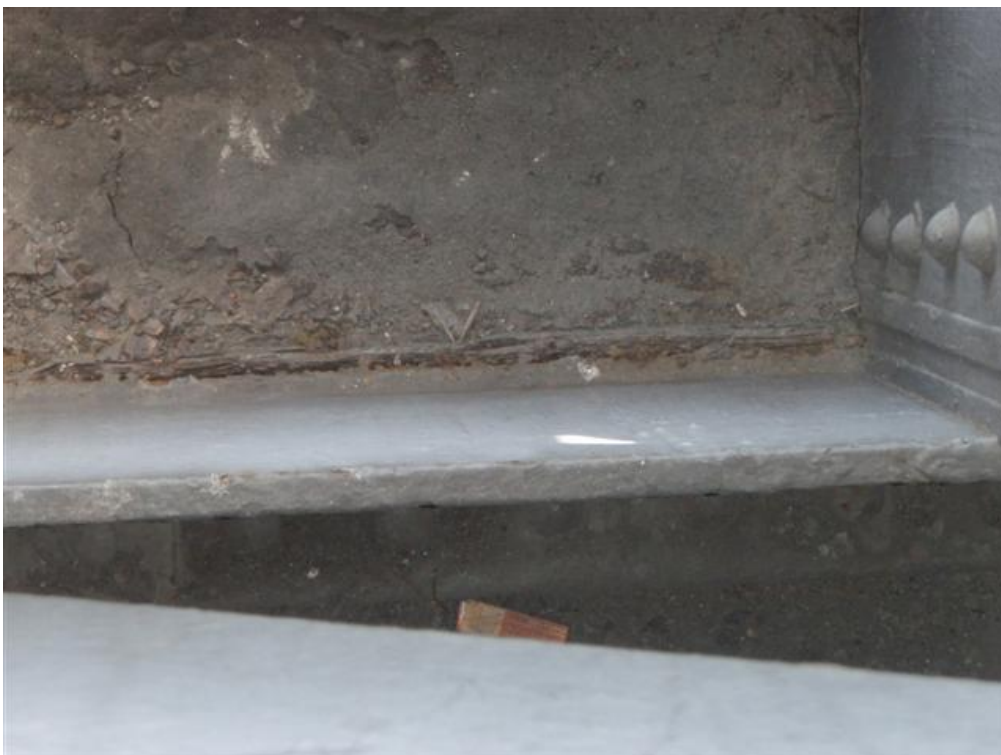
P52 - MGE2-BB-Lamination to inner stiffener - 17/04/11

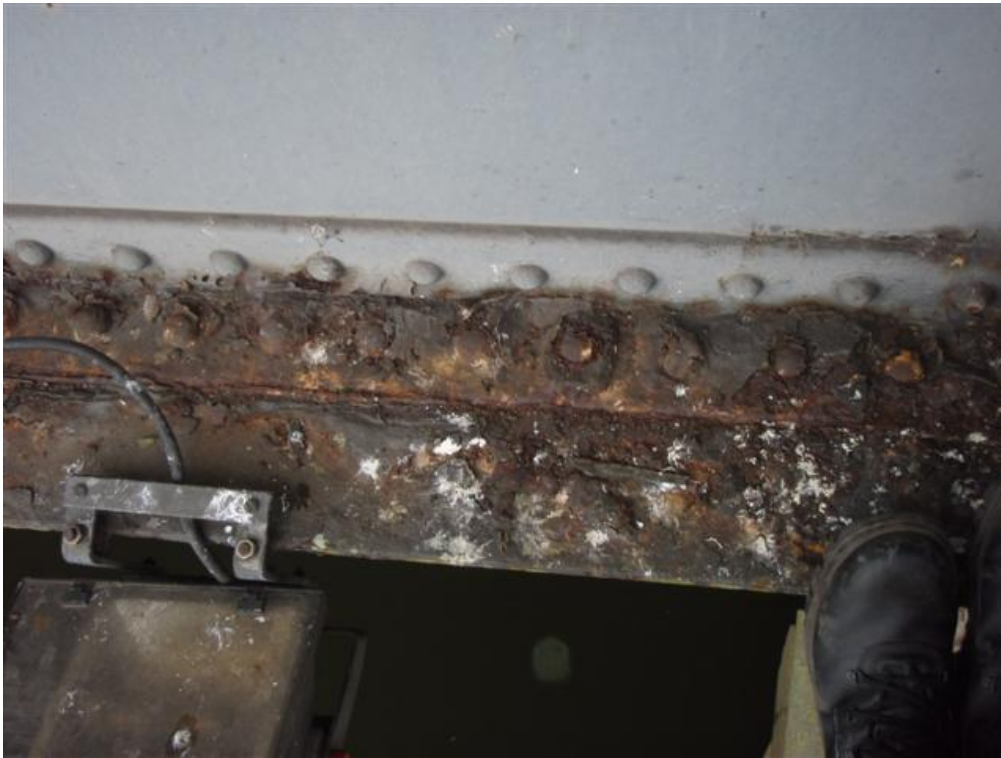
P53 - MGE2-BB-Lamination to outer stiffener - 22/04/11
