BRIDGE DETAILED & HCE EXAMINATION REPORT

ELR: WCM2	Contract Mileage: 102 m 0088 yds 4.00 ch			Struc. Ref 031/082A	
Examination Type:	Additional Assess HCE	NR ID:	11016334	Exam Date:	14-Feb-2012
Area:	Scotland West	BRS:	0	OS Ref:	NS58716475
Structure Name:	NEW CLYDE BRIDGE	Type:	BU	Exam ID	305231
Route:	Gretna - Glasgow Central (via Beattock)	Complete Examination:		N/A

OS Ref: NS58716475 BRS: Name: NEW CLYDE BRIDGE

The remit was to examine structural elements affected by HCE code MJA in accordance with document HCE – Codes v1.5.

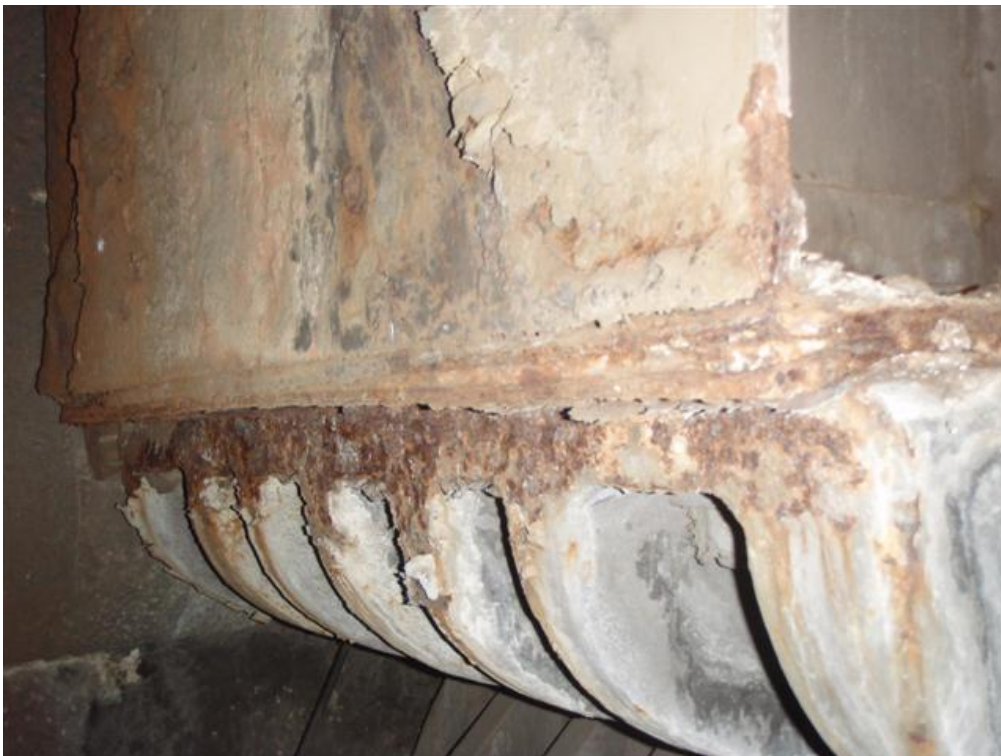
P54 - MGE2-BB-Lamin & RJ to bot flange at HM end - 22/04/11

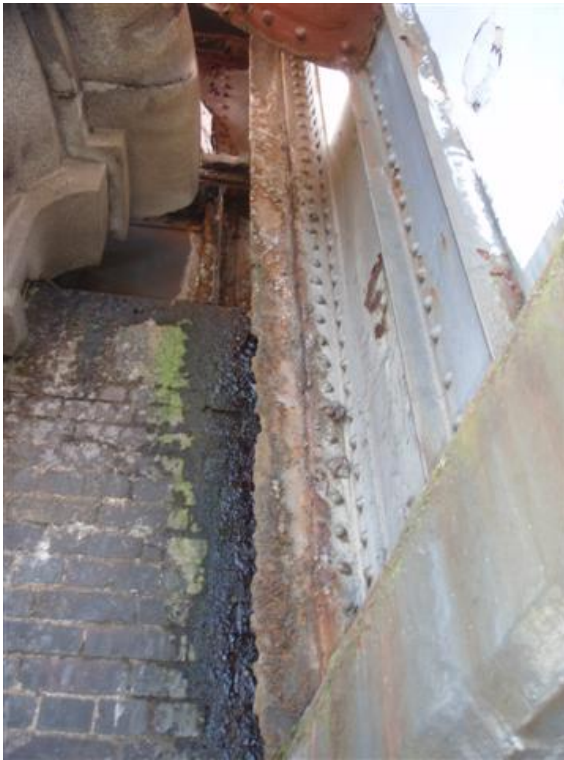
P55 - MGE2-LM EP-Thin/LOS at upside bottom - 17/04/11

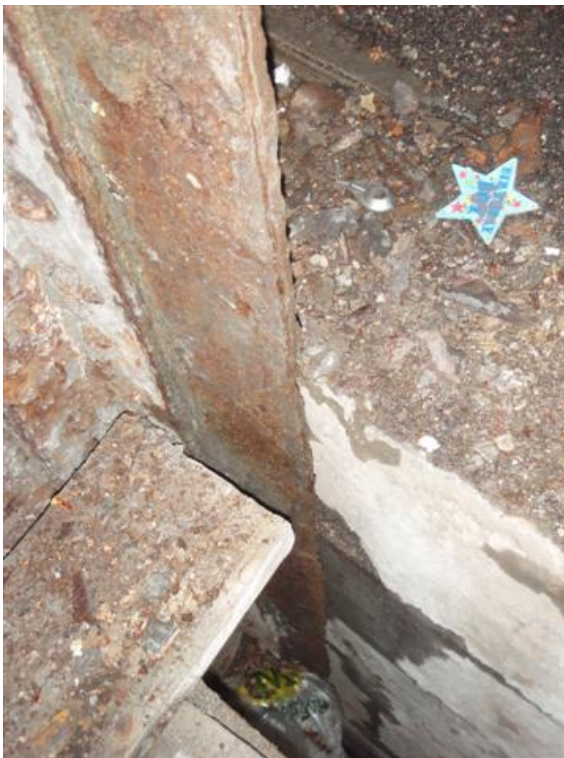
P56 - MGE2-LM EP-Thin/LOS at downside bottom - 17/04/11

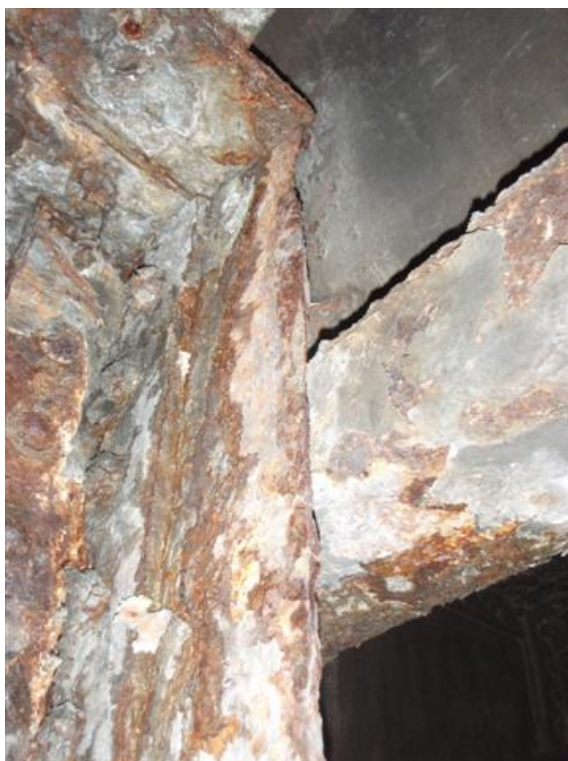
P57 - MGE2-LM EP-Thin/LOS at downside top - 17/04/11

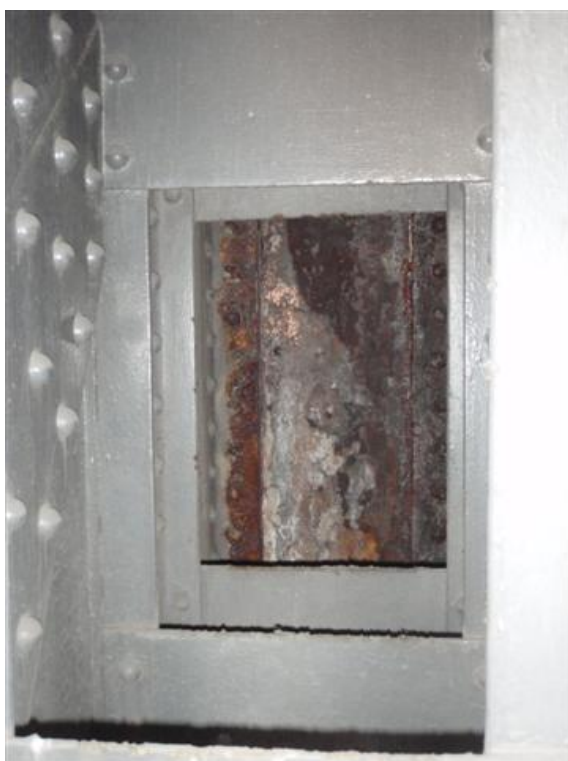
P58 - MGE2-LM EP-Thinning to inside face - 17/04/11

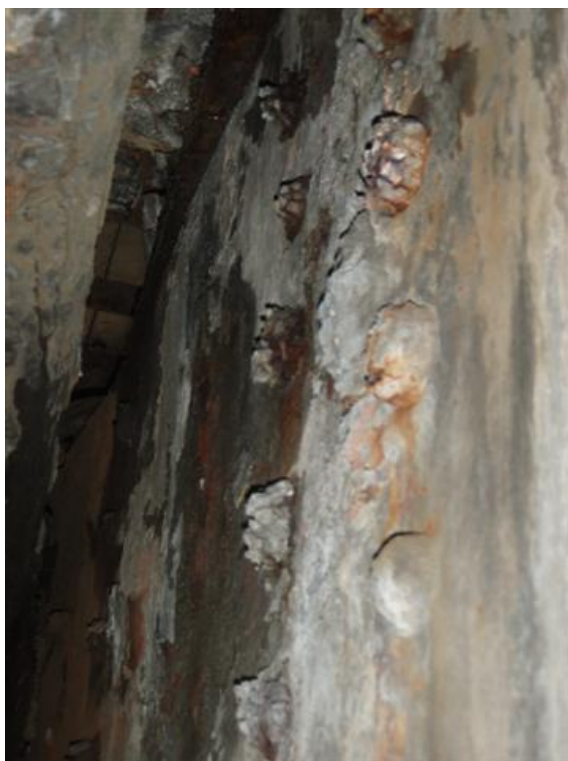
P59 - MGE2-HM EP-Thin/lamination at top - 18/04/11

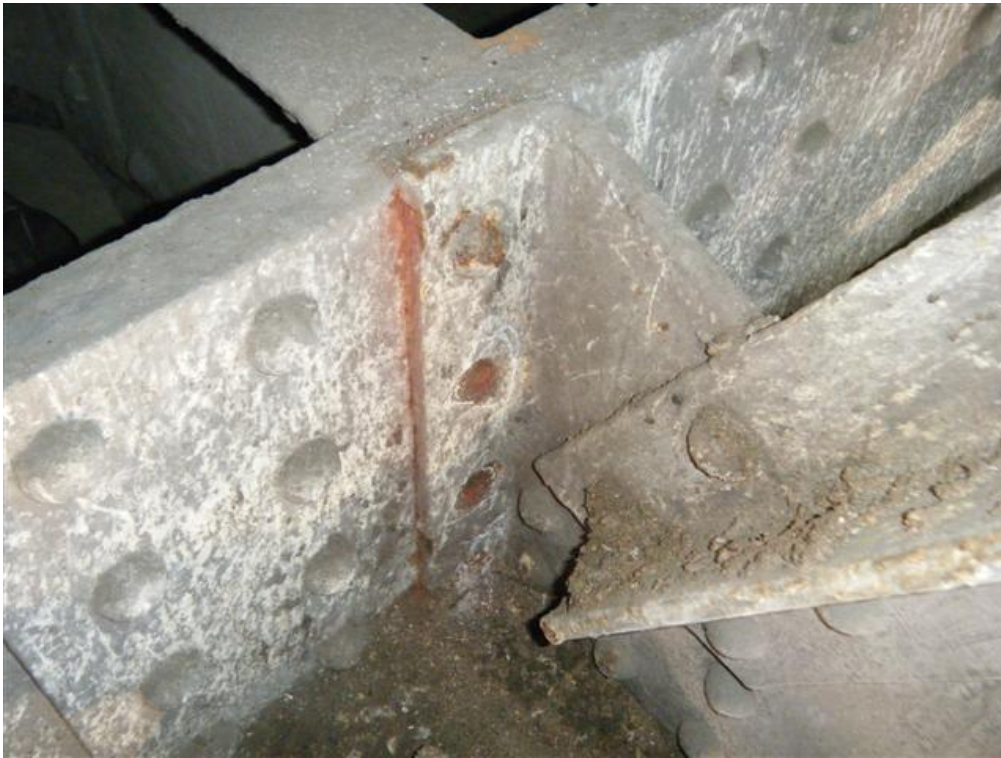
P63 - BRG-Sheared rivets at bracer tie plate at MG17 - 20/04/11

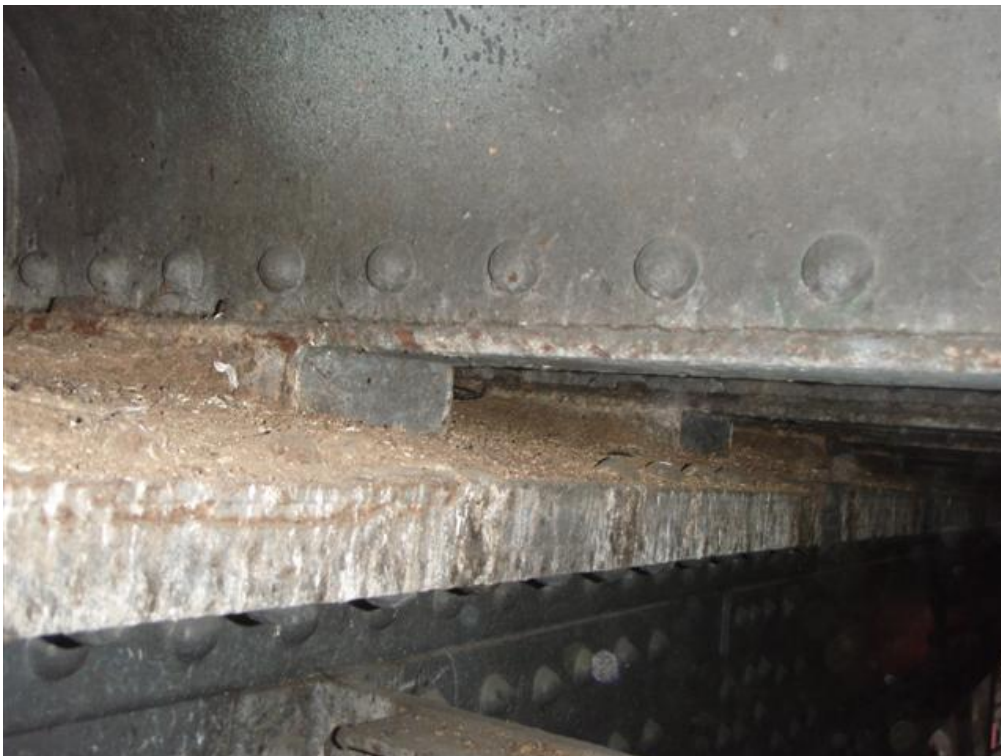
P64 - DCK1-Deck on steel blocks over MGE1 - 20/04/11

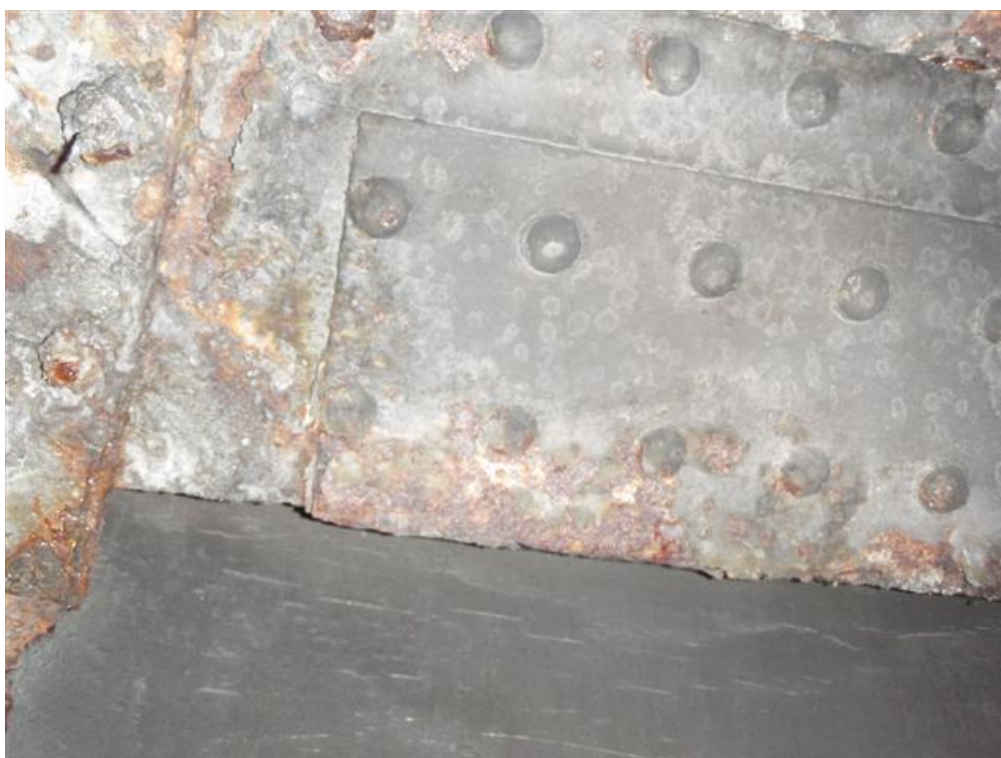
P70 - DCK9-Typical lamination to deck ends - 17/04/11

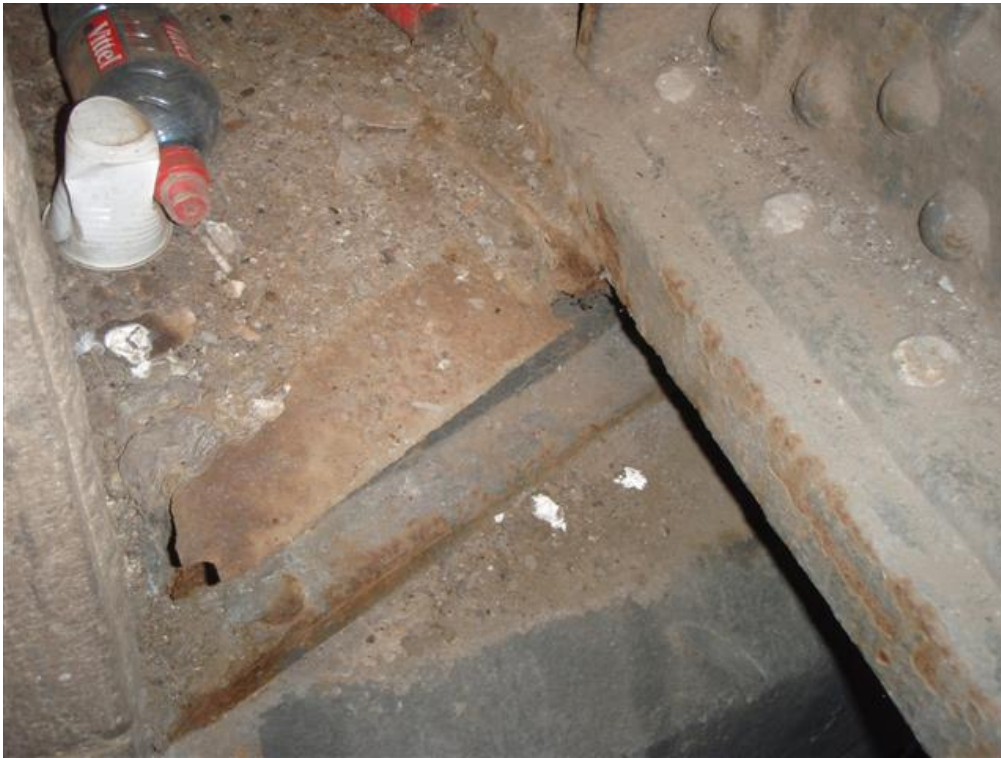
P75 - ES1-COL2-LOS to exposed steel at upside- 20/04/11

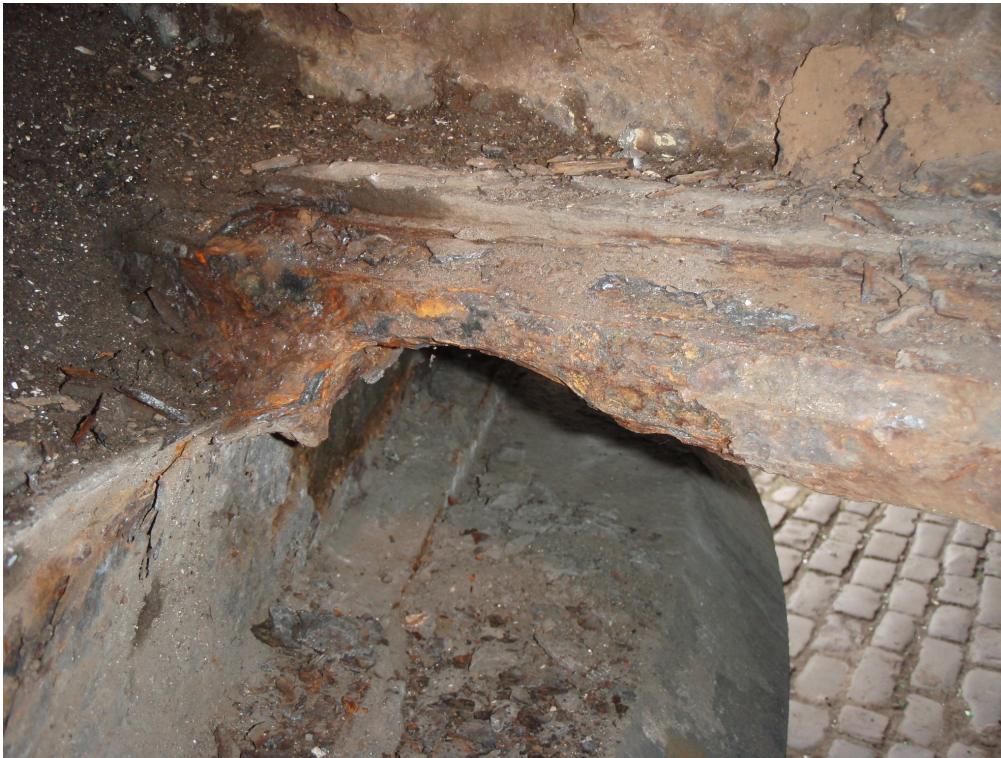
P79 - ES1-PCL1-Thinning to KE over Column 1 - 20/04/11

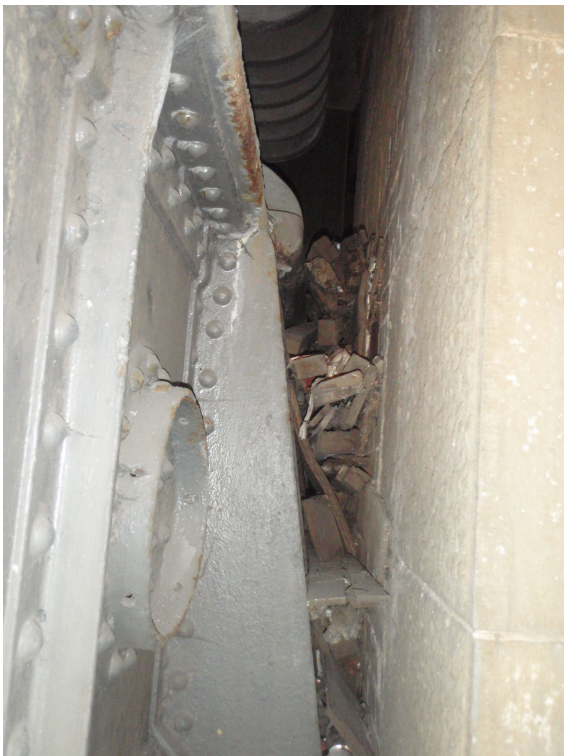
P80 - ES1-PCL1-Wood stacked behind Girders 2&3 - 20/04/11

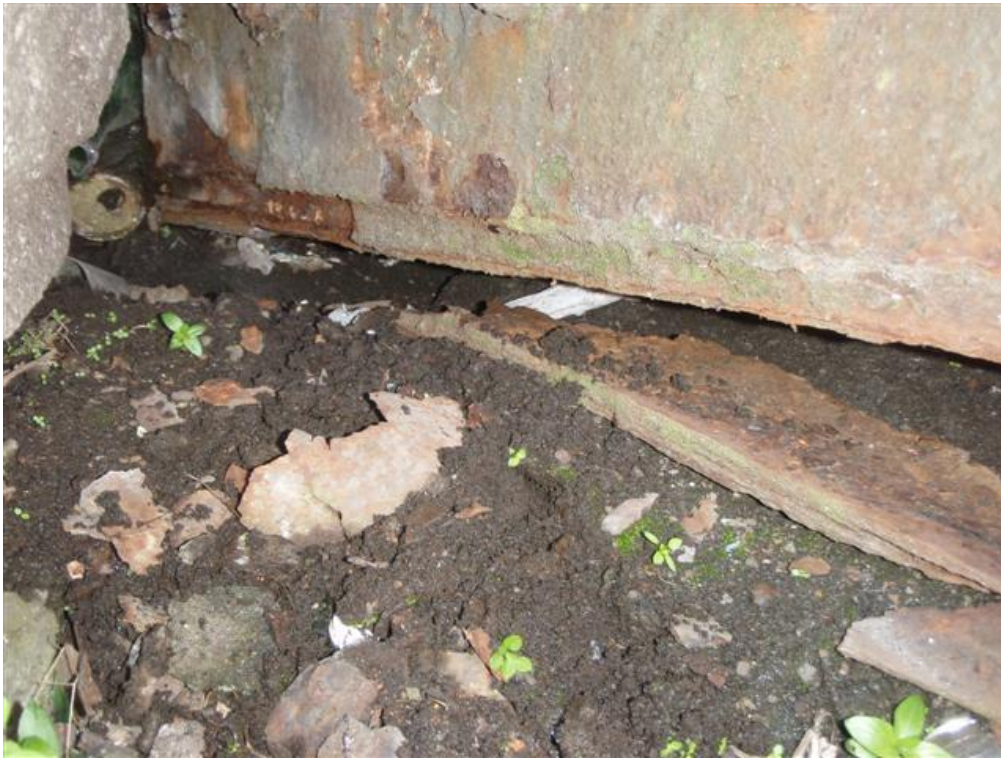
P83 - ES1-PCL1-Lamination to Girder 4 upside - 17/04/11

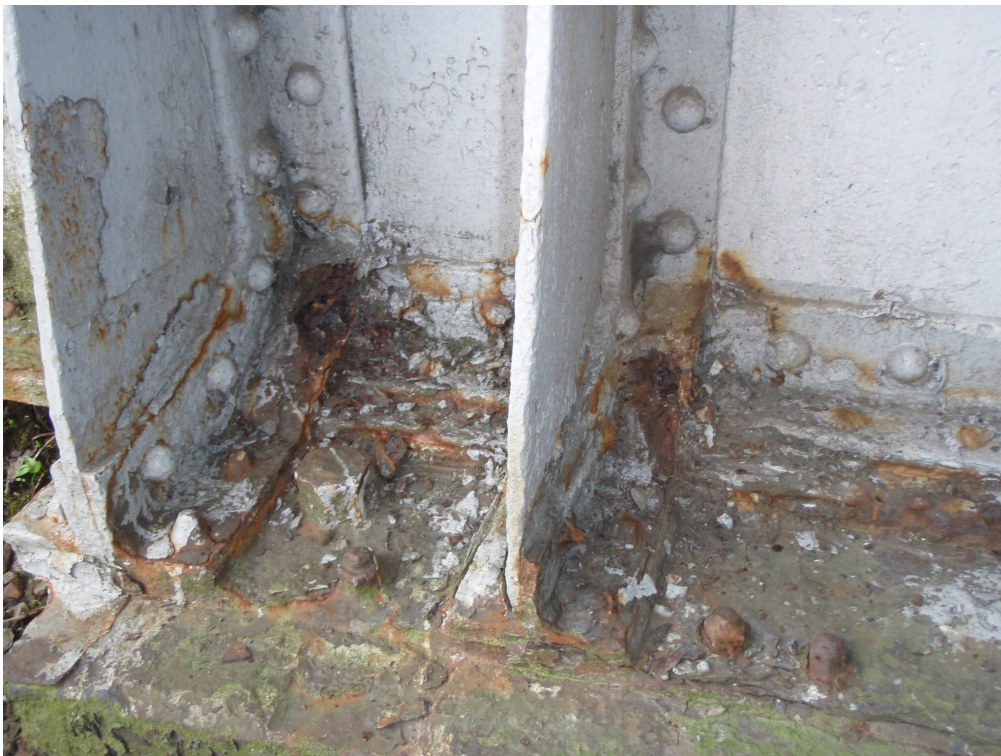
P84 - ES1-PCL1-LOS to web stiff Girder 4 HM up - 20/04/11

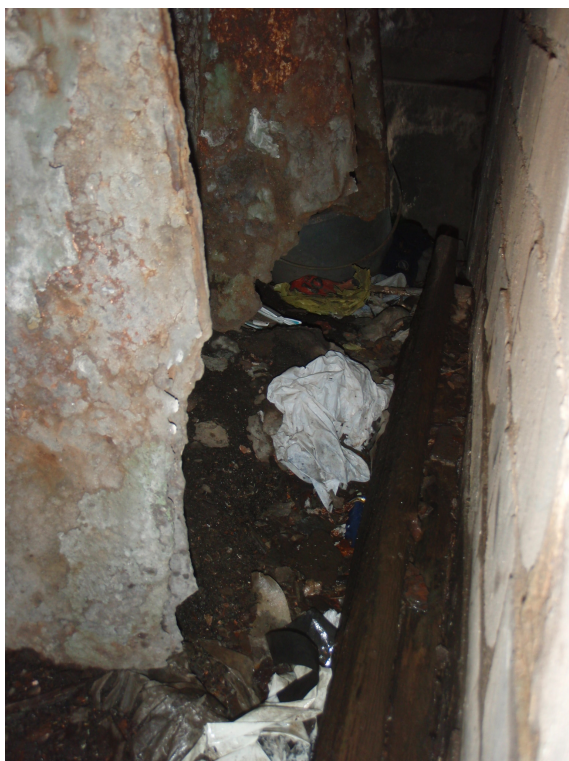
P85 - ES1-PCL1-LOS to web stiff Girder 4 LM up - 20/04/11

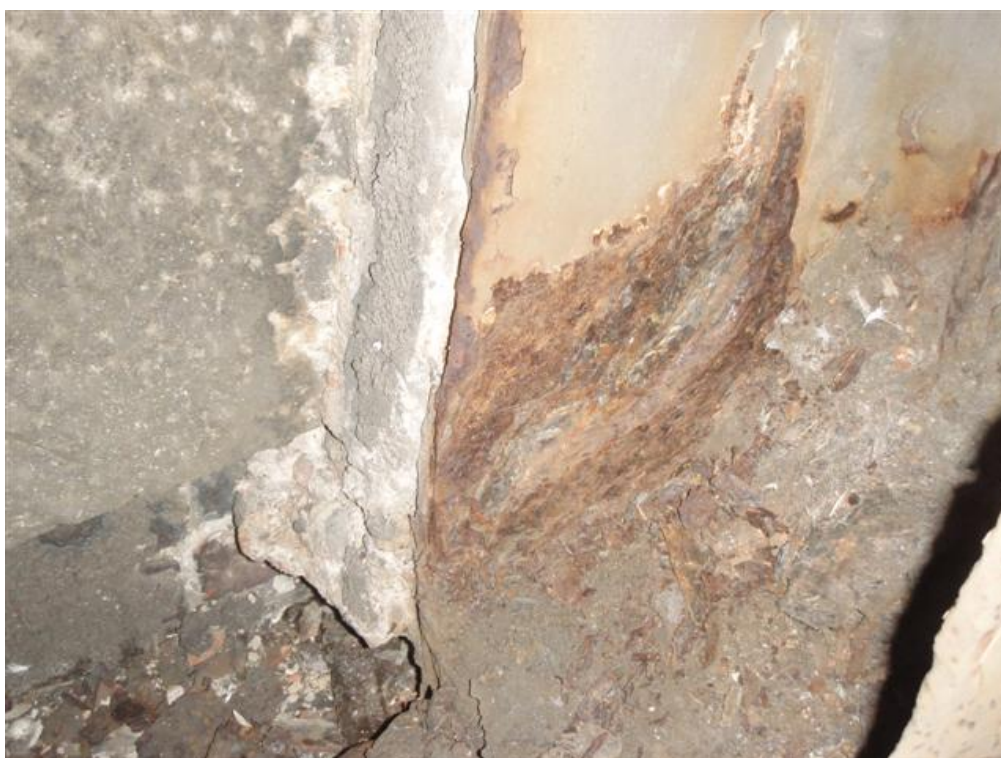
P92 - IS1-PCL1-Thin/lamin to web stiff at HM up - 22/04/11

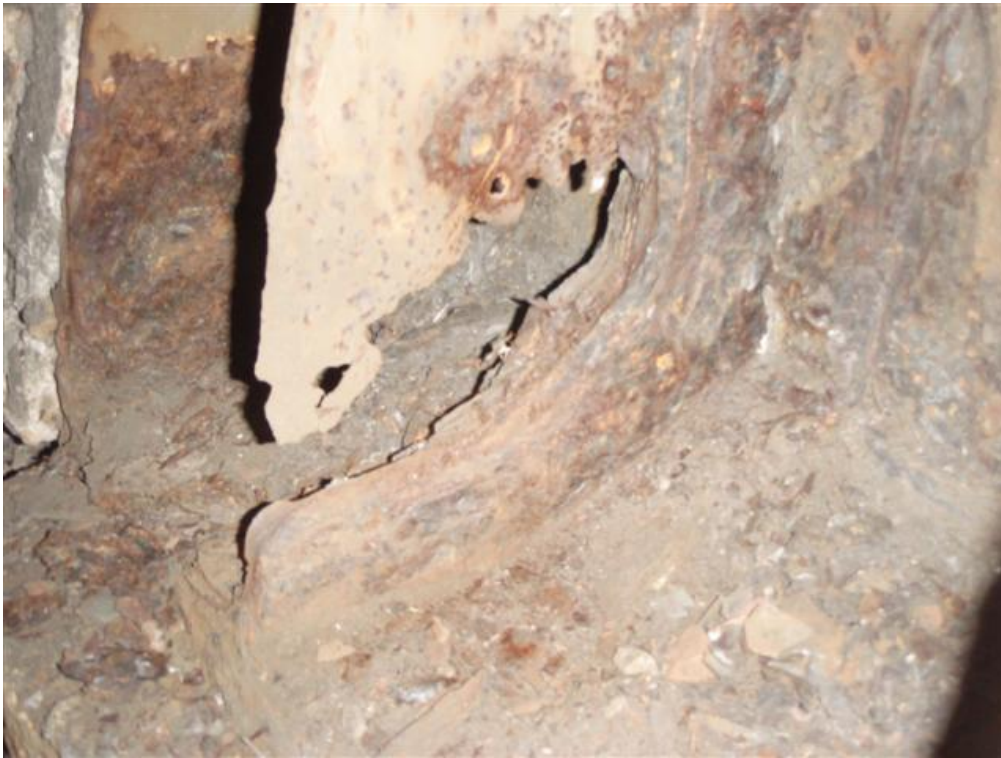
P93 - IS1-PCL1-LOS to 2nd web stiff at HM up - 22/04/11

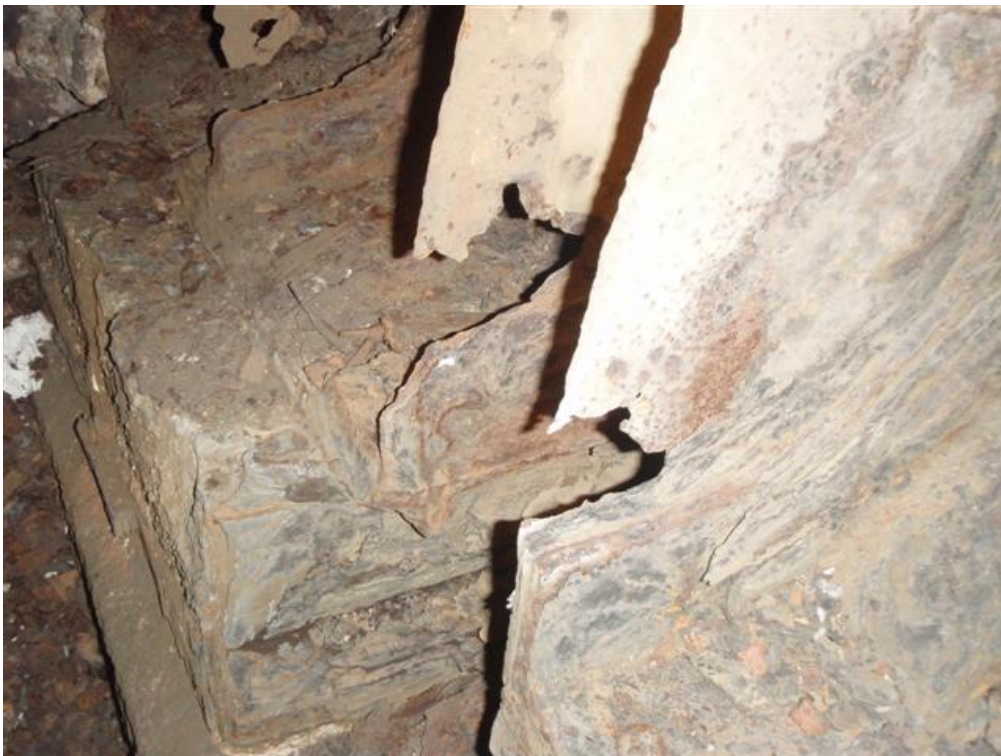
P94 - IS1-PCL1-LOS to 3rd&4th web stiff at HM up - 22/04/11

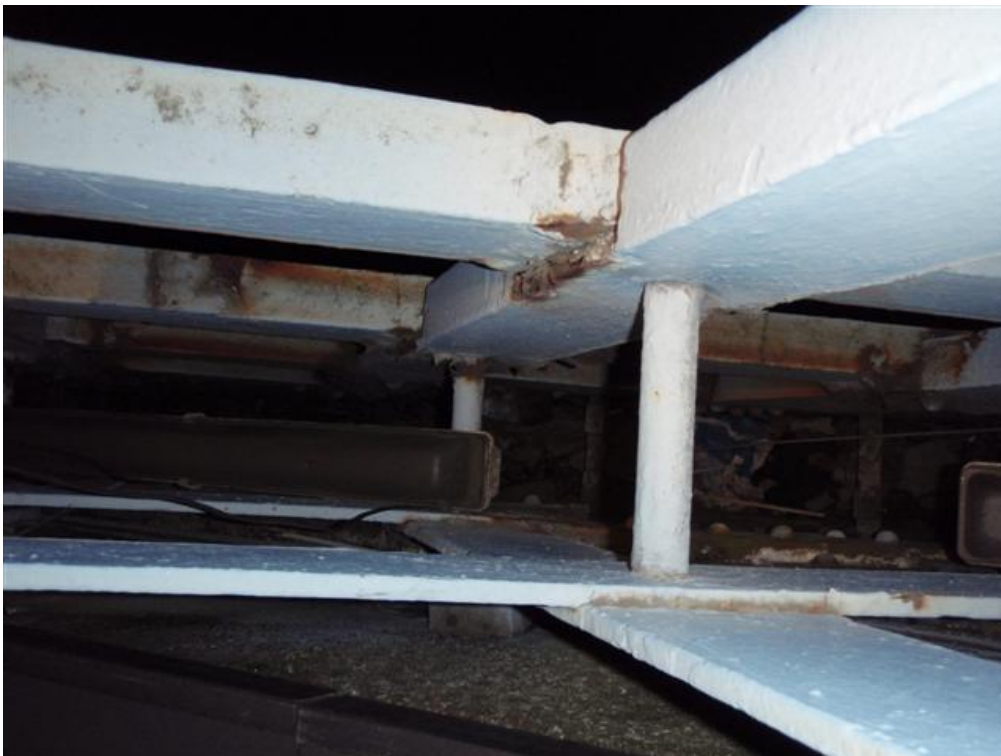
P98 - DK1-PPT1-Debris in bottom channel - 06/03/11

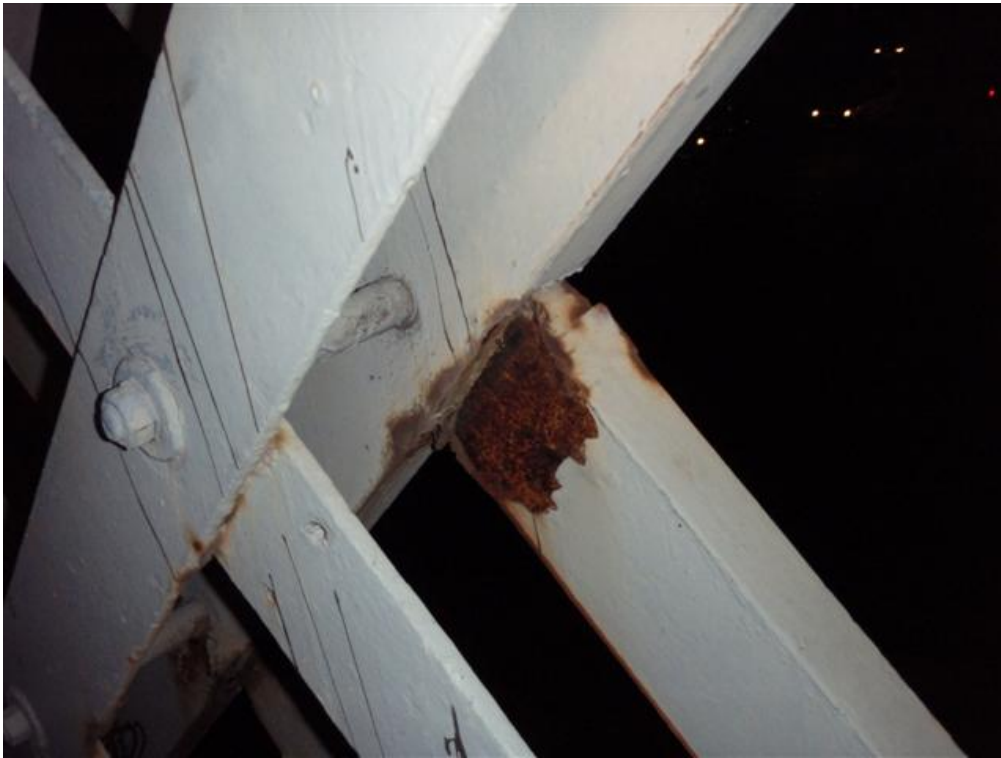
P99 - DK1-PPT1-Typical lamination to lattice - 06/03/11

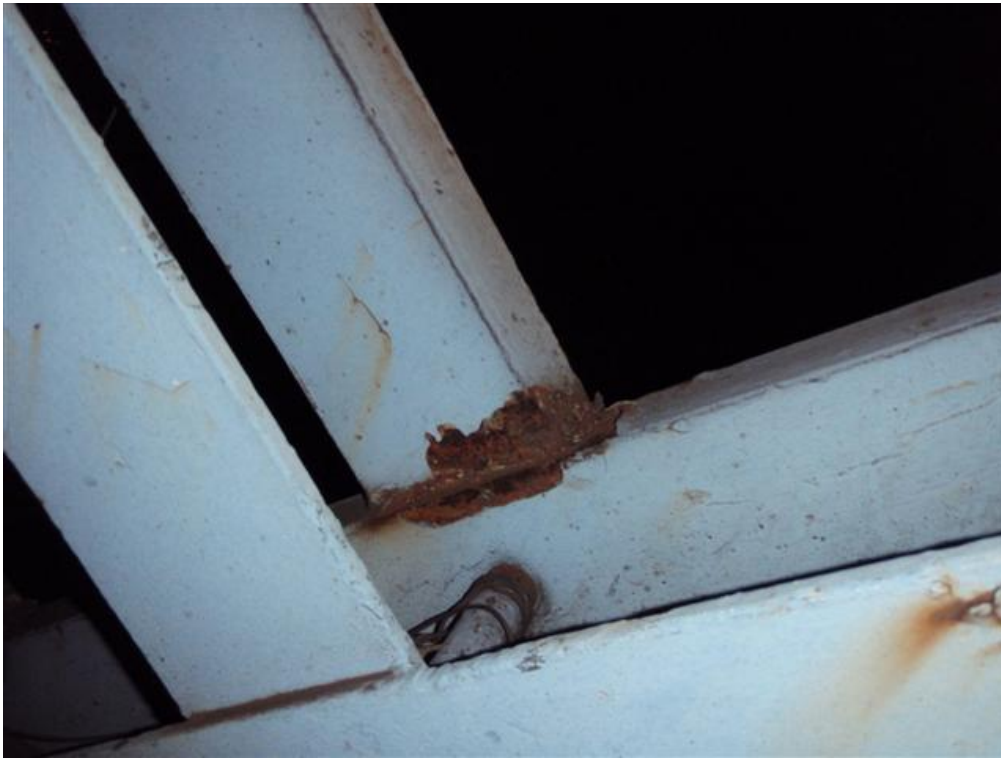
P103 - DK1-PPT2-Typical lamination to lattice - 06/03/11

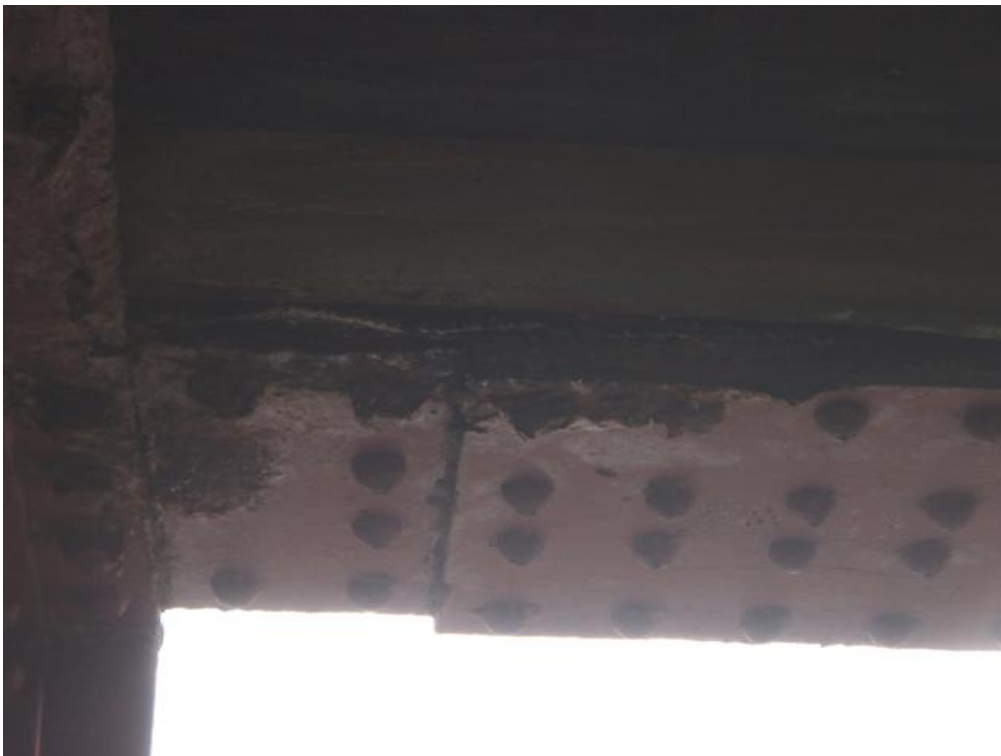
P104 - DK1-PPT2-Typical lamination to bottom boom - 18/04/11
